# **Case Studies of Inductive Coordination and Electrical Protection Issues in the Field**

**PEG GENERAL MEETING - 2013**

**DALE STEGMAIER – ICEP ENGINEER, CA  
LARRY PAYNE – COMMON SYSTEMS STAFF**

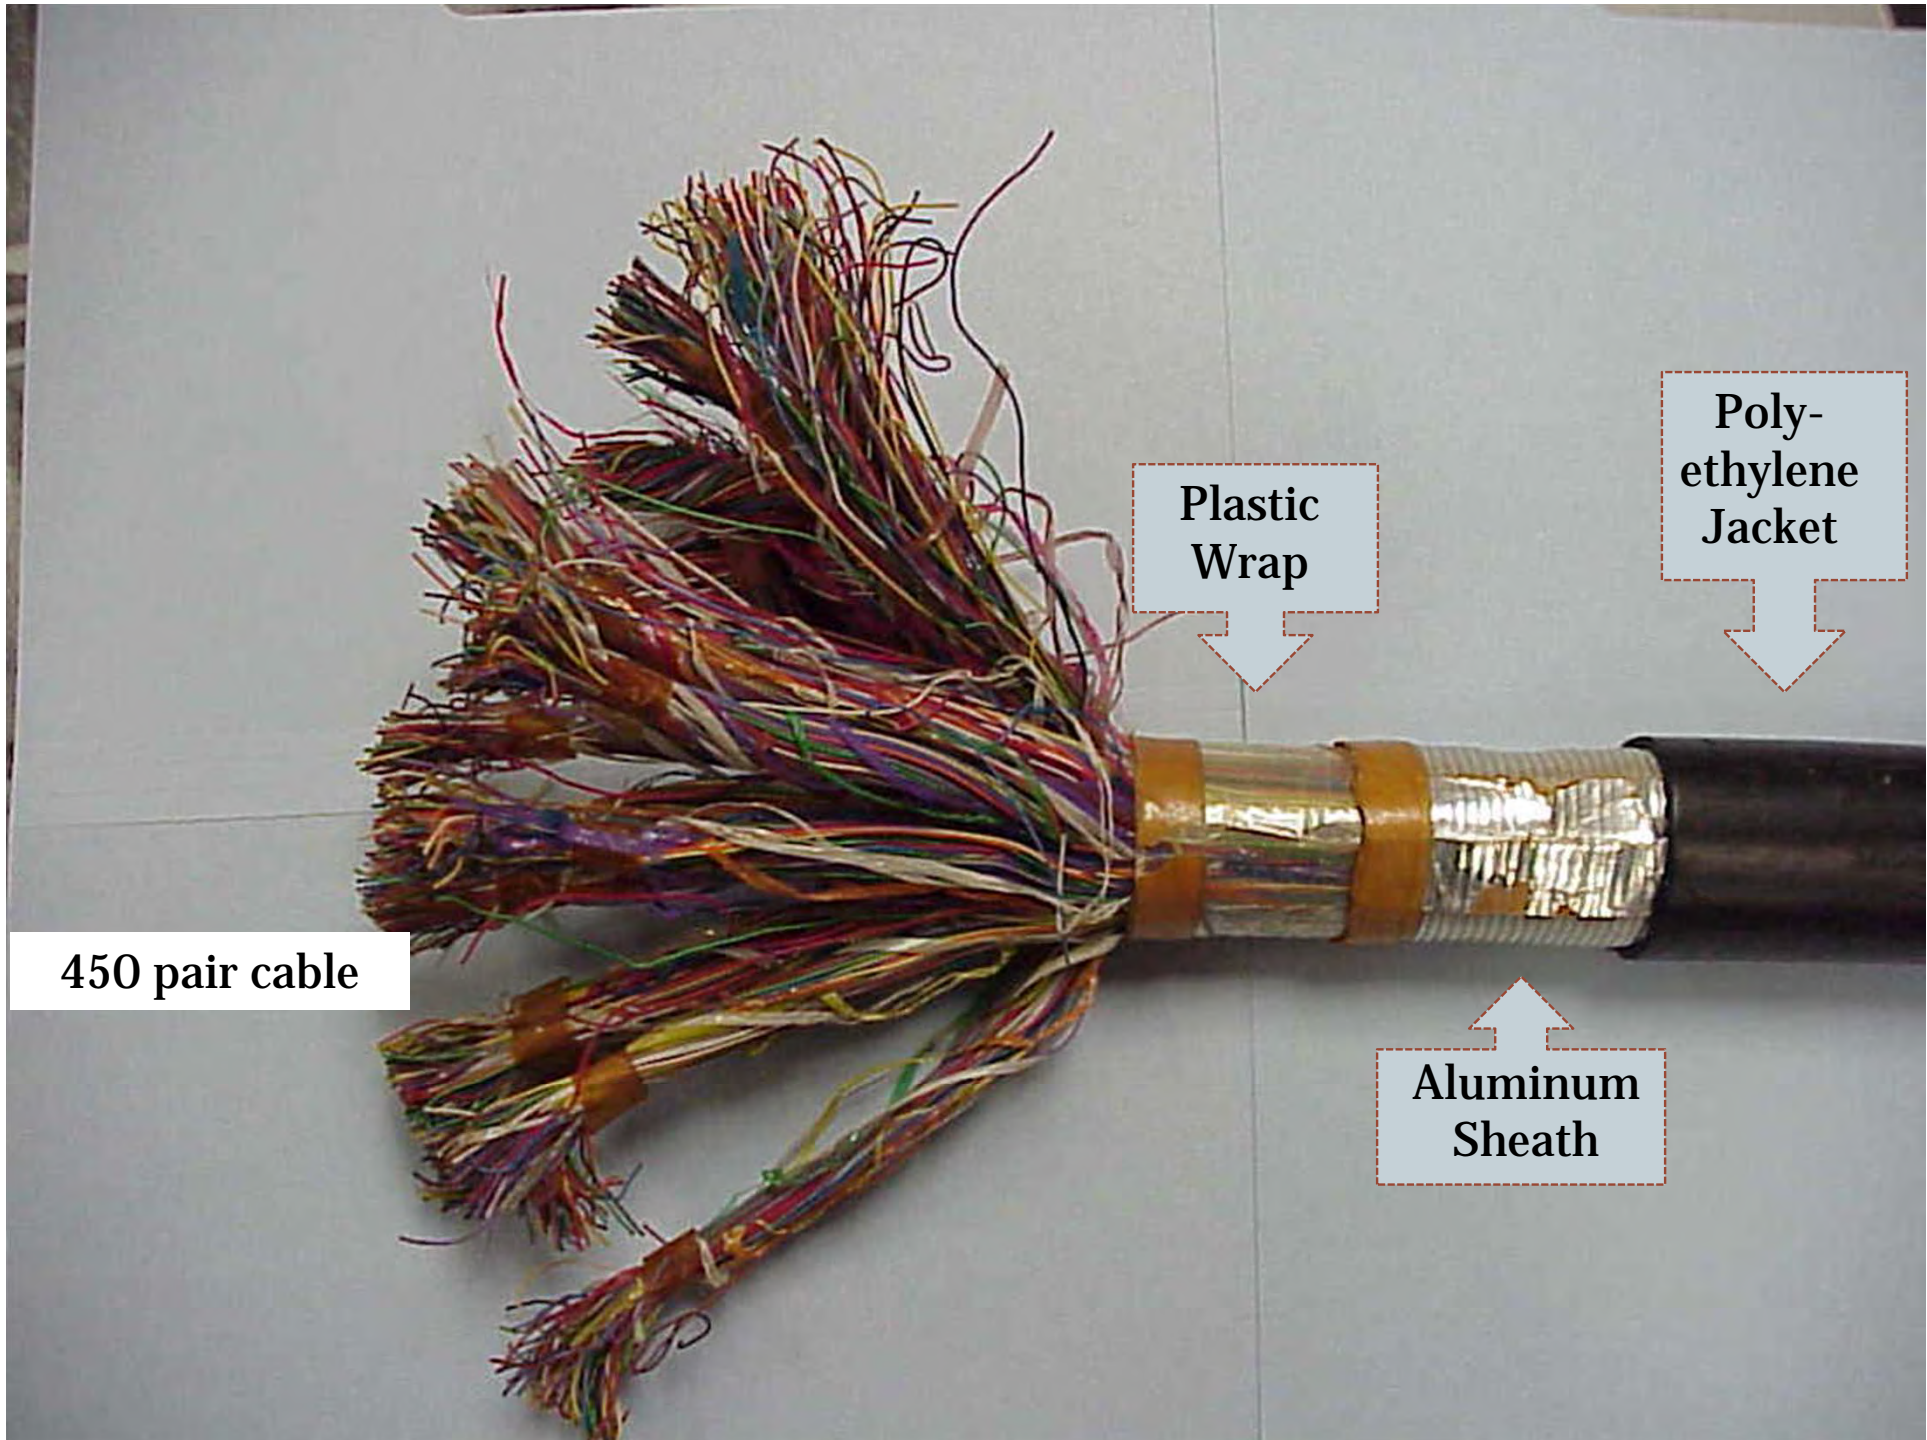
450 pair cable

Plastic  
Wrap

Poly-  
ethylene  
Jacket

Aluminum  
Sheath

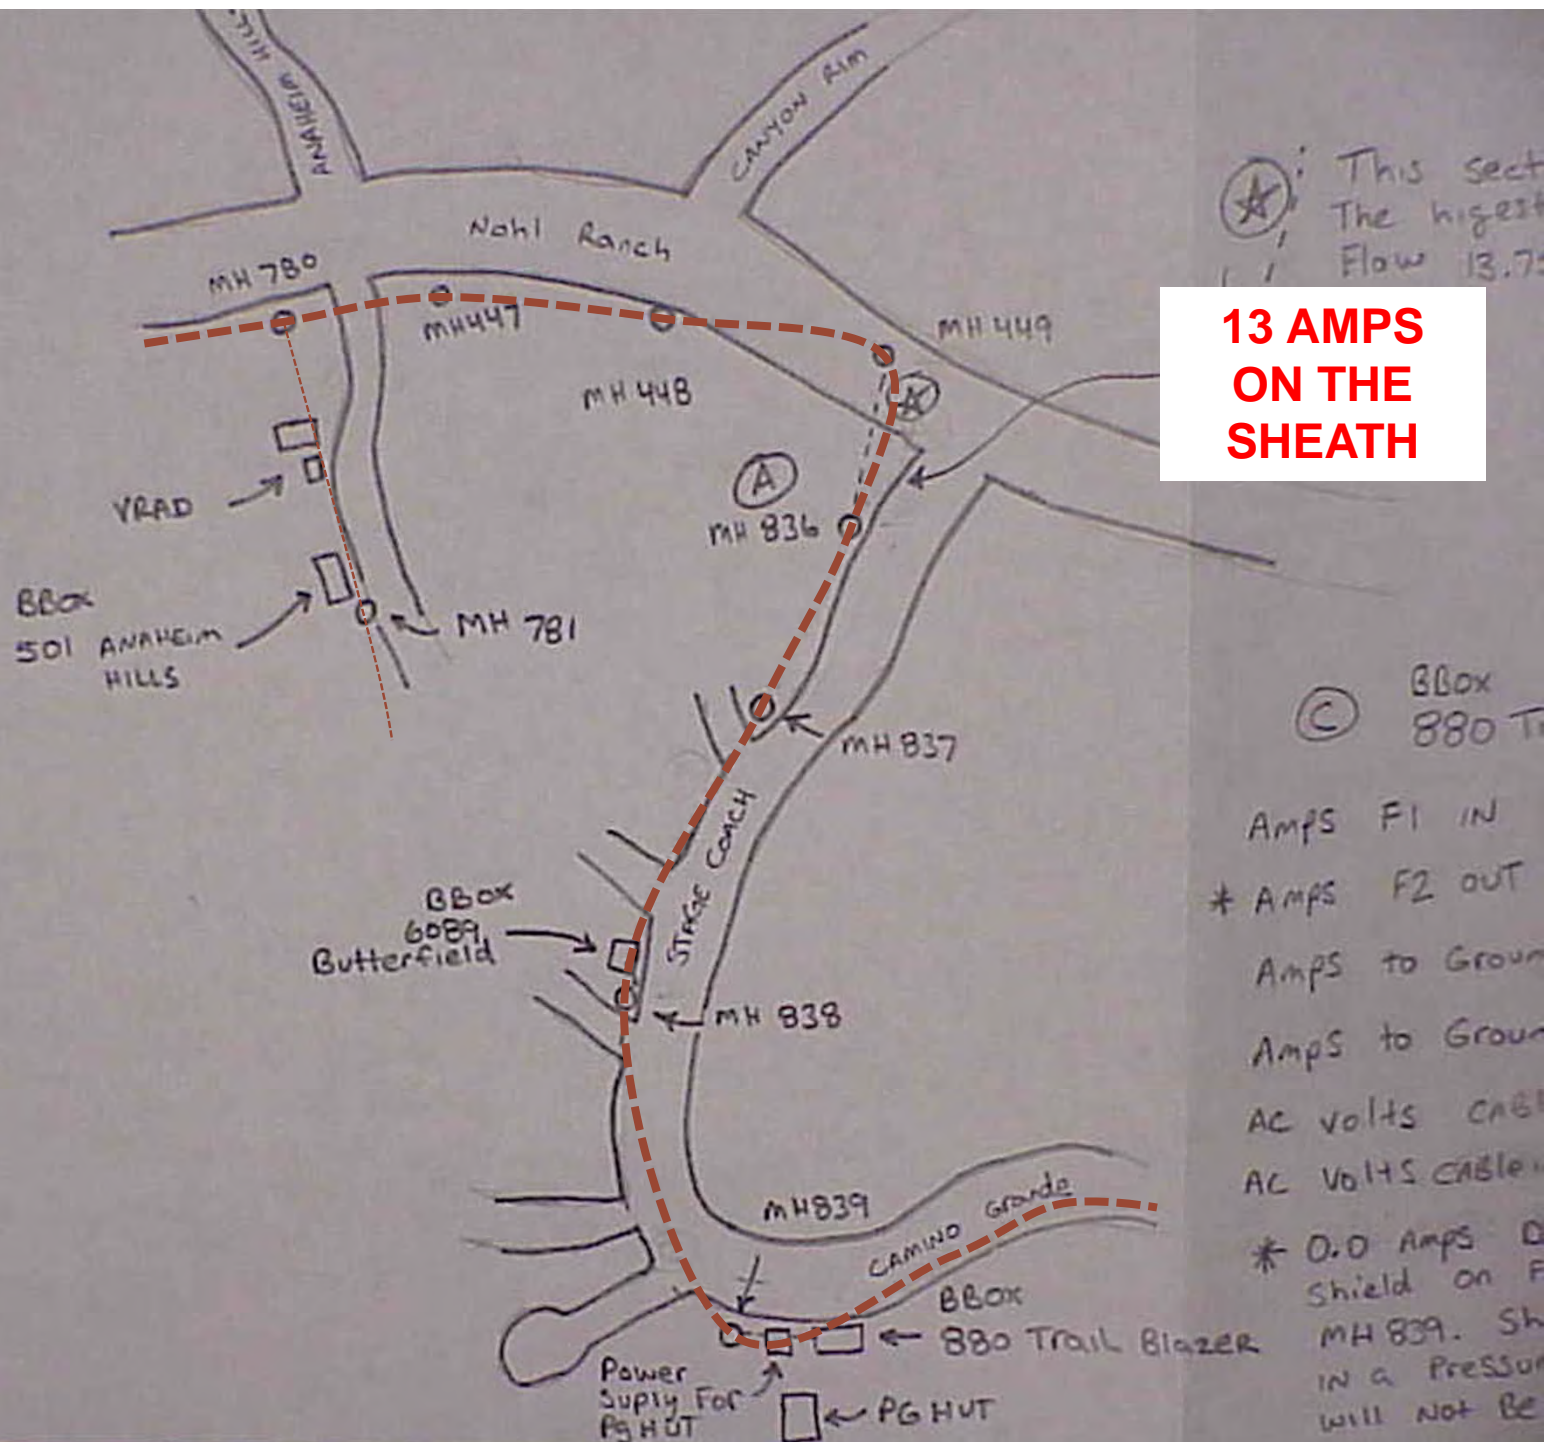
13 AMPS  
ON THE  
SHEATH

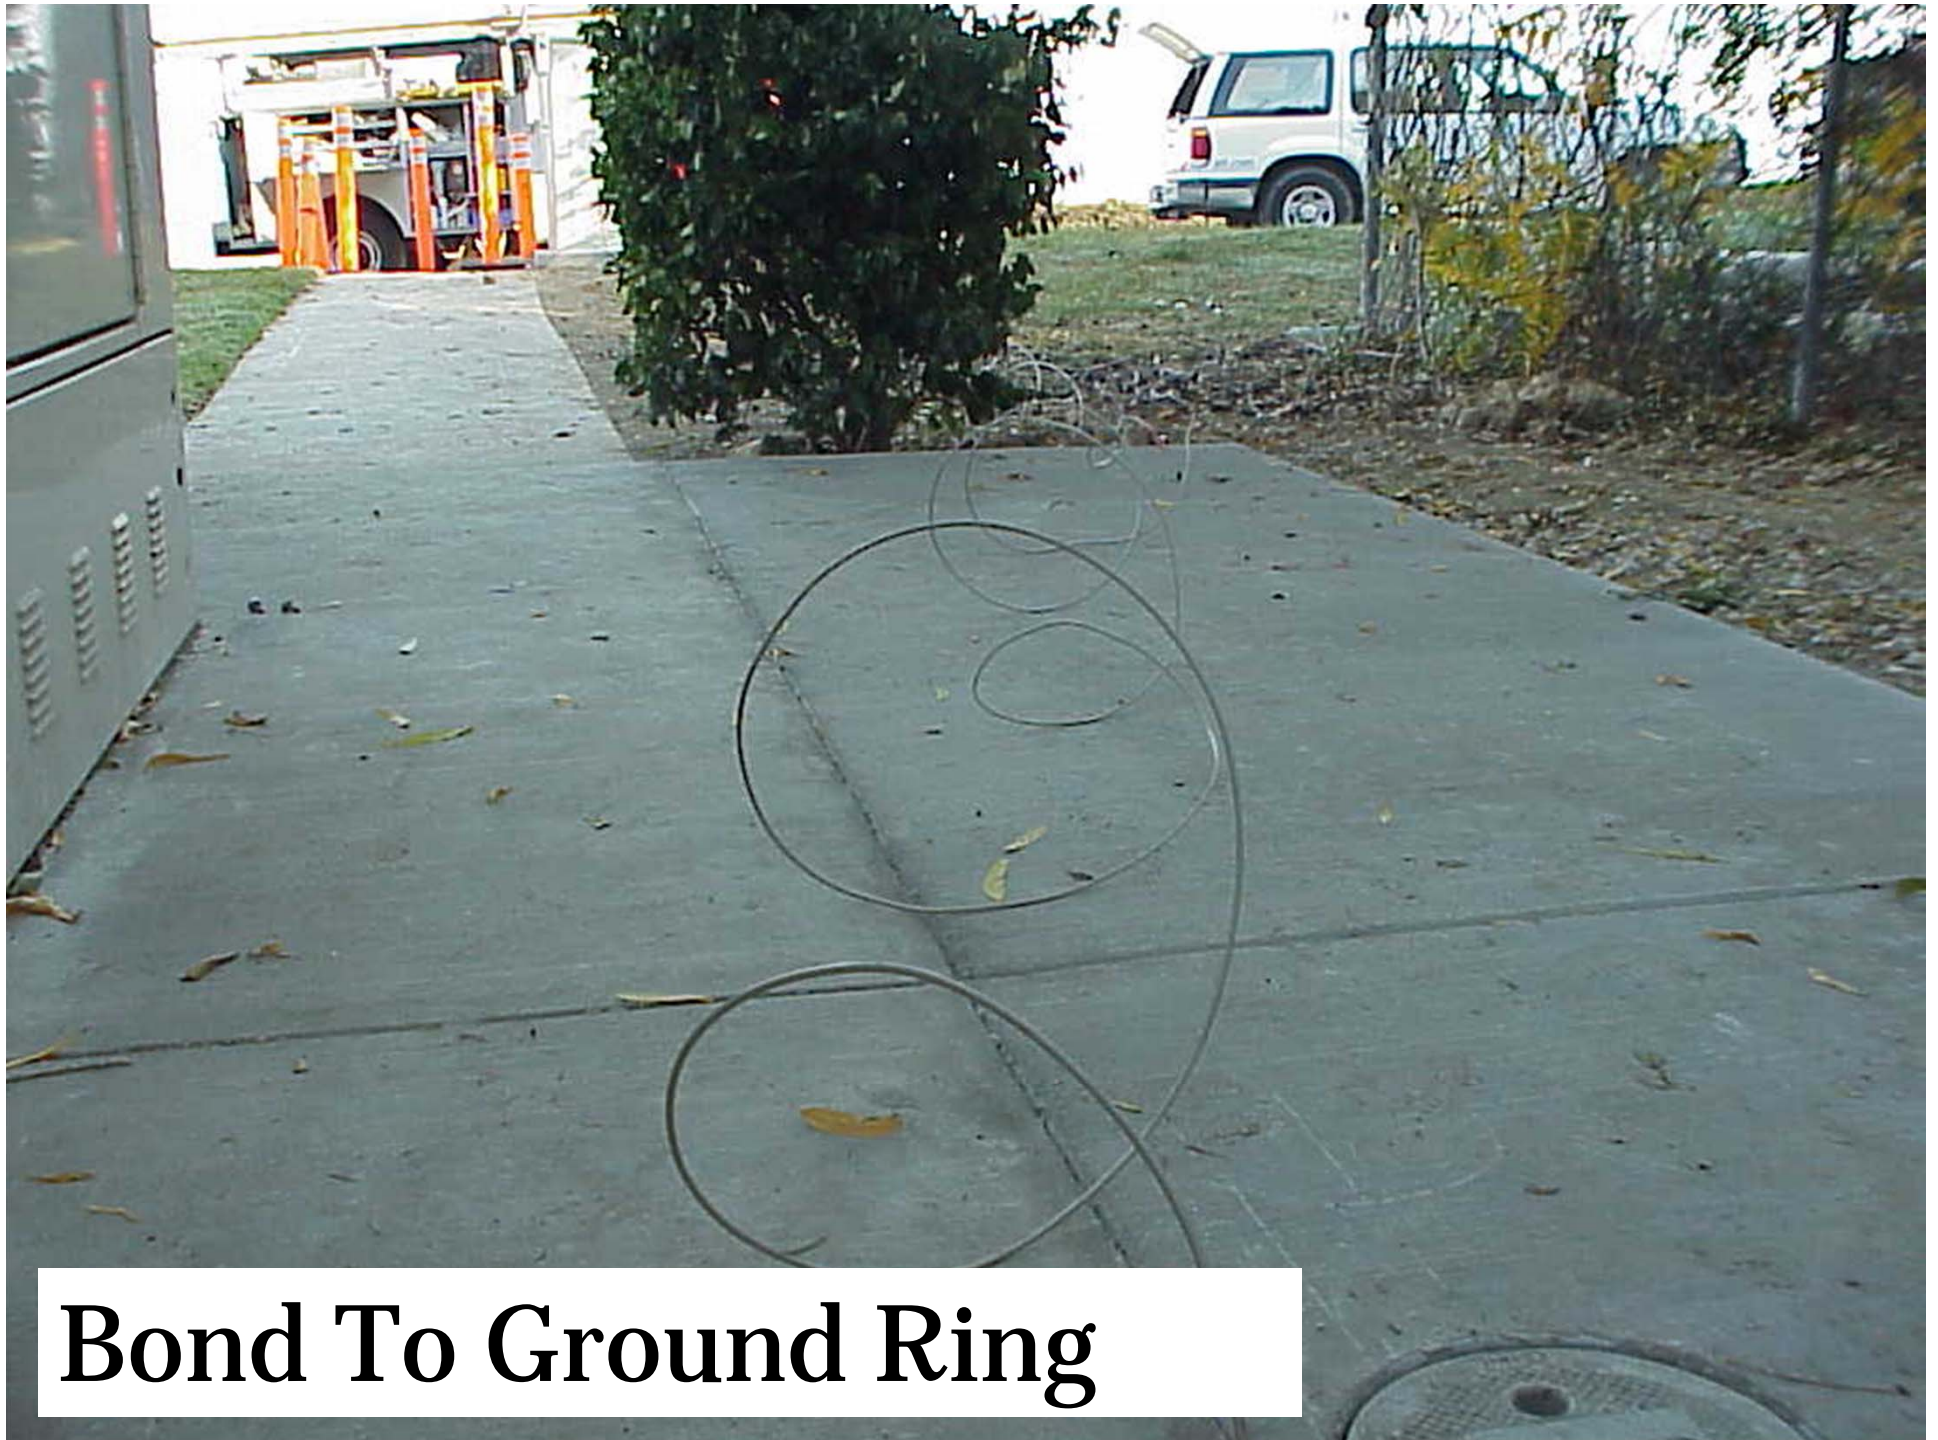
**Bond To Ground Ring**

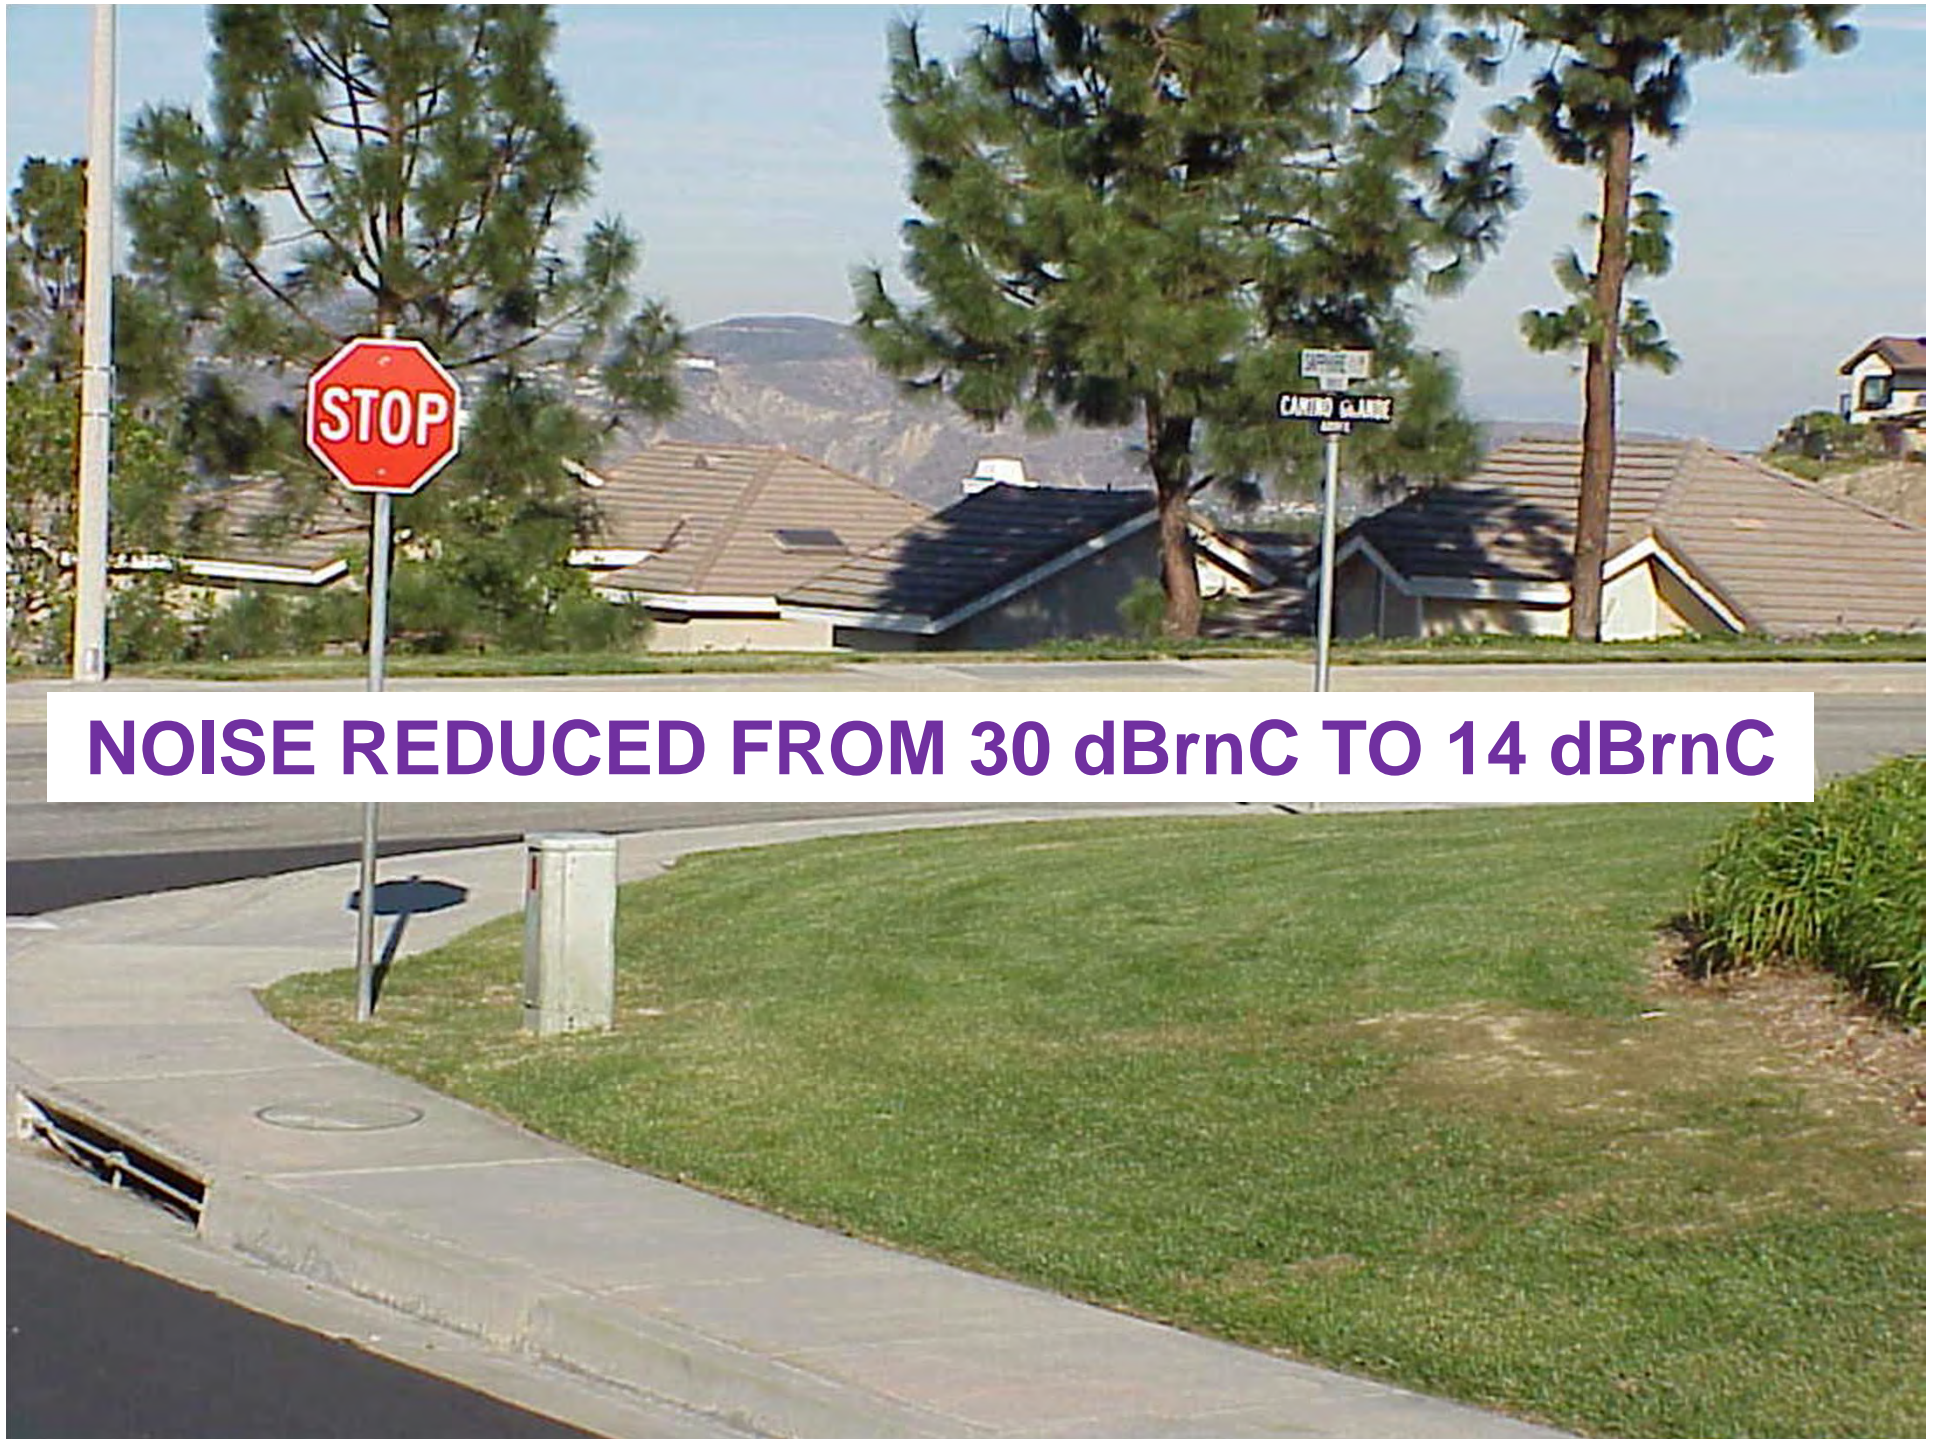
**NOISE REDUCED FROM 30 dBrnC TO 14 dBrnC**

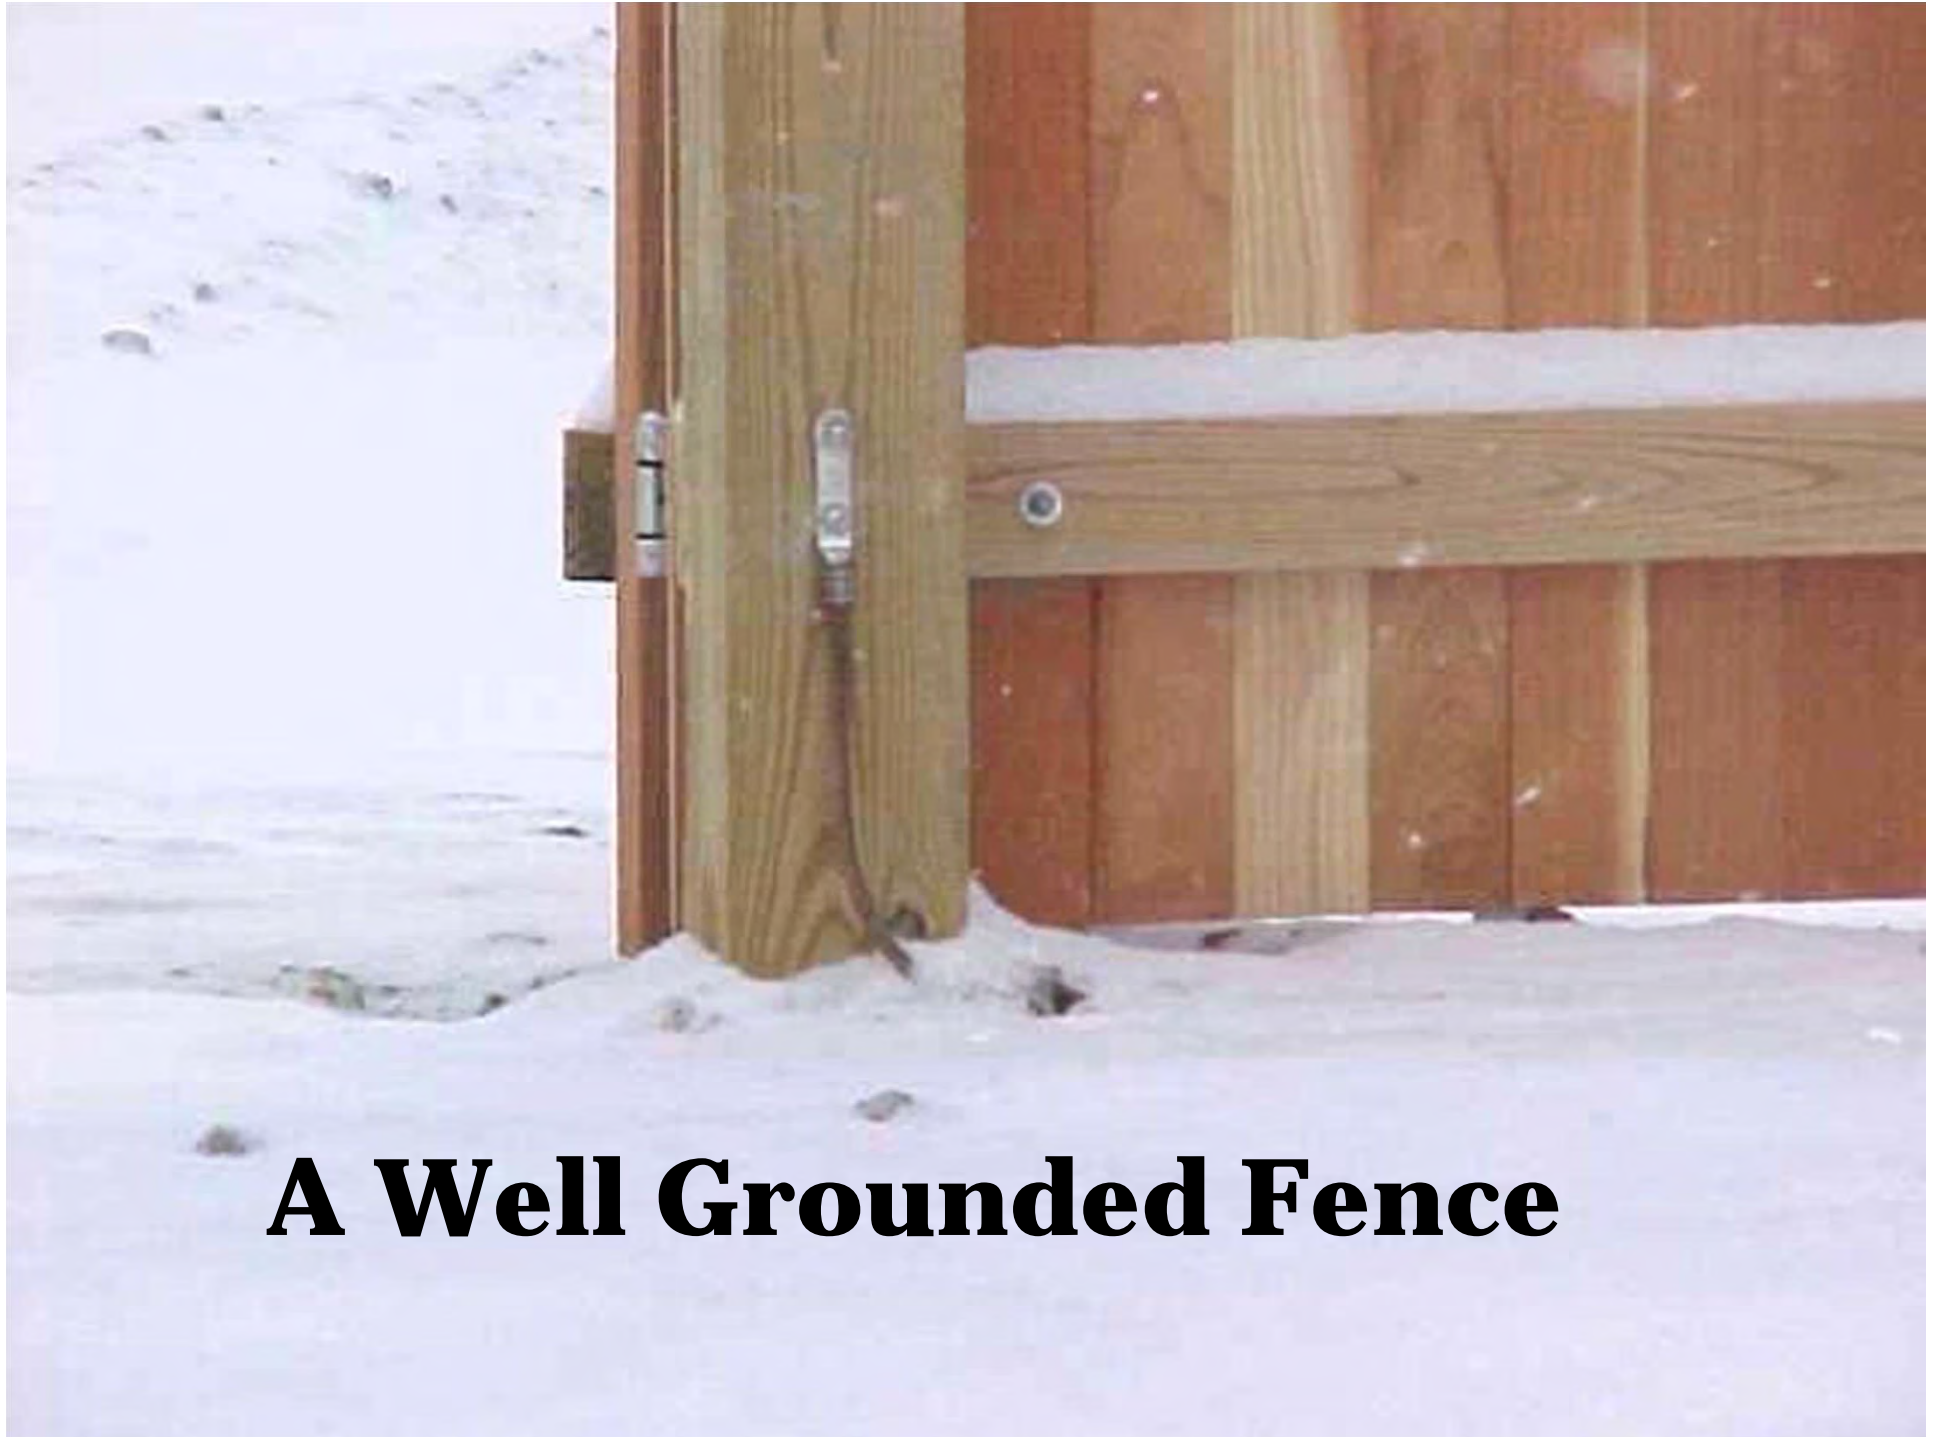
**A Well Grounded Fence**

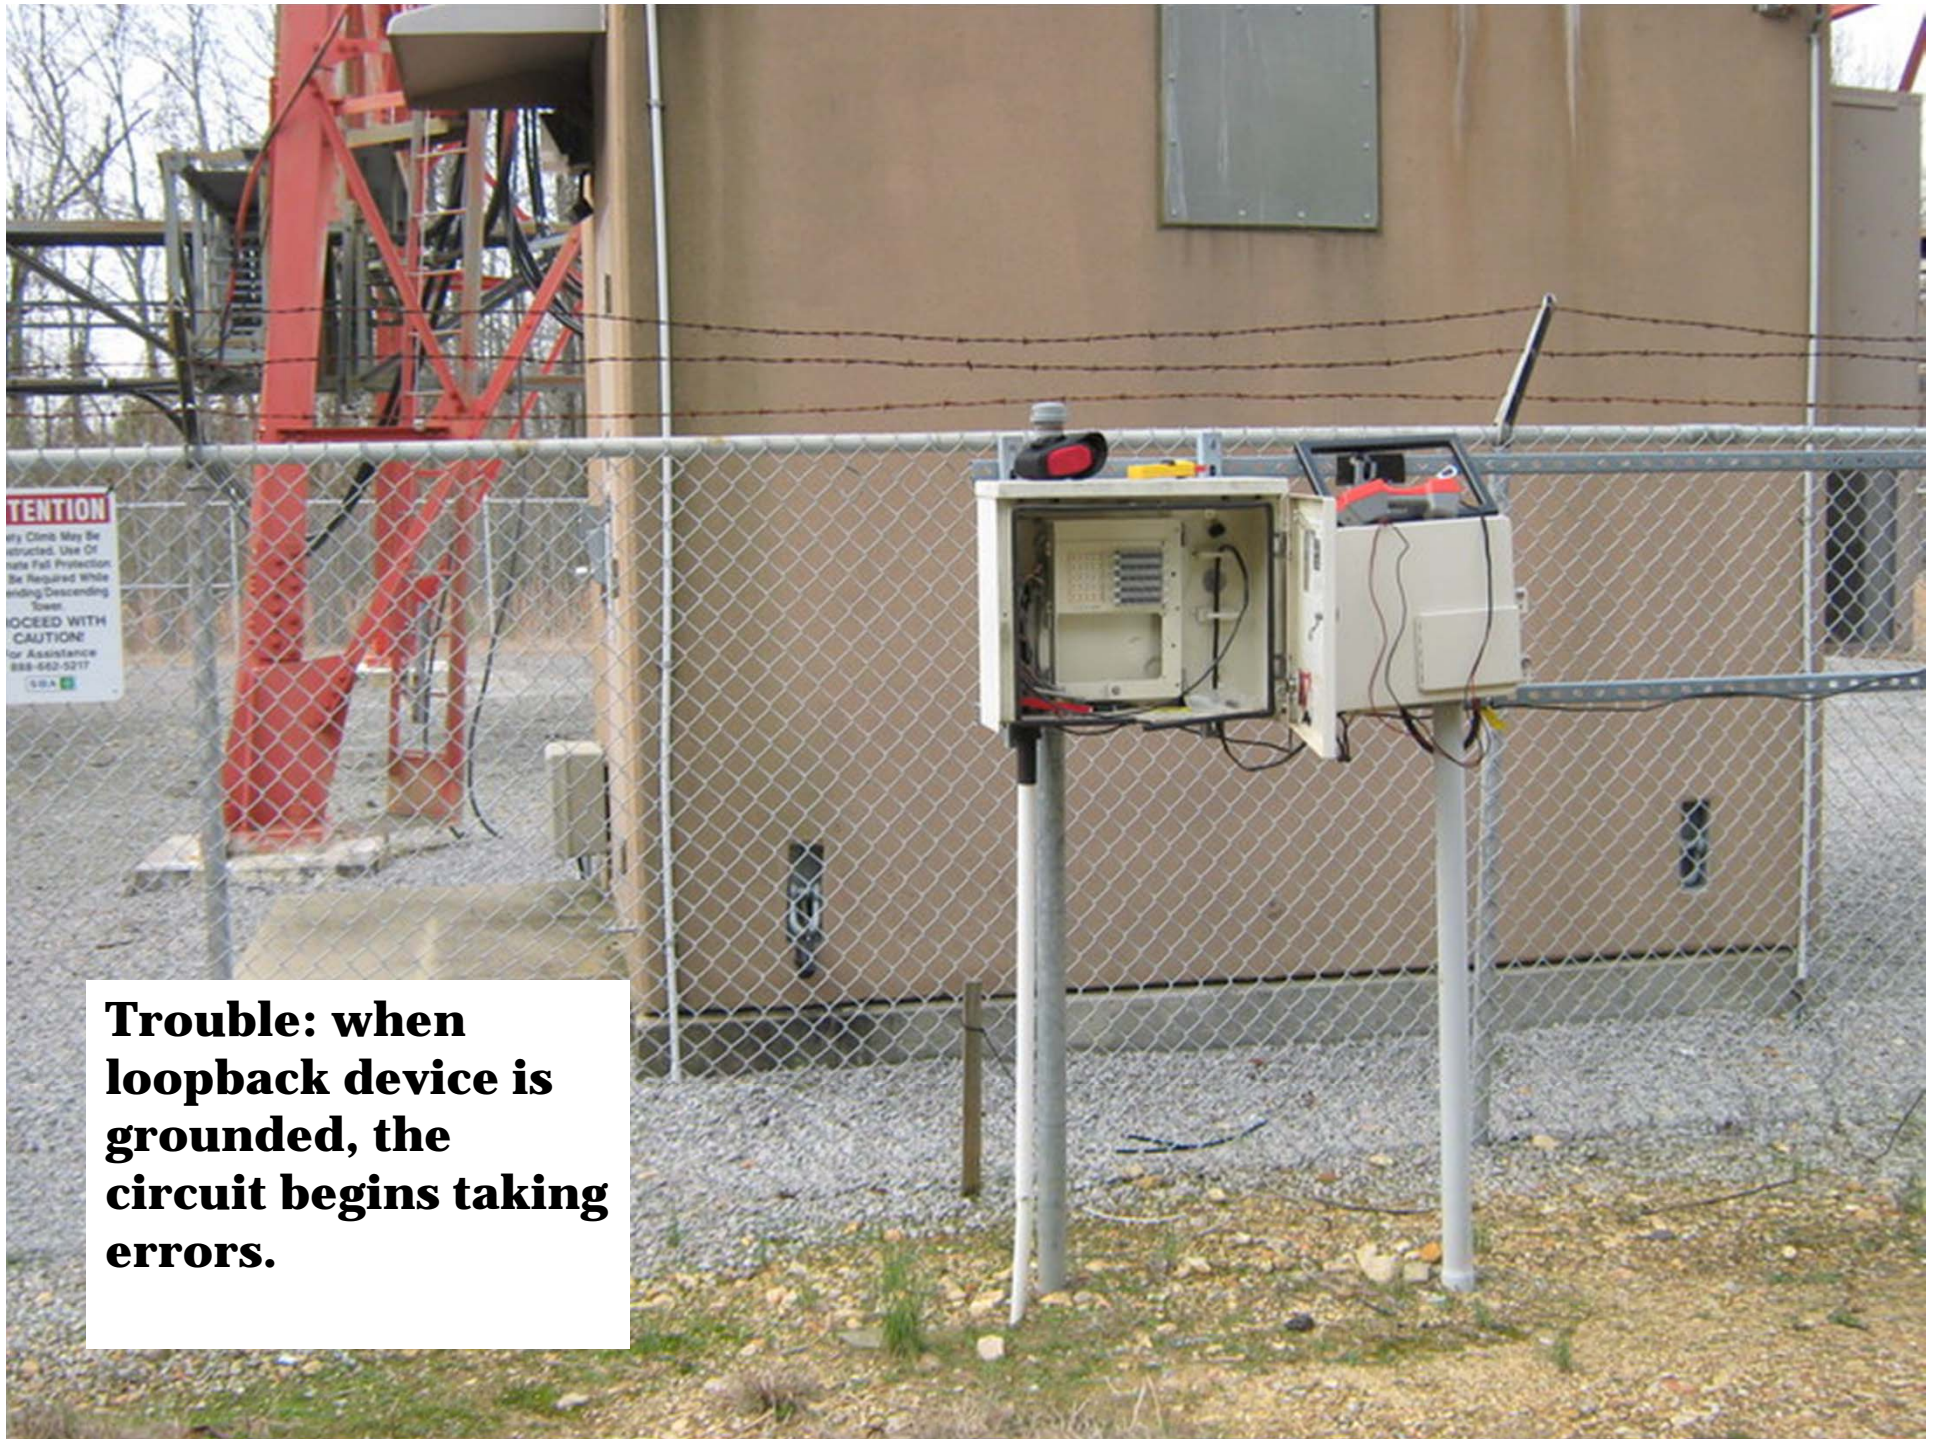
**Trouble: when  
loopback device is  
grounded, the  
circuit begins taking  
errors.**

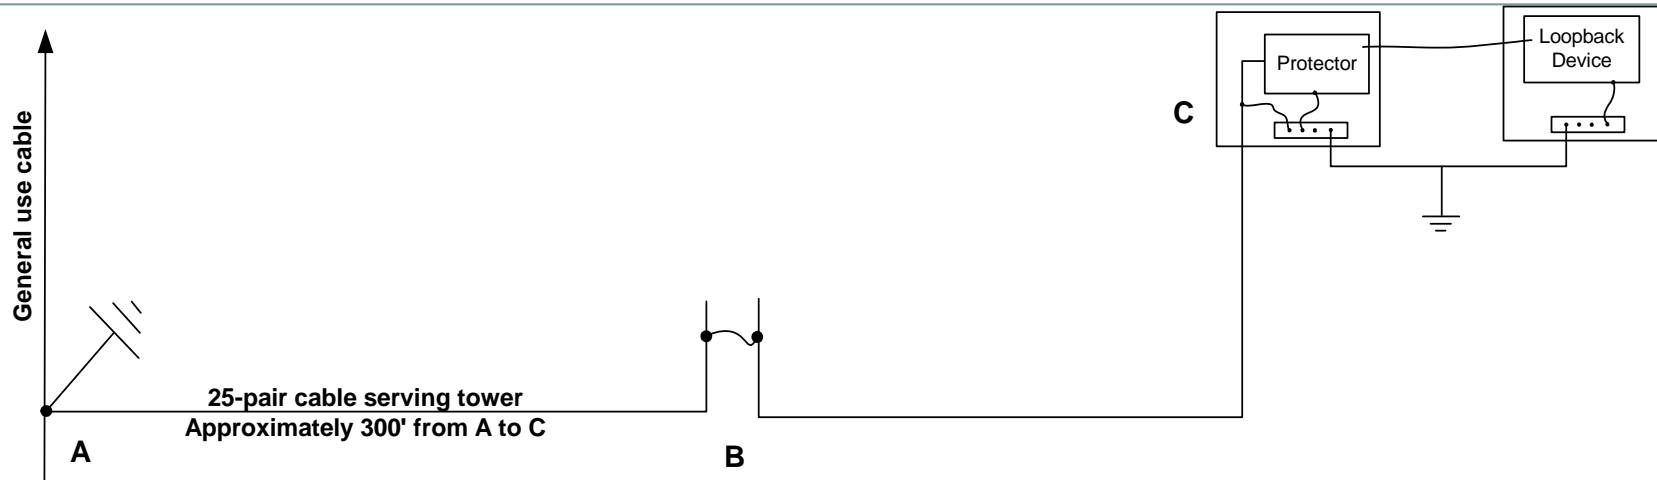
**This method works by measuring induced voltage and current flow on the shield**

- Induced Current at the Bond Strap at Location C = 7 ma (Between the Grounds at Location A & C)
- Induced Open Circuit Voltage at Point C with Bond Strap Removed = 0.1 volts
- Calculating the Resistance of Shield Between A & C -  $0.1 \text{ volts} / .007 \text{ a} = 14\Omega$
- This Resistance Should be  $< 1 \Omega$  (25 Pair Cable Shield has  $\sim 1\Omega$  per 1000 ft)
- The Only Bond Between Locations A & C was at the Splice at Location B
- Bond was corroded, when replaced, the Induced Current Flow at Location C Increased to 1.12 amps
- Indicating that the Resistance of the repaired shield was less than  $1 \Omega$

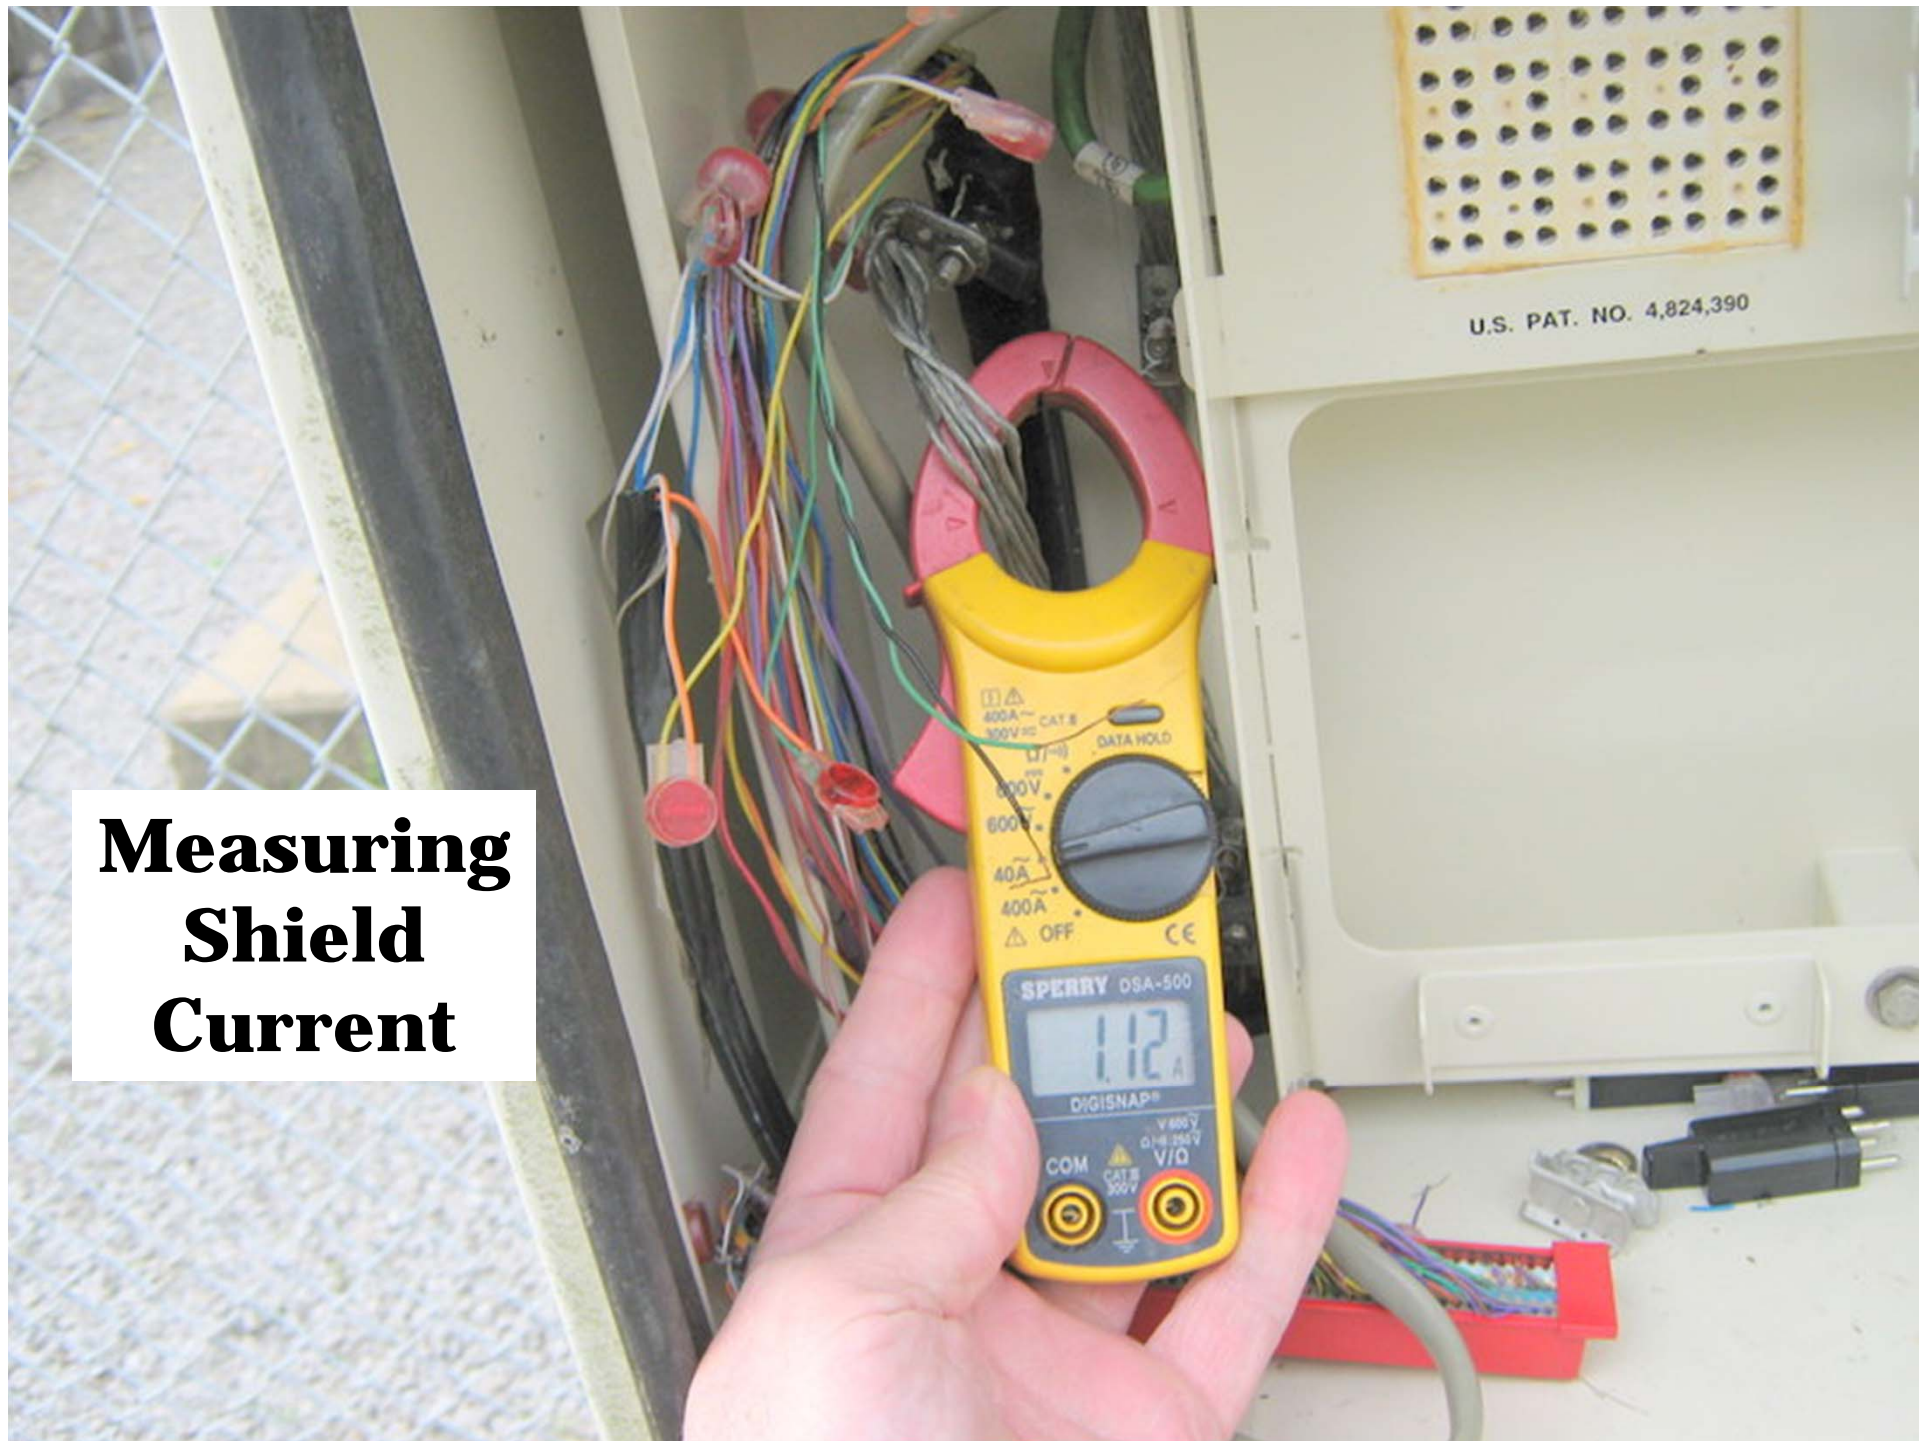
**Pedestal with  
Corrosive Bond**

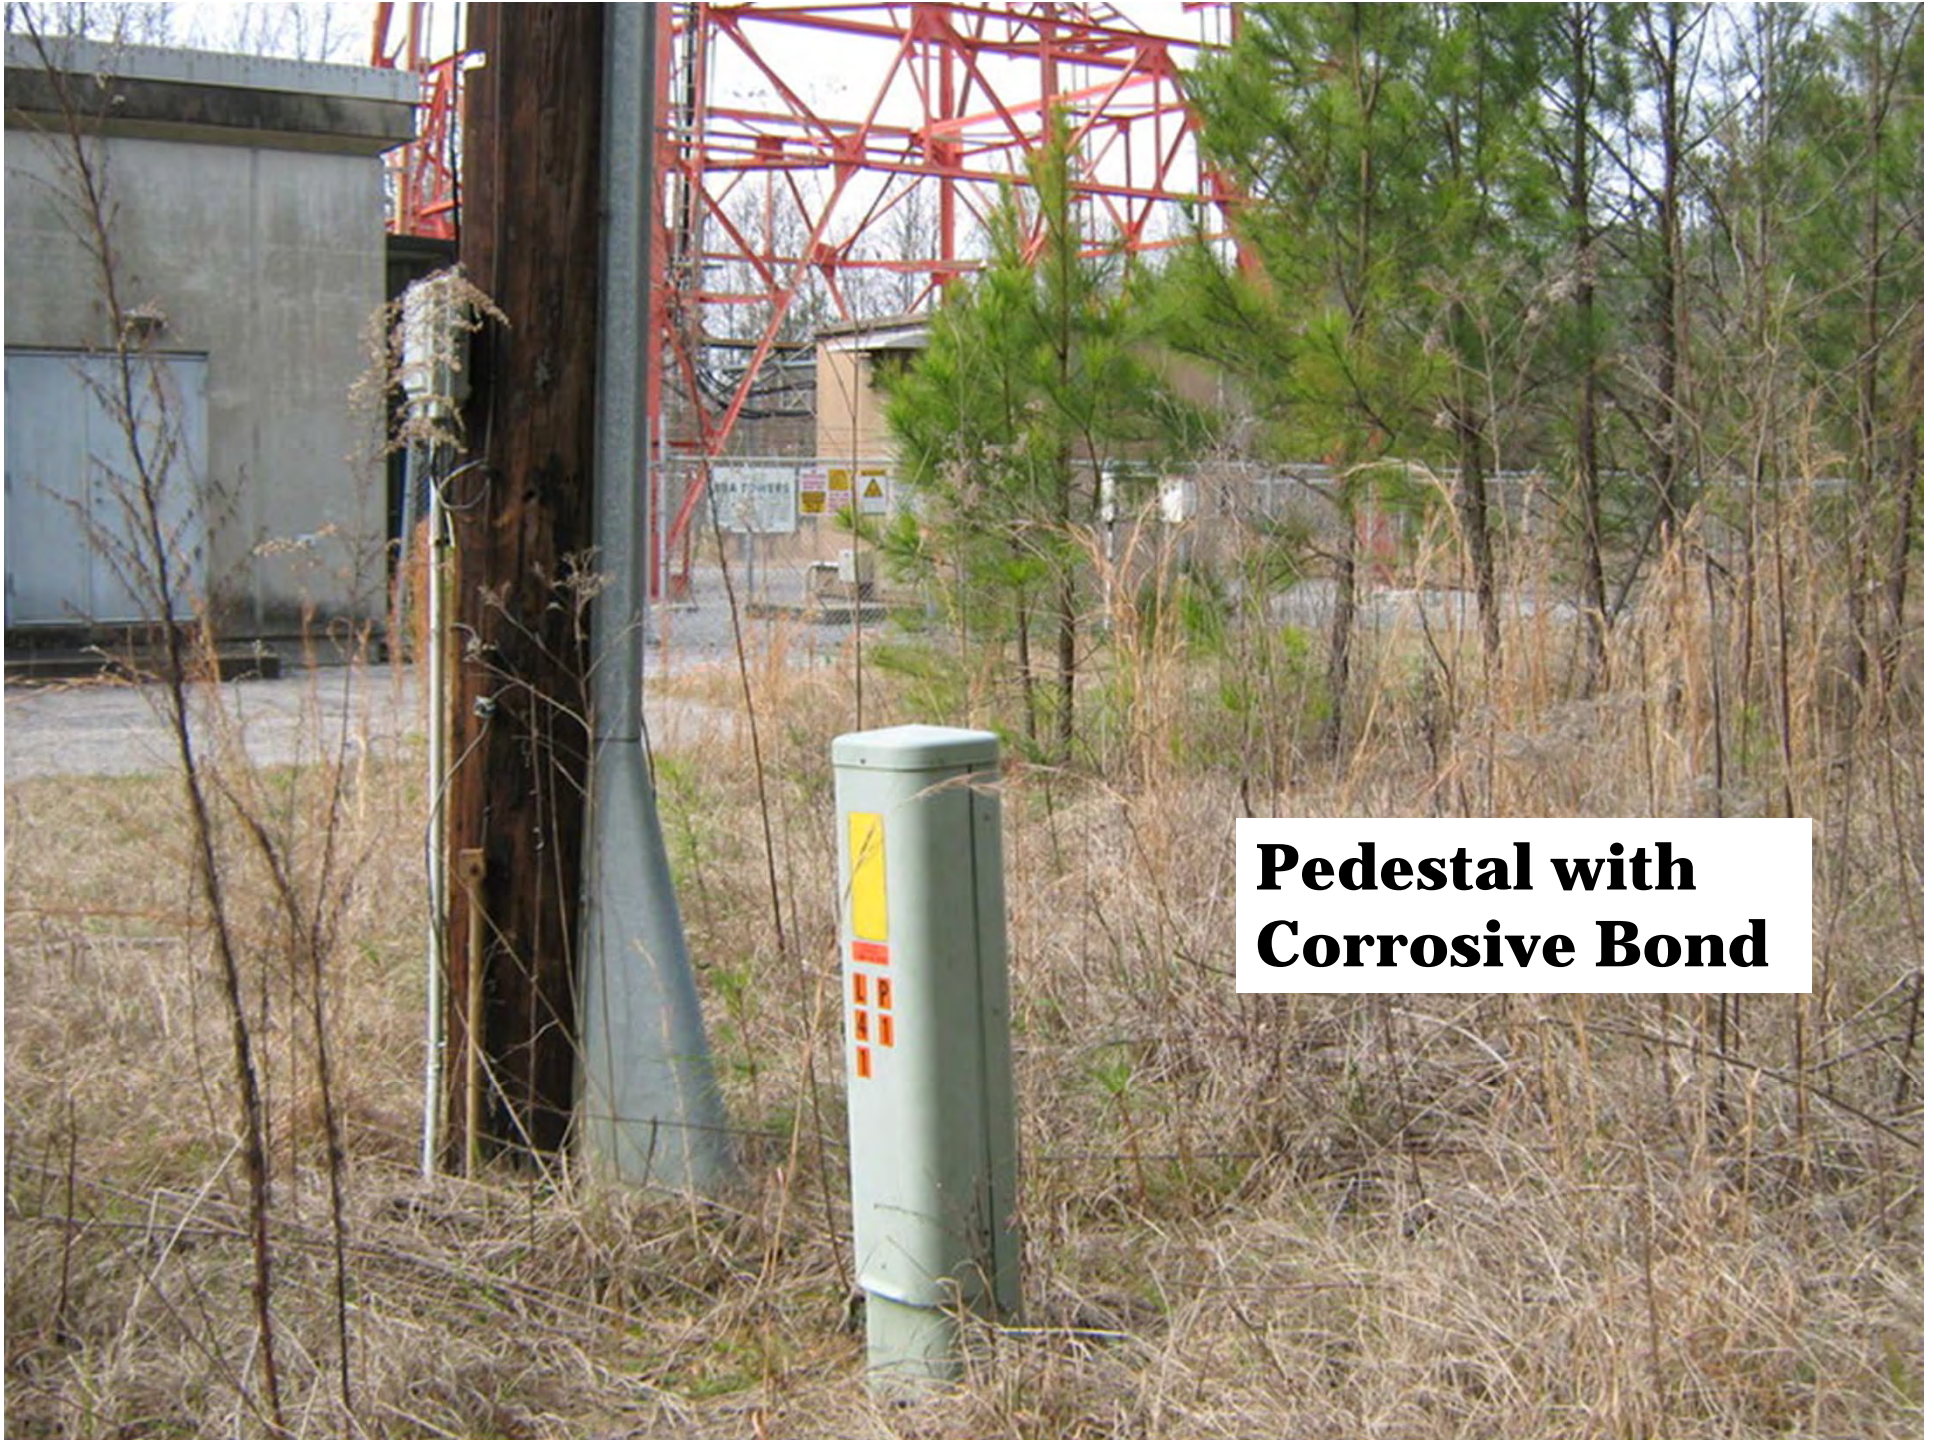
**Sections of  
Corroded  
Shield at  
Splice  
Location B**
