# **Case Studies of Inductive Coordination and Electrical Protection Issues in the Field**

**PEG GENERAL MEETING - 2013**

**DALE STEGMAIER – ICEP ENGINEER, CA  
LARRY PAYNE – COMMON SYSTEMS STAFF**

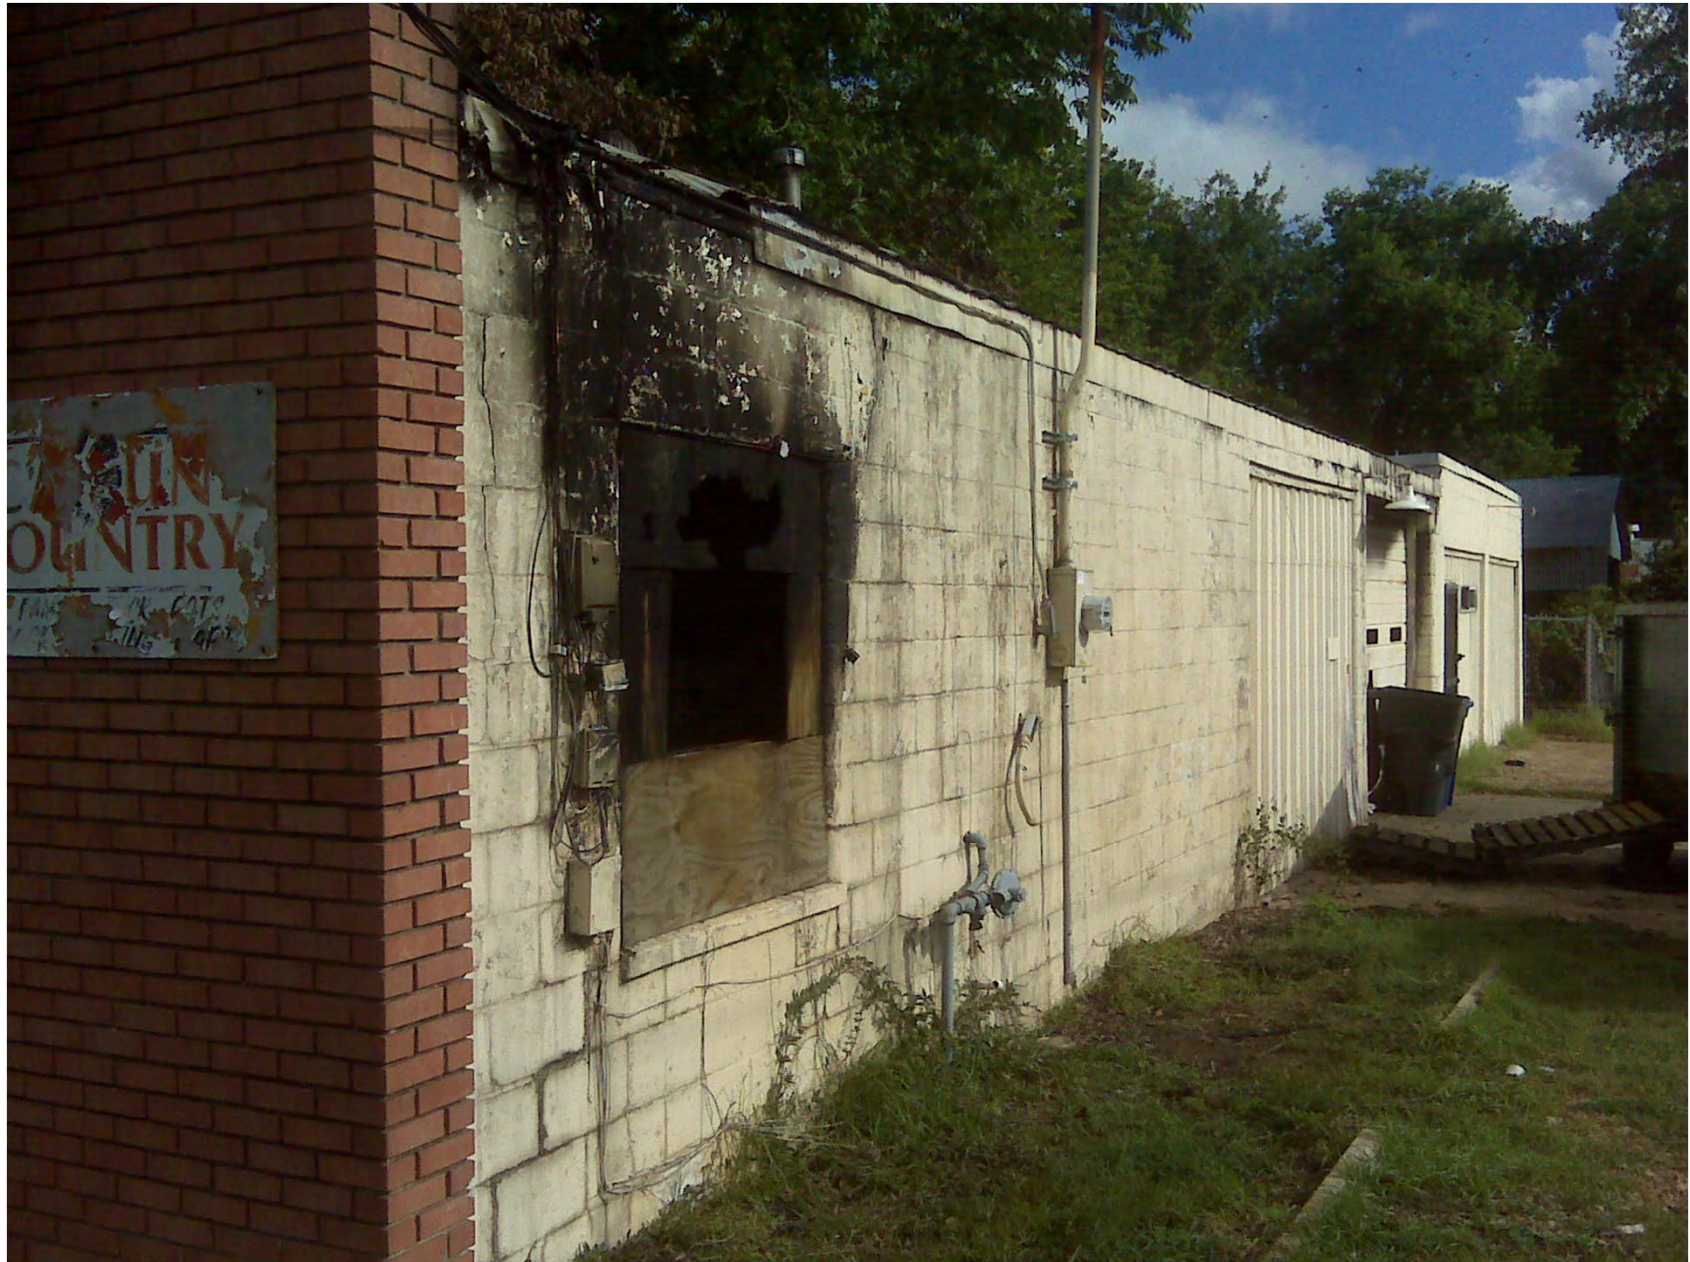
**NEC Article 800.24 Mechanical Execution of Work.**  
Communications circuits and equipment shall be installed in a neat and workmanlike manner.

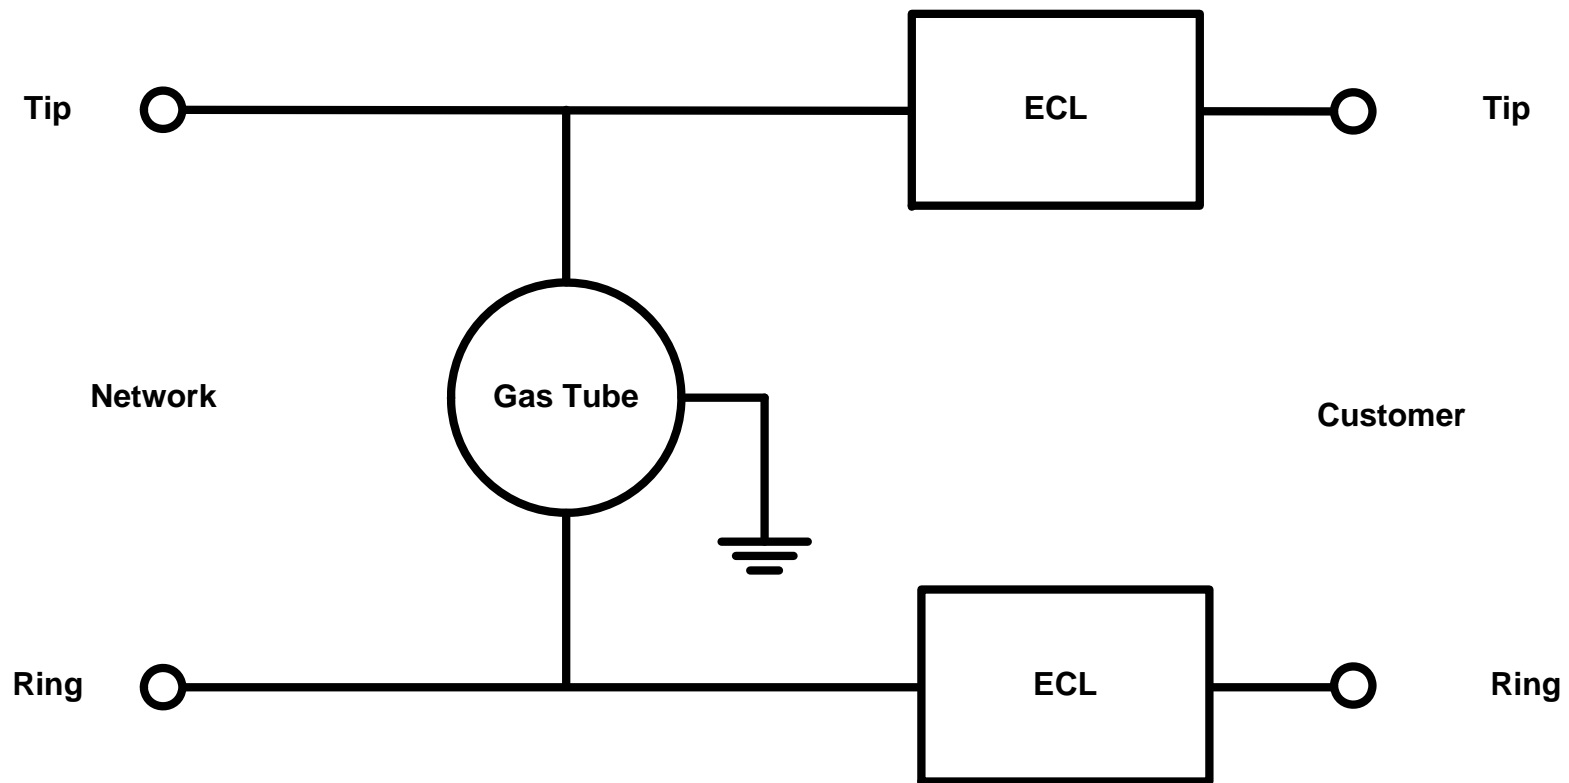
# Three Element Gas Tube with ECL Station Protector Schematic

- Switches very quickly from a low resistance state – approximately  $12\Omega$  - to an open circuit when current threshold is exceeded
- Signal / surge path is opened until gas tube fires
- Signal / surge path is shorted to ground until surge is removed
- Critical to connect “Network” side to cable pair, “Customer” side to customer’s inside wiring
- Results – no more damage to electric fence controller in more than a year
