Case Studies of Electrical Protection Issues in the Field

DALE STEGMAIER & LARRY PAYNE PEG GENERAL MEETING - 2013

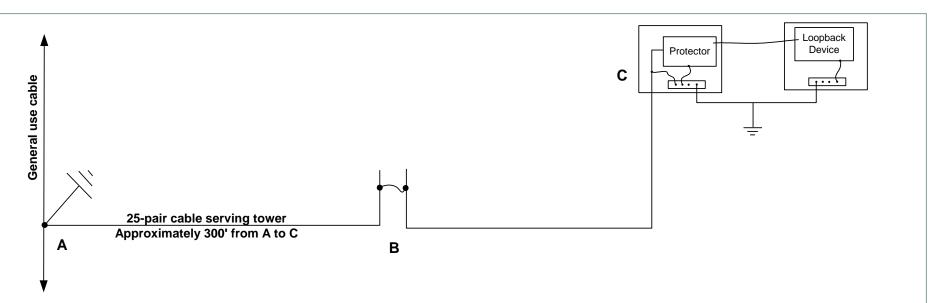
By clamping on the bond strap at location C and seeing no current flow, I was able to immediately determine the shield wasn't working properly from the ground at point A to the ground at point C. Since this is a 300' section of 25-pair cable, the resistance in the shield between point A and C should be less than 1 ohm (1000' of 25-pair cable has a shield resistance of about 1 ohm).

I then removed the bond at point C and measured the induced voltage which was 0.1 volts. This indicted the shield wasn't completely open, so I re-attached the bond and used a more sensitive clamp-on ammeter (AEMC 3731) and measured 0.007 amps. This allowed me to do the simple calculation of (V = I X R) and determine how much resistance I had in this 300' section of shield. My resistance was R = (0.1 / 0.007) = 14 ohms. Therefore, we had a high resistive splice that was adding this additional resistance and was drastically limiting the amount of current that could flow in the shield.

The bonds in the pedestal at location B was where the problem existed. When this bond was replaced, the resistance dropped from 14 ohms to less than 1 ohm and the current increased from 0.007 amps to 1.12 amps.

This section now has 1.12 amps of current flowing on the shield (99% more than before). This increased current is now creating a strong enough magnetic field around the cable to effectively cancel the magnetic fields from the power lines and we can now ground our loopback without the circuit taking errors. When we only had 0.007 amps current flowing in the shield, the magnetic field it was creating around our cable was cancelling less than 1% of the induction from the power lines and thus enough voltage existed on the pairs between the pair and earth that everytime we grounded the loopback, the induced voltage was enough to allow the protectors in the loopback card to intermittently fire to earth and thus caused continued intermittent errors on the circuit.

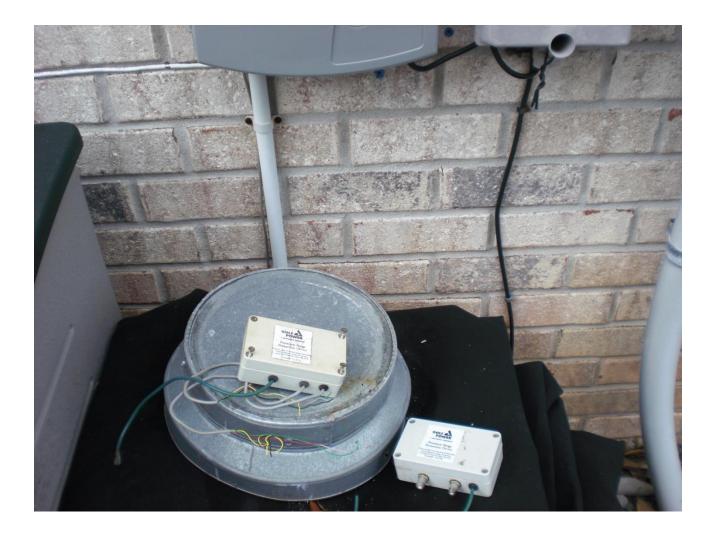
"Special Protector"

- Required by Power Company for Warranted Protection from Damage
- Placing in series and on customer side of telephone protector
- Would not pass HPNA Signal
- NEC issues
- No listing mark

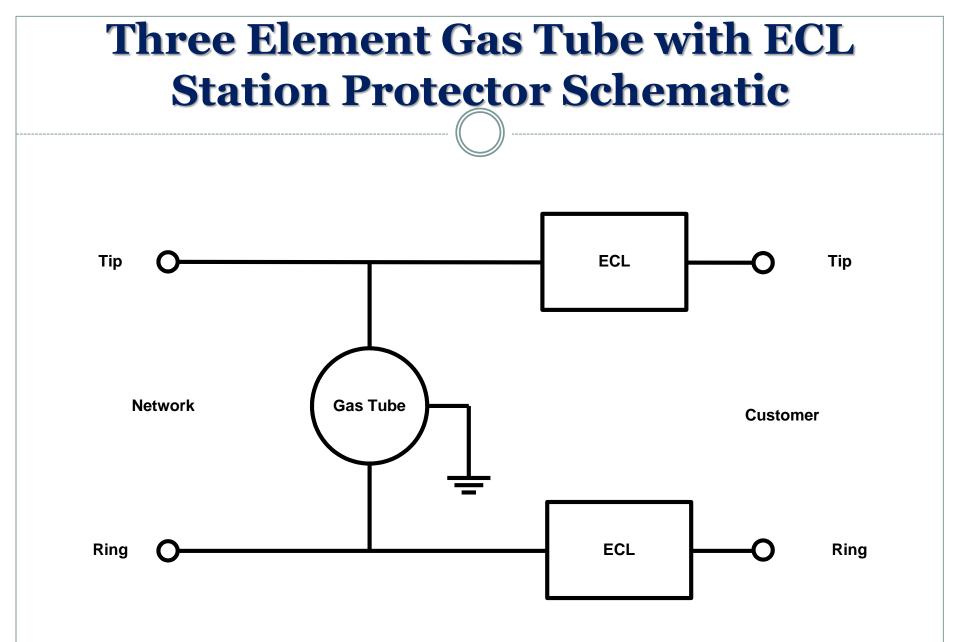
Electric Fence Controller Damage

- Controller for electric fence being damaged frequently by lightning storms.
- Suggested use of special protector
- Originally designed for telecommunications equipment at customer premise.
- GDT and ECL

- Switches very quickly from a low resistance state approximately 12 Ω to an open circuit when current threshold is exceeded
- Signal / surge path is opened until gas tube fires
- Signal / surge path is shorted to ground until surge is removed
- Lightning results no more damage to electric fence controller
