The Challenges for Contractors Working on Tier 1 Carrier Cell Sites: How to Ensure You Stay on the Air

Presented by: Joe Pfau

**Quality Power Services, LLC**

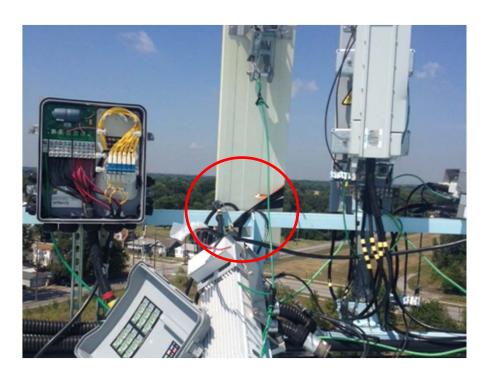
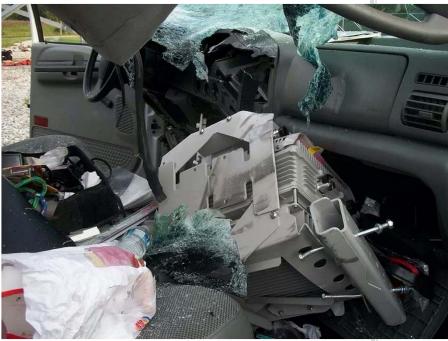
- Used/Inferior materials
- Poor workmanship
- Shortcuts (cutting costs)
- No Safety Procedures

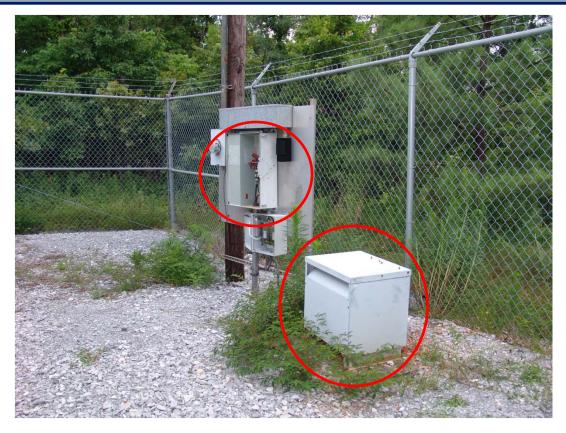
# Case Study - House Fire

- Home next to cell site (200' away) experienced numerous well pump losses due to lightning.
- Equipment lost in the residence, arcing was observed
- Problems did not occur before tower was built
- Utility distribution fed individual services at well house, residence, cell site, radio building (at end of line).
- Cell site carrier took steps to isolate its' site from utility.
- Radio station located inside compound and shared tower.
- Refused to install isolation means.
- House eventually caught fire.

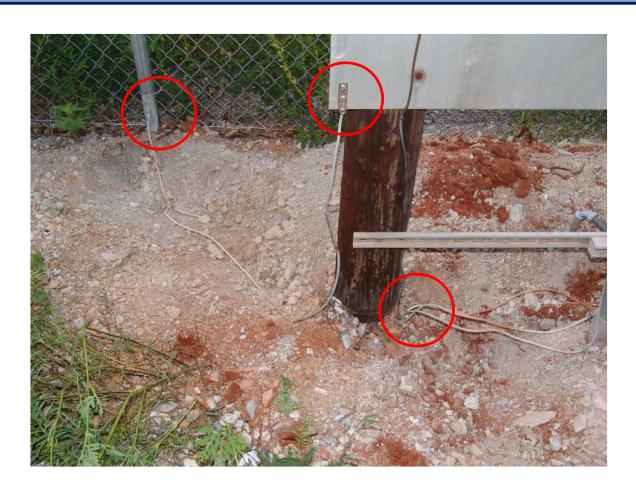
- Houston-we have a problem
- Aluminum back plate is also bonded to fence
- Circuit is complete

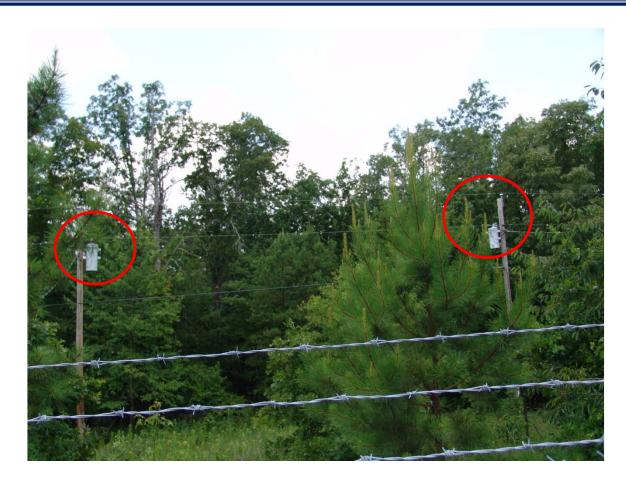
- Medium voltage distribution and step-down transformers
- Path complete on grounded neutral
- Home that had been struck numerous times and finally caught fire was one pole down to the left

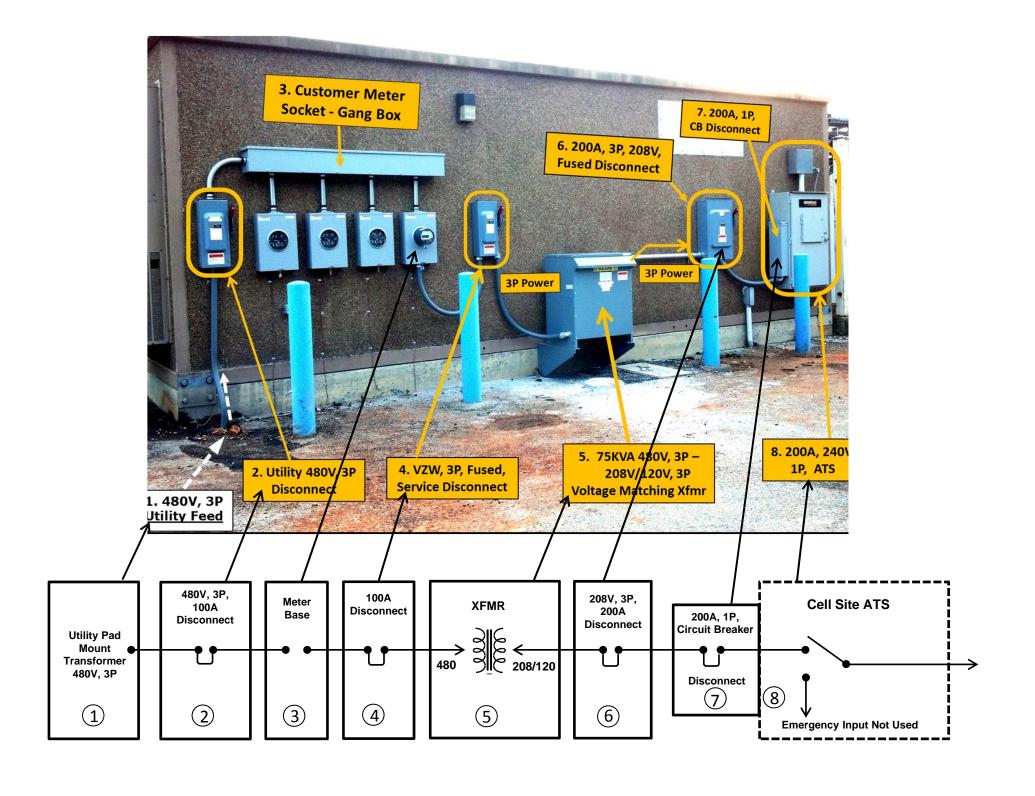
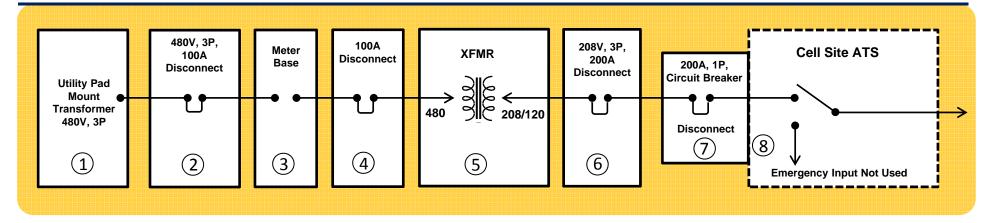
#### **OBSERVATIONS & SAFETY PROBLEMS**

- 1 & 2 Utility Power Service & Disconnect: 480V, 3P, 100A Utility Feed to the facility is undersized. Limit is 100A. Impact: Insufficient power capacity to add new tenants. The manual disconnect unsecure, power could be shut off by anyone. Utility required disconnect, but customer is responsible
- Meter Gang Box: Power to Meter Gang is 480V, 3P, 100A.

Impact: 100A power insufficient for adding tenants. Additionally, in the current power configuration, carrier must provision a new 480 / 240 Step Down Transformer and service disconnect for each new tenant customer (~\$15K per).
- 4 Service Disconnecting Means is confused with multiple disconnects, and presents electrical coordination problems; No Selective Coordination, Safety hazard, Several code requirements unmet. Utility required disconnect but refuses to seal.

Impact: Electrical Reconfiguration work required.
- (5) Cannot provision new 3P Generator to support 1P tenant needs . 480V 3P, 100A insufficient/un- useable power Impact: No Backup power for tenants
- 6 N-G bonding in cell site service entrance is unsafe (neutral not bonded) and does not meet NEC. Impact: MUST reconfigure.
- 7 Numerous NEC violations. Incorrect PVC, strapping, bonding bushing Impact: MUST reconfigure.

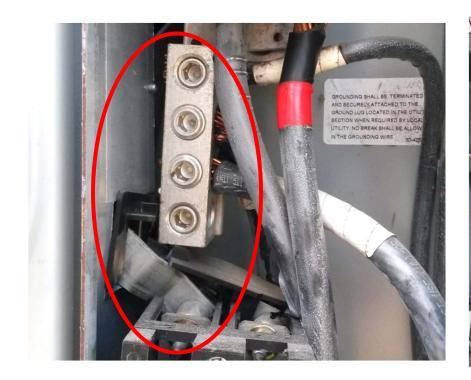
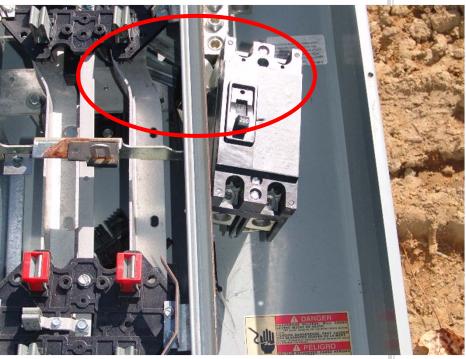
#### **Result = Disaster**

- Contractor was removing carrier shelter and equipment with Track-hoe
- No one bothered to check conduit that was connected to H-frame
- Contractor pulled conduit with conductors still attached to breaker

- What happens when you have untrained persons that do not know or understand the task they have been assigned?
- Create 3 carrier outage that destroys H-frame

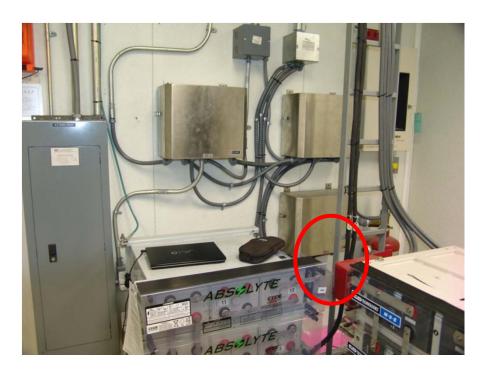
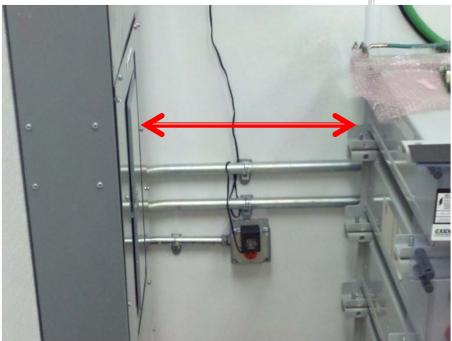
- Working space issues
- Battery blocking direct access to panel
- No room to service tower light controllers
- NEC Working space violation.
- Only 18" clearance between panel board & battery frame

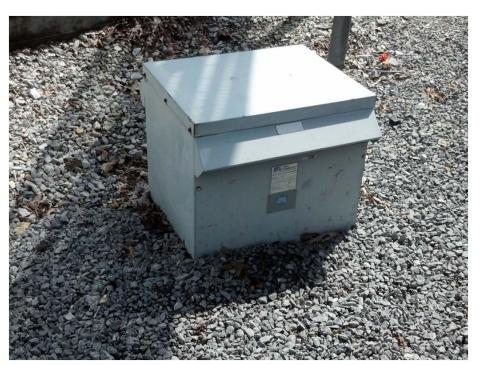
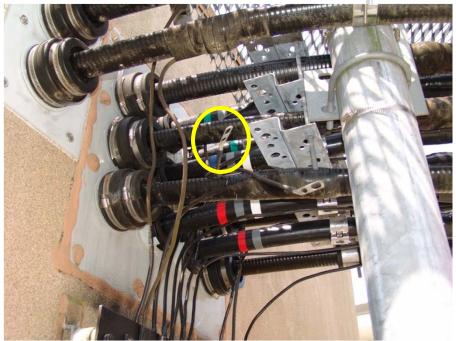
- Transformer covered with gravel
- Ventilation blocked
- Very high operating temperature
- Coax left ungrounded

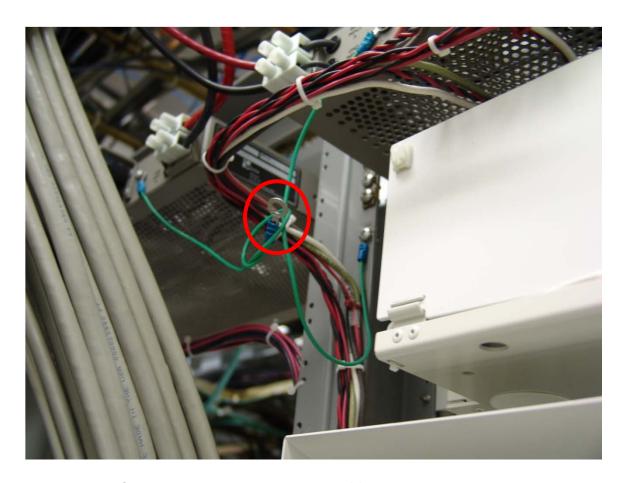
Chassis ground left floating

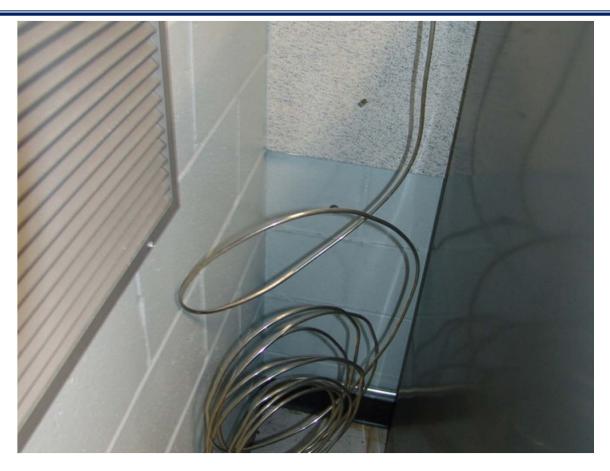
#### **Ground Connection**

- AL: New RF ground bar for upgrade was installed
- Contractor never connected discharge lead to buried ring
- Customer did not perform acceptance
- Outage due to lightning

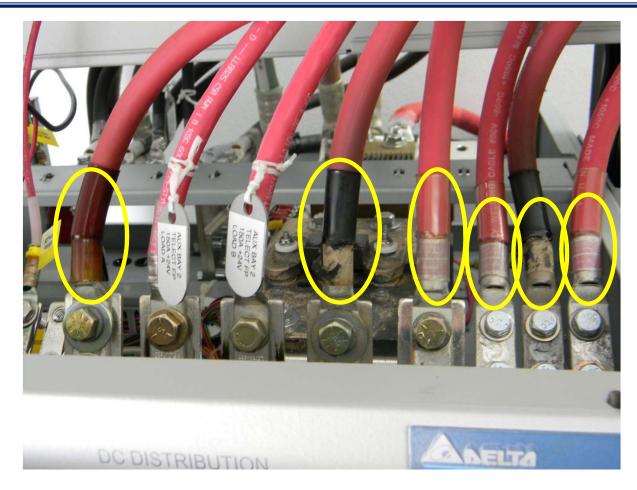
### LTE Installation

- Contractors did not follow proper methods and LTE went off the air.
- Found lugs had been installed but not crimped
- Heat shrink had been placed over the lugs

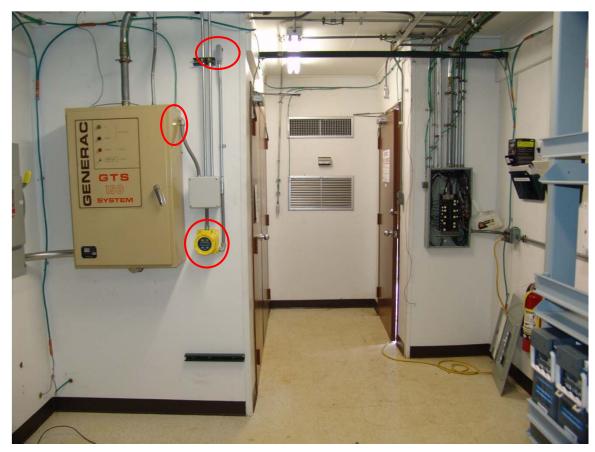
#### **Leak Detection**

- Installed system that did not meet directive
- Sensor output de-energized run circuit to generator, not to a shut off valve outside
- Dangerous condition still exists

- System designed to shut down source of gaseous fuel source (Propane) in case of leak.
- Sensor mounted in generator room on other side of wall
- Control wiring goes to ATS

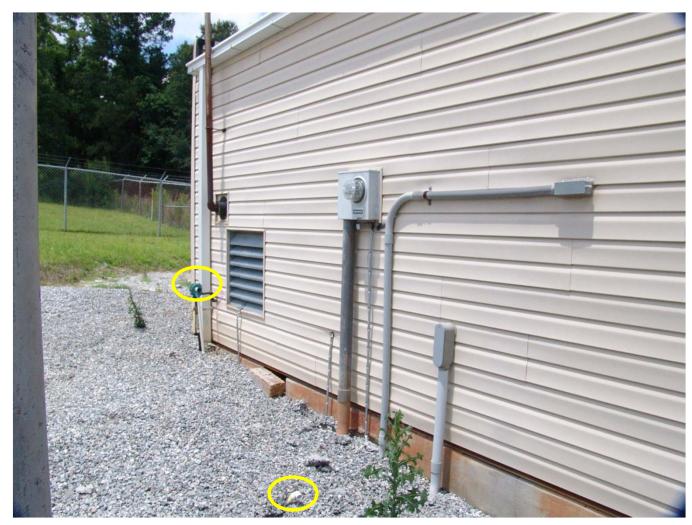
### **Leak Detection**

- Regulator vent required to have 10' clearance from sources of ignition
- Clever underground PVC vent

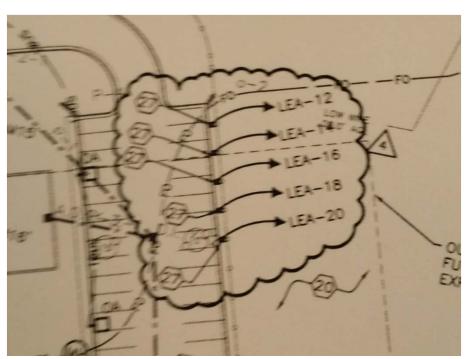
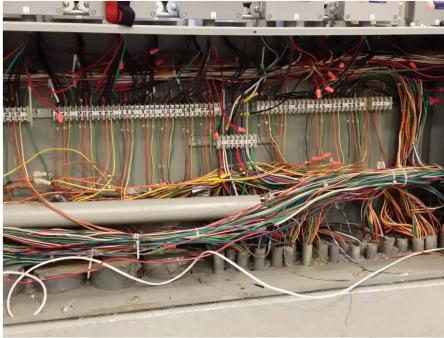
# **Generator 120v Receptacles**

- Engineer designed 20A circuits fed from panel LEA
- Circuits did not exist in panel LEA-had to be traced
- Discovered wiring violations (single neutral and EGC for 5 circuits)
- Underground conduit is damaged (crushed) and conductors cannot be replaced
- If left in place, it will result in future failure
- Resolution: Has not been determined due to choices affecting load and costs

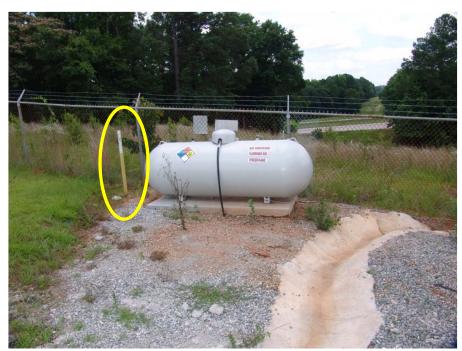
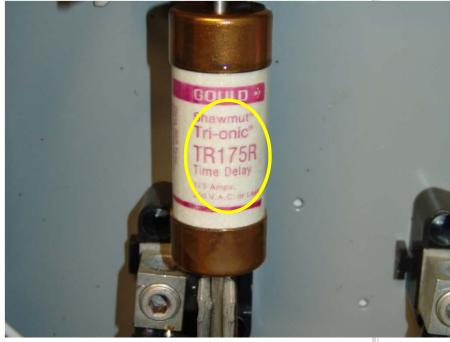
- Provide Thorough Pre-work walk / investigation
- Visit to site revealed proposed location is on border of HP gas line
- Exposed possible safety issue by requiring technician to cross ditch
- Discovered service is undersized
