Measured Surge Activity at Cellular Sites

Alabama Engineering

Presentation Objective

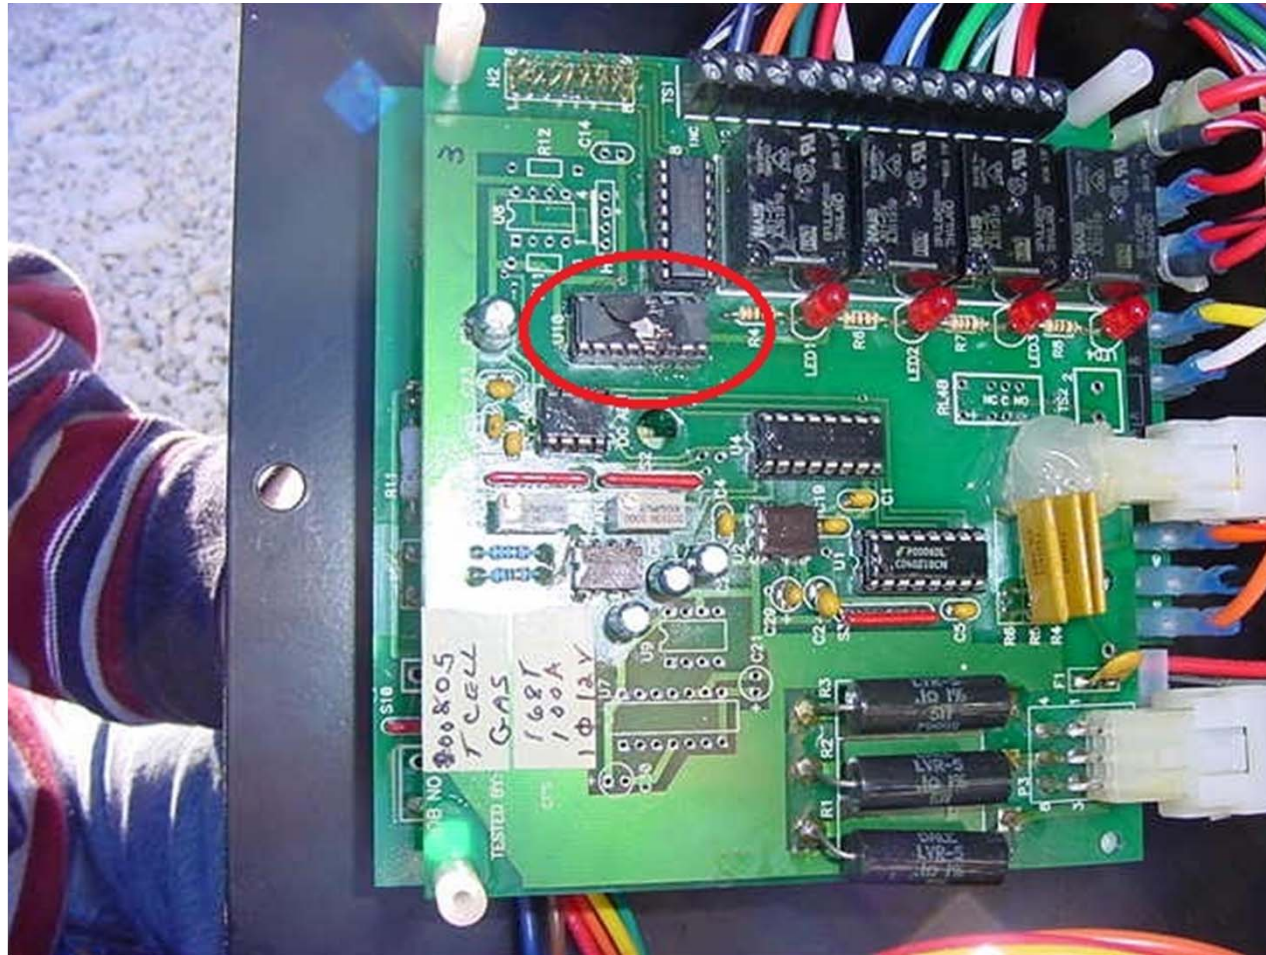
It Is Hard To Put Smoke Back In Once It Has Been Removed

There are the obvious signs, but then there are those that are not.
Which raises the question, how did this happen?

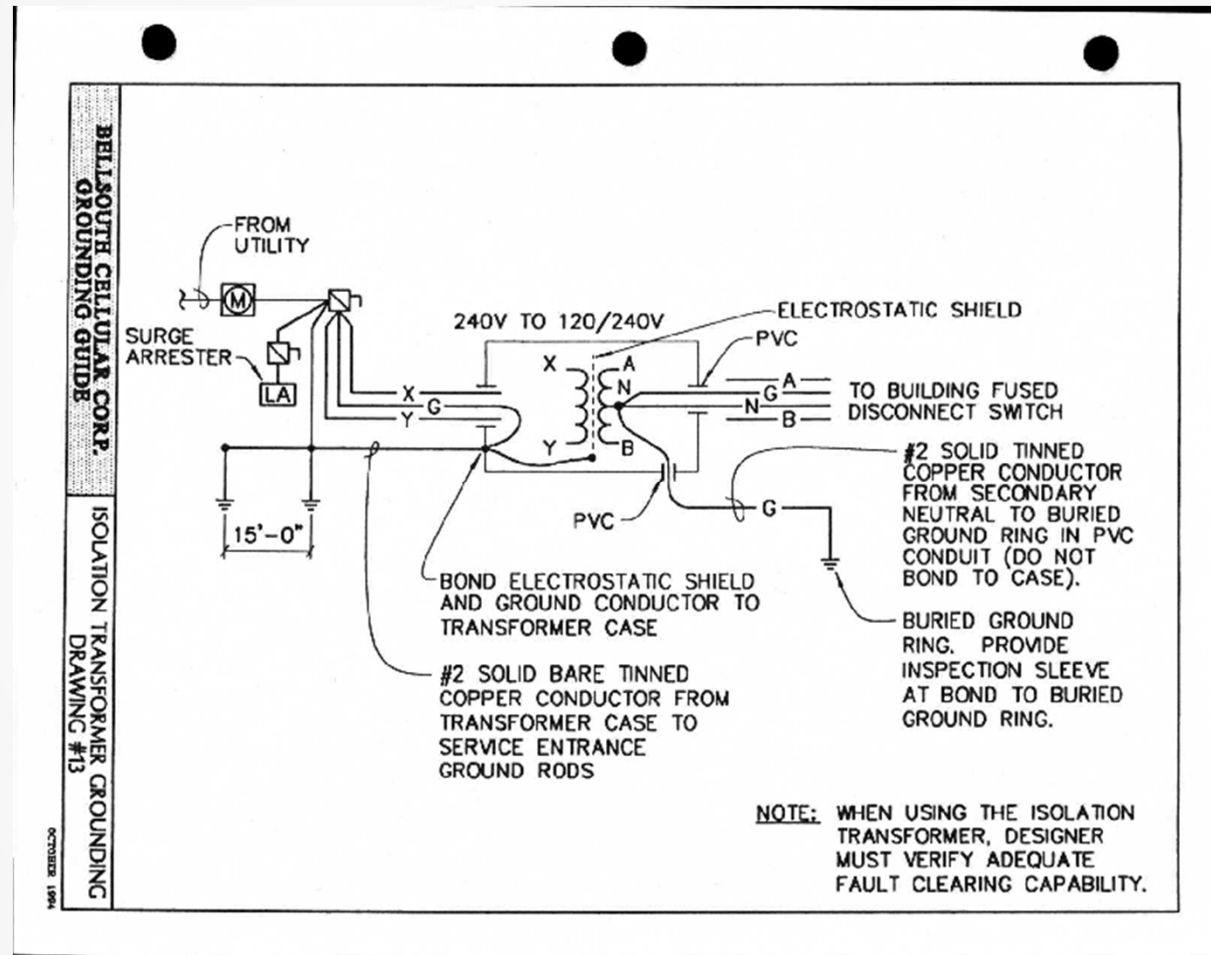
BMI Isolation Transformer

Isolation of primary and secondary was specified in engineering drawings. Practice by contractors rarely, if ever followed this.

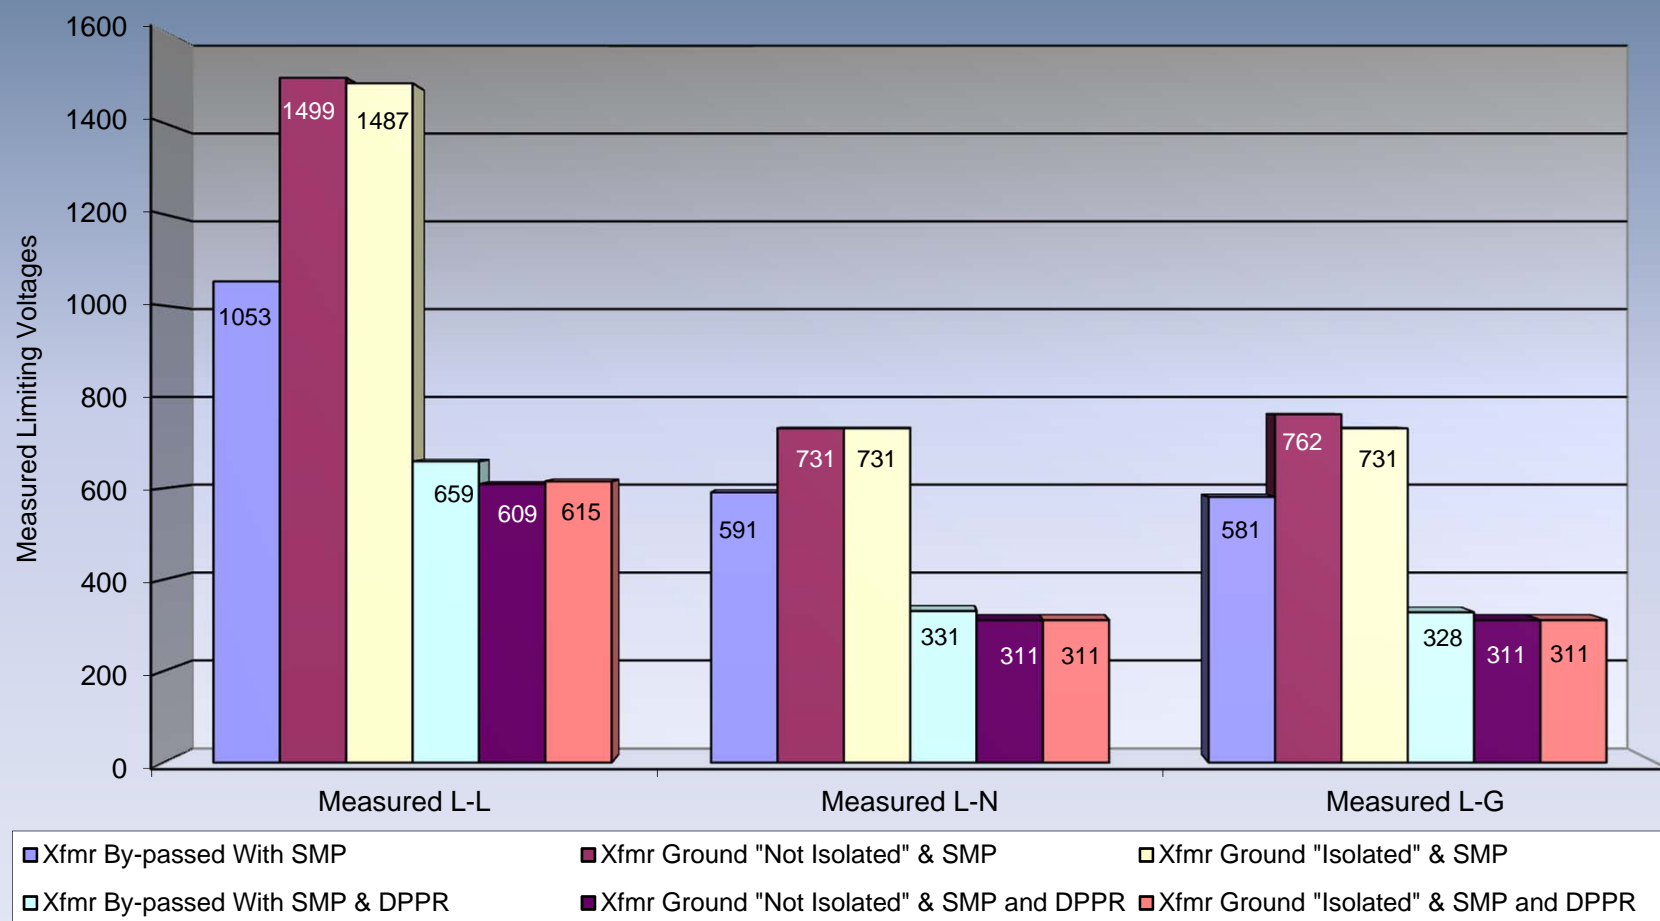
Isolation XFMR, L-L

Transient Injected L-L at Service Disconnect, 40mm MOV installed upstream from Xfmr

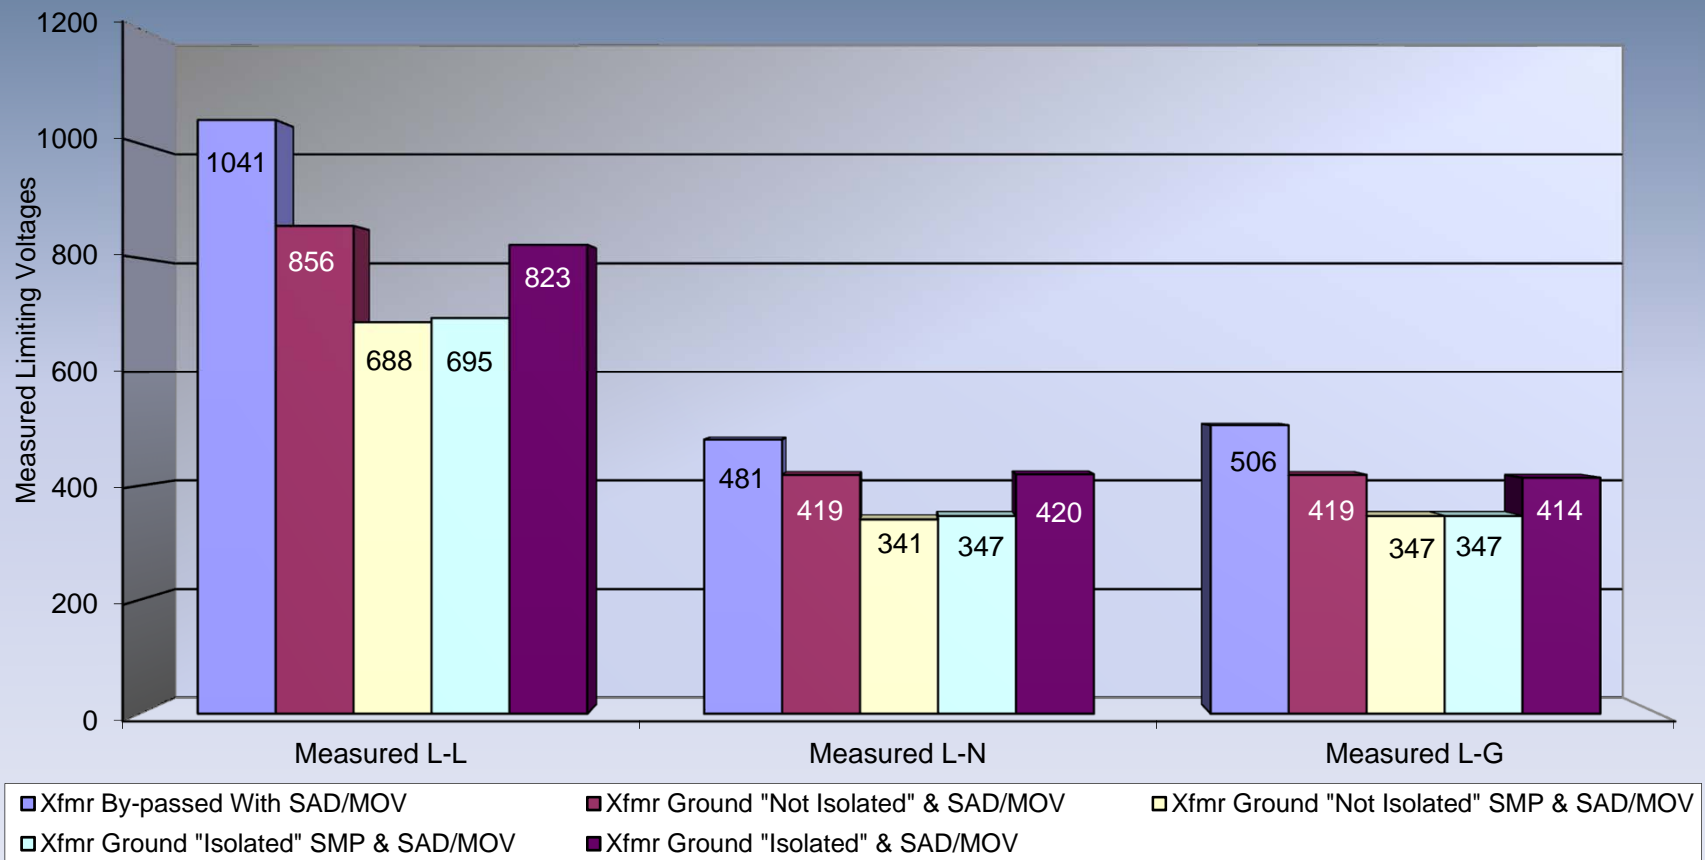
Isolation XFMR, L-L

Transient Injected L-L at Service Disconnect, SAD/MOV installed at DP-1

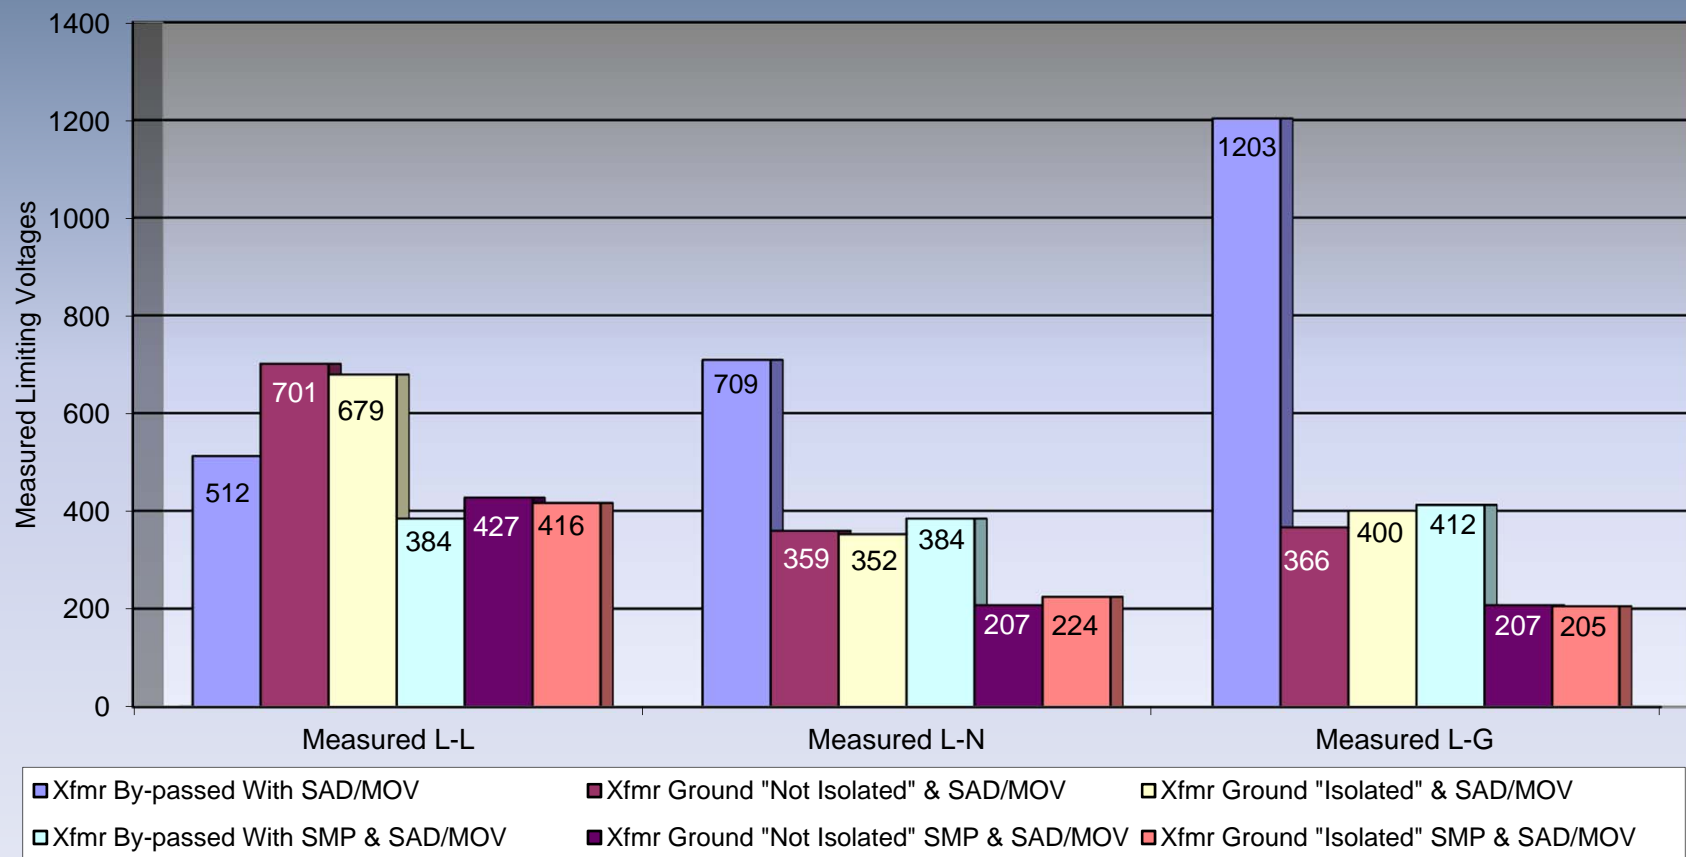
Isolation XFMR, L-G

B3/C1 Transient Injected L-G at Service Disconnect

- Transformer did offer some protection, but not as desired.
- The windings of the transformer were additive depending on polarity of the transient.
- Equipment exposure to high surge voltage if interior SPD failed.
- Combination Wave Transients could become a Ring Wave transient through the transformer windings
- Two SPD's offered better protection
- Two level SPD protection with filtering tuned to IEEE 100kHz transient provide best protection
- Transformer Saturation cost alone cost over \$27,000.00 through out the market (60 sites (??) at the time)
- Data from testing showed cost and performance of two level SPD outweighed cost and performance of transformers
- As a result, Isolation XFMR's were not purchased after testing

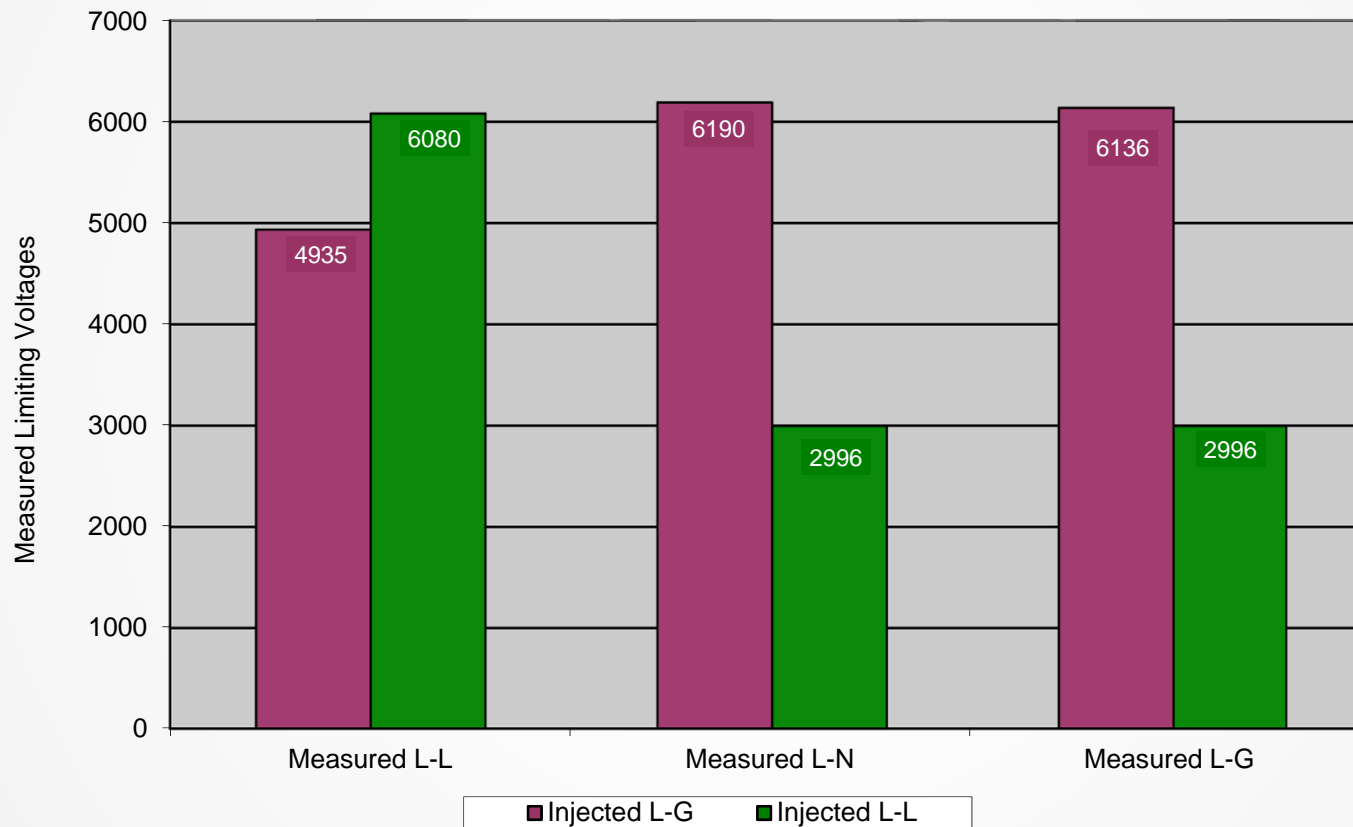
BMI-Schillinger RD, Induced Voltages

Induced Voltages IEEE C62.41-1991 B3/C1 CW, No TVSS
With Halo and Shelter Grounds Connected

6kv Transient injected L-N created 4.9kv transient on L-L
6kv transient L-L induced 2.9kv on L-N/L-G

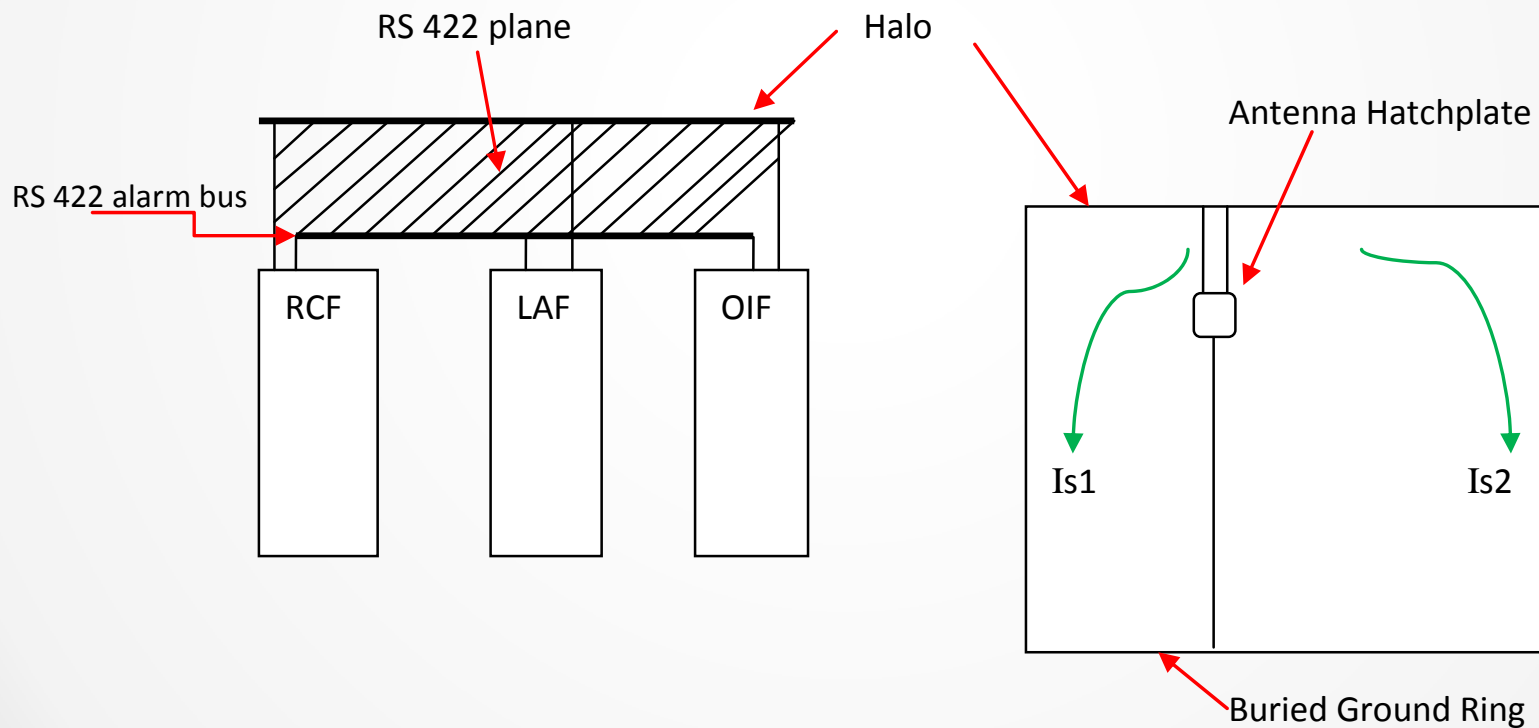
Coupled Voltages

The total transient voltage at the RS422 receiver input of a LAC could be as high as 730V (350V + 380V) for a lightning current of 100kA in a typical six sector cell site configuration.

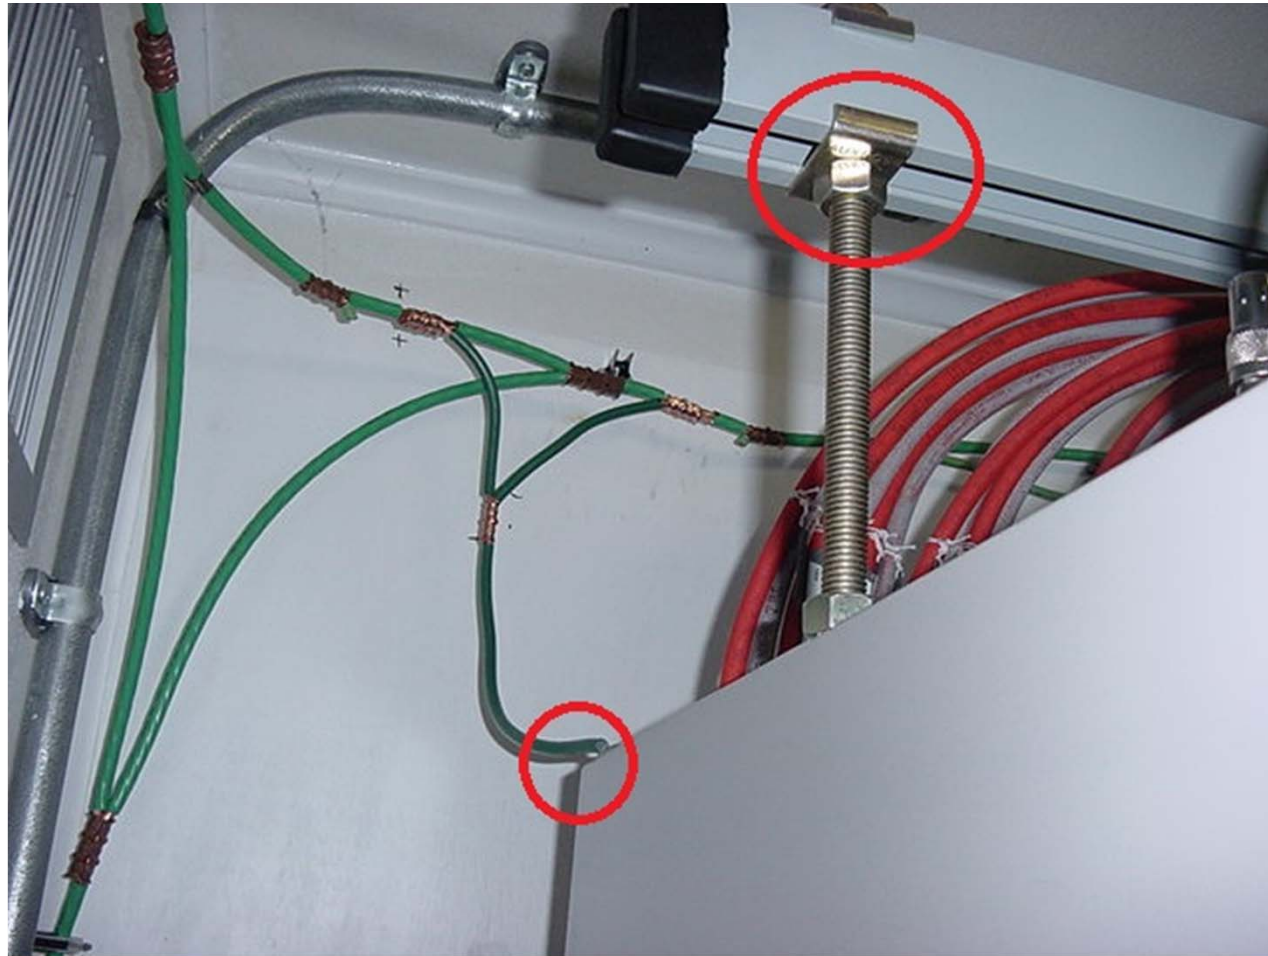
Toyota: AutoPlex Frame

- Site is north of Lexington, KY of I-75.
- Unlike other sites, this site experienced abnormal lightning activity causing damage to AutoPlex Equipment, DIF Frame in particular.
- T1 Protection was purchased and installed but DIF frame still had issues
- Audit revealed numerous issues of DC current flow on AT&T AutoPlex frame grounding
- Grounding architecture modification was recommended and upgrade work performed

DC current was measured on all thread and 6AWG, + and - polarities

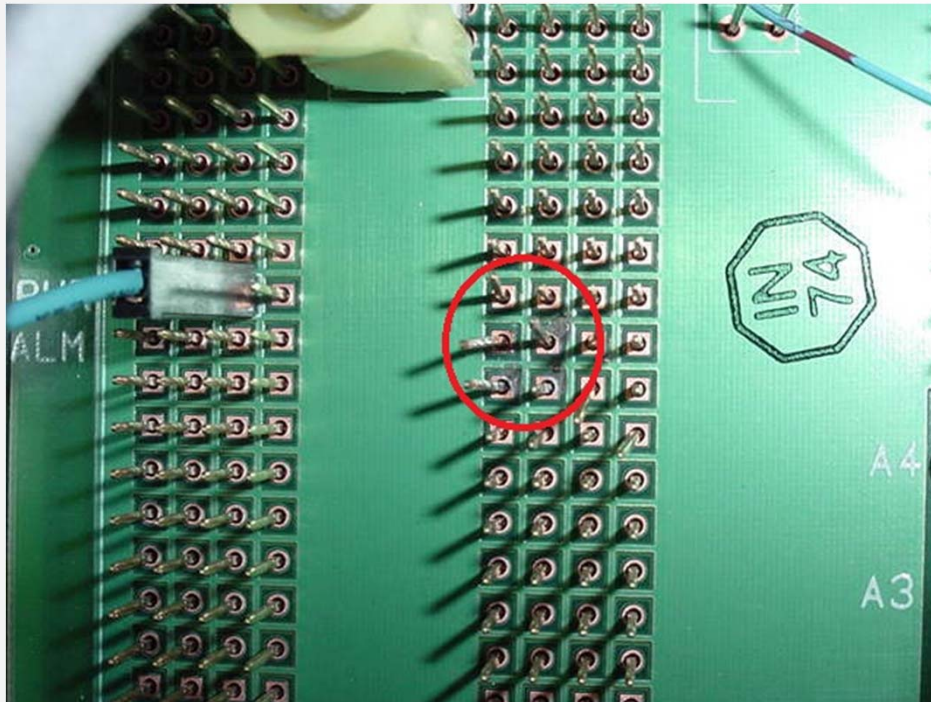
Toyota-DIFI Board

- May 2004, Site was hit again.
- Lost Digital Interface Frame
- Second audit was performed before damaged cabinet could be removed.
- Careful examination of RS422 buss.

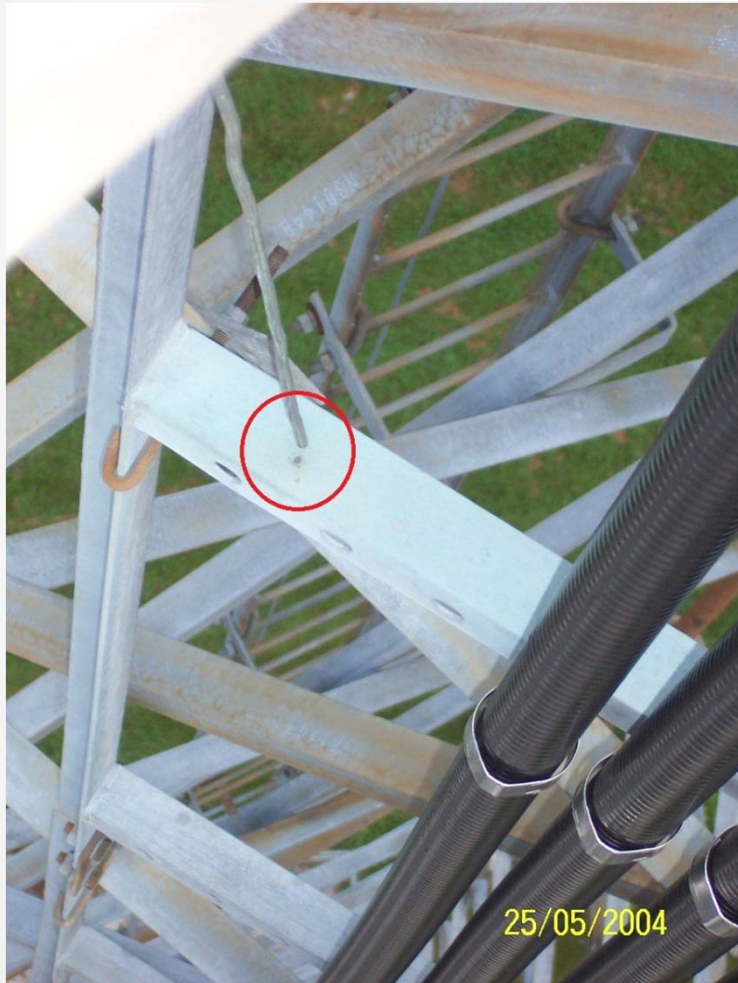
Toyota-Tower

- Tower and shelter ring were dug up and visually inspected, no issues found. 2AWG SBTC conductors installed per VZW standards
- 3 Point Ground resistance test was 4.75Ω . Copy of test given to VZW Engineering.
- Using binoculars, the top coax collector bar ground discharge leads looked as if they were bonded. Tower crew was dispatched “just to see” and found ground floating.
- The first of a line of severe storms that deluged KY that year was on the horizon.
- Installed a temporary ground clamp bond to the tower structure.
- There have been no issues since.

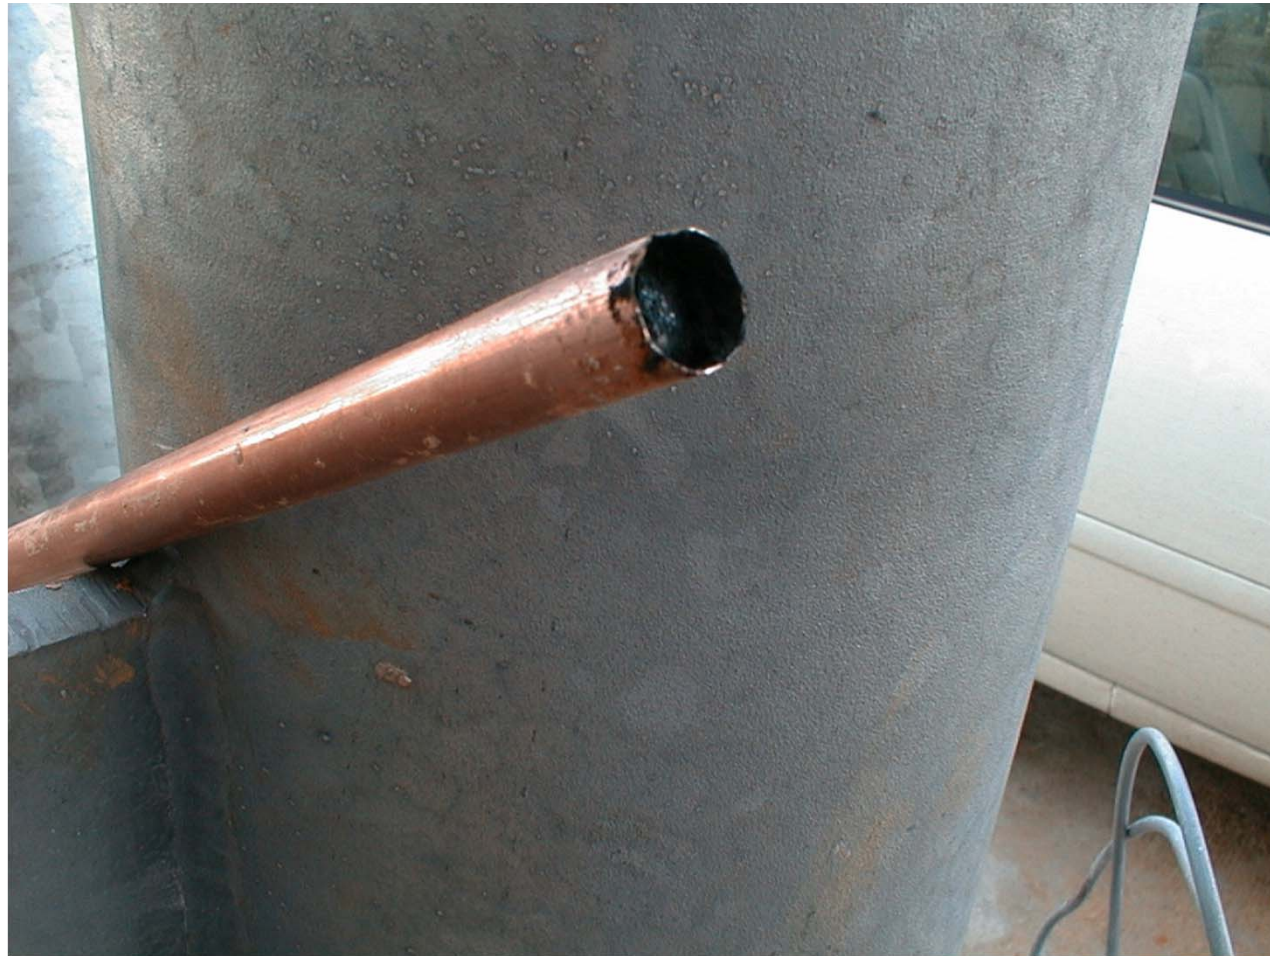
Results of DC Return Current Flow

Effects of High current flow on buried ring

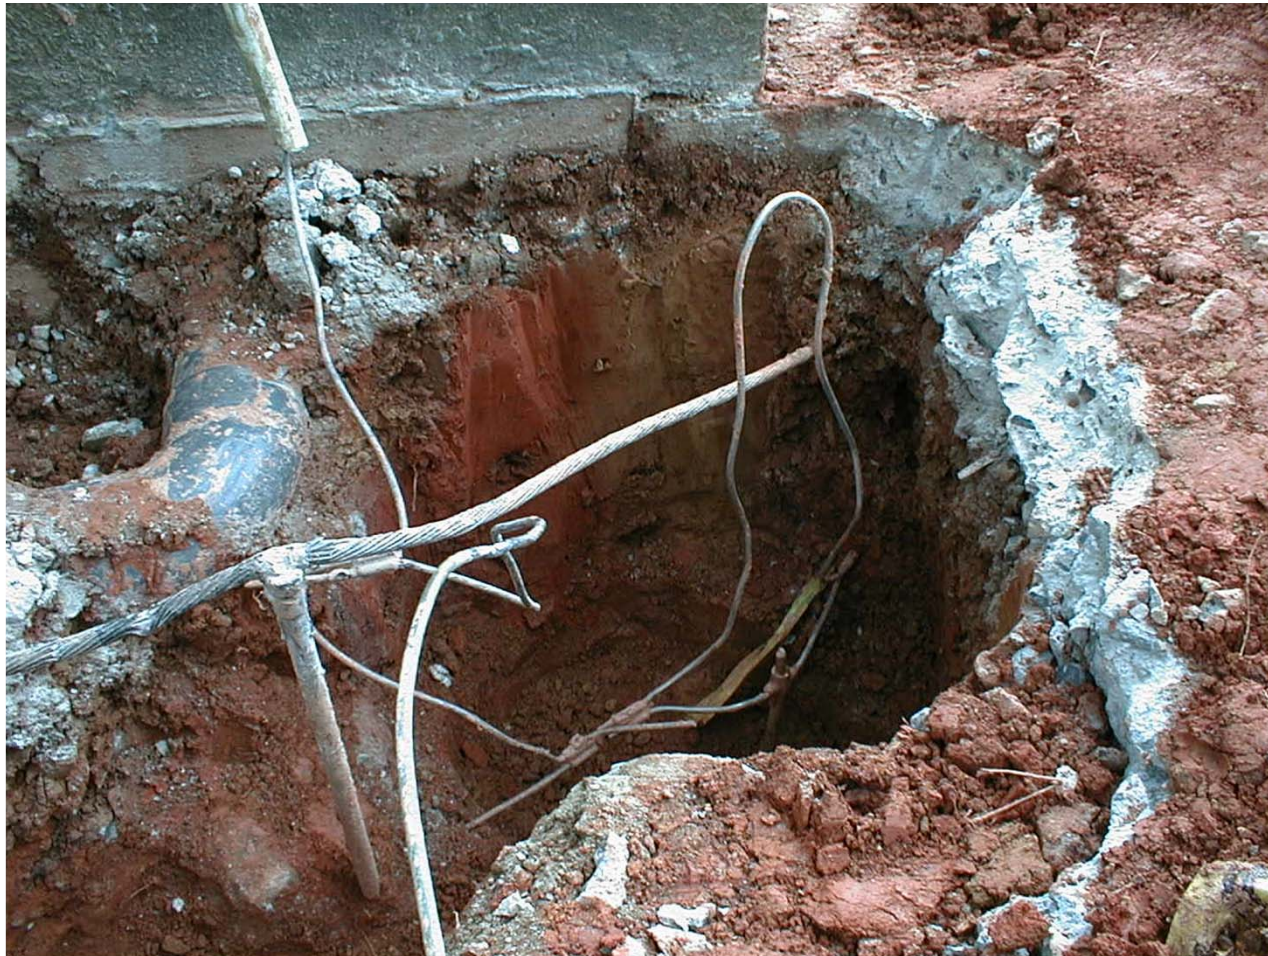
Buried Ring Integrity

Importance of monitoring contractors

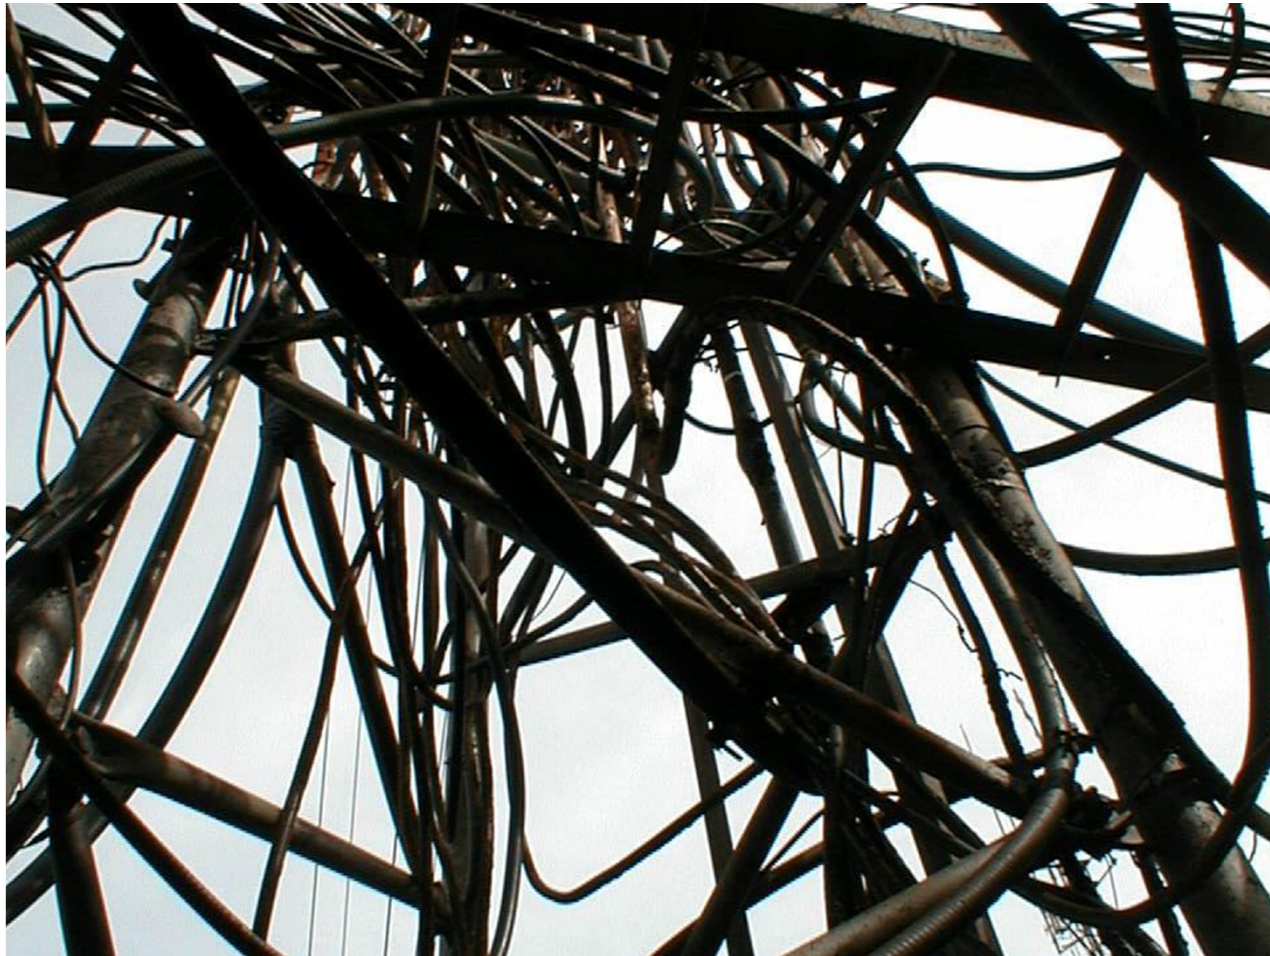
RF Grounding on Towers

Importance of insuring proper installation

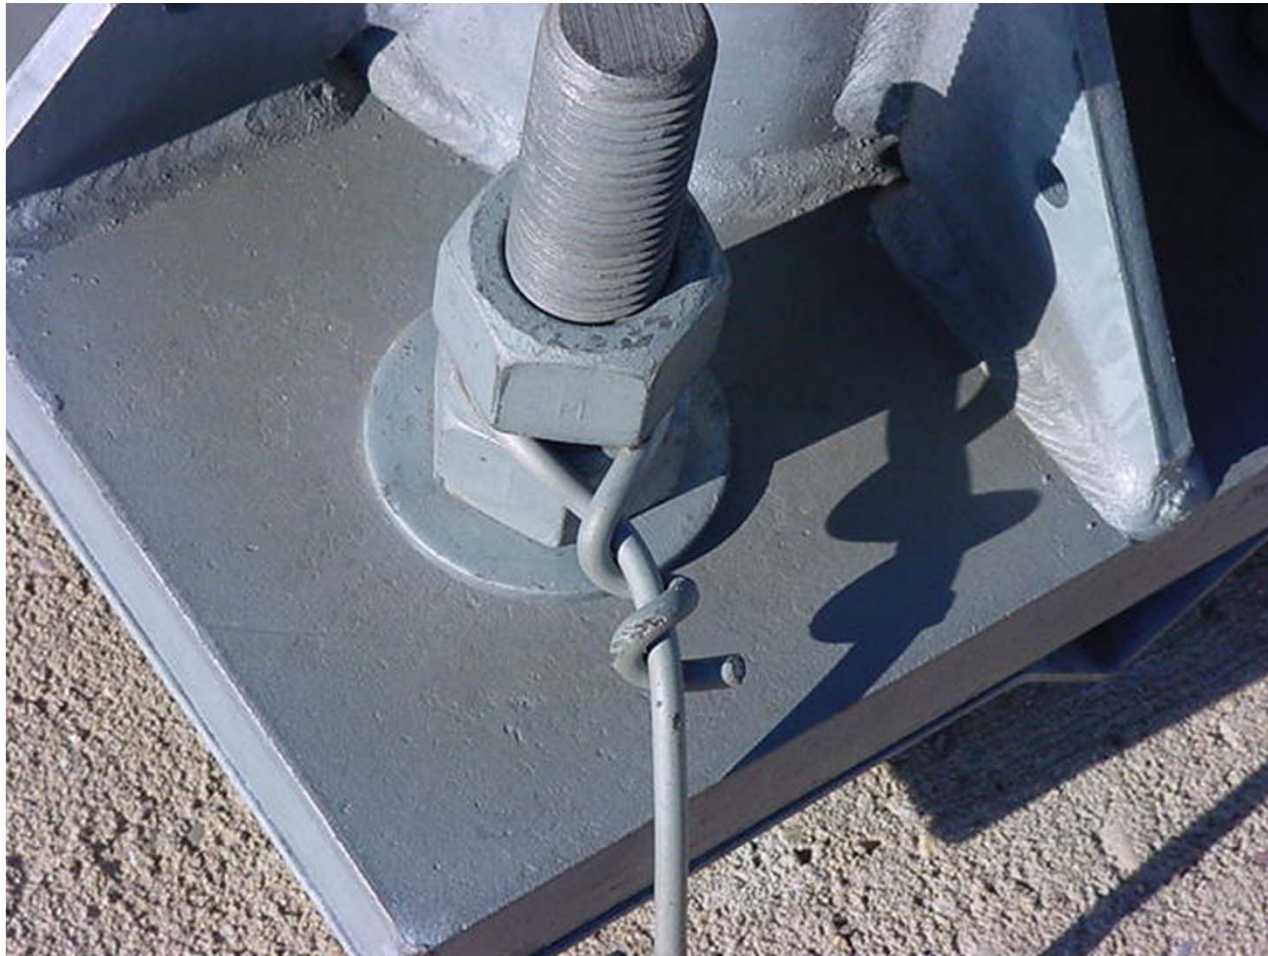
Tower Bonding

Verify Installation Methods
