# **Optical Network Terminals (ONTs):**

## ***Lightning Damage and Standards - What's the Latest Information?***

**Jim Wiese**  
**ADTRAN, Inc.**  
**901 Explorer Blvd.**  
**Huntsville, AL 35806**  
**[Jim.wiese@adtran.com](mailto:Jim.wiese@adtran.com)**

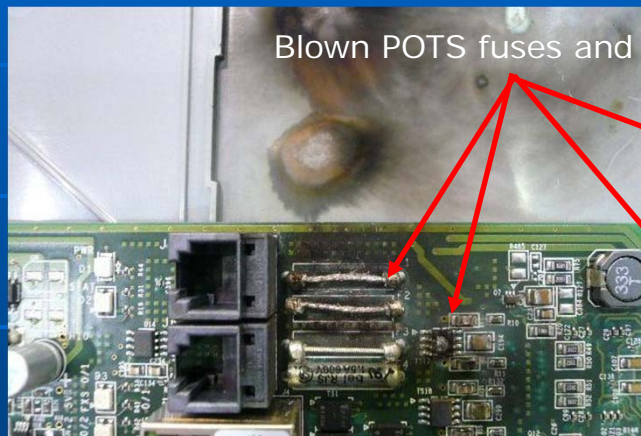
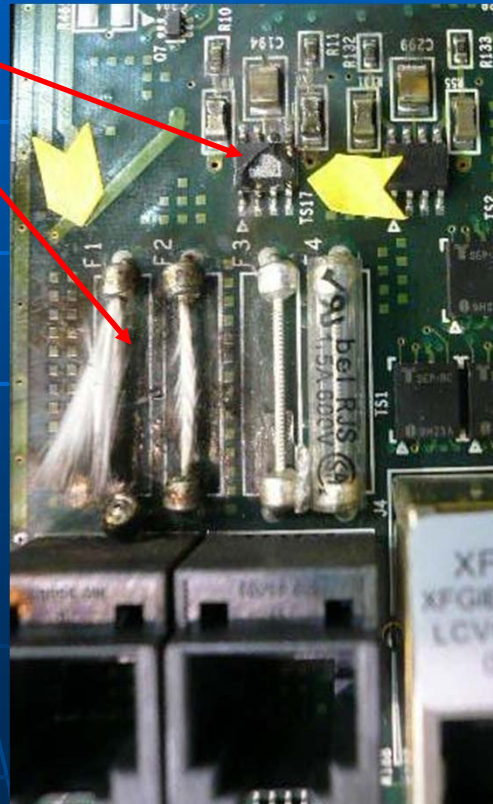
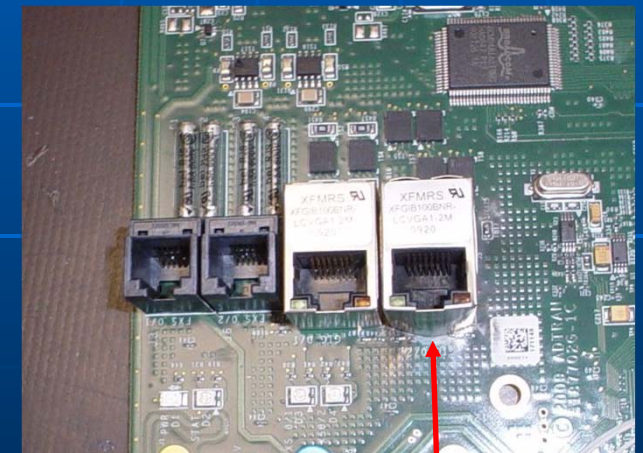
# Typical Lightning Damage

- **The Severity of the Damage – component damage far exceeded what would be expected even on OSP interfaces from lightning and power fault tests in GR-1089-CORE.**
- **Type of damage – POTS protection IC's, Ethernet jacks/circuits, RJ11's, frame ground traces.**
- **Circumstances – storm related.**
- **Geography – no significant correlation to geography.**
- **Similar types of damage reported across all ONT Vendors.**
- **Damage NOT limited to a specific vendor or service provider.**
- **Damage NOT limited to United States.**
- **International problem, Japan NTT major ongoing investigation and ITU-T contributions.**

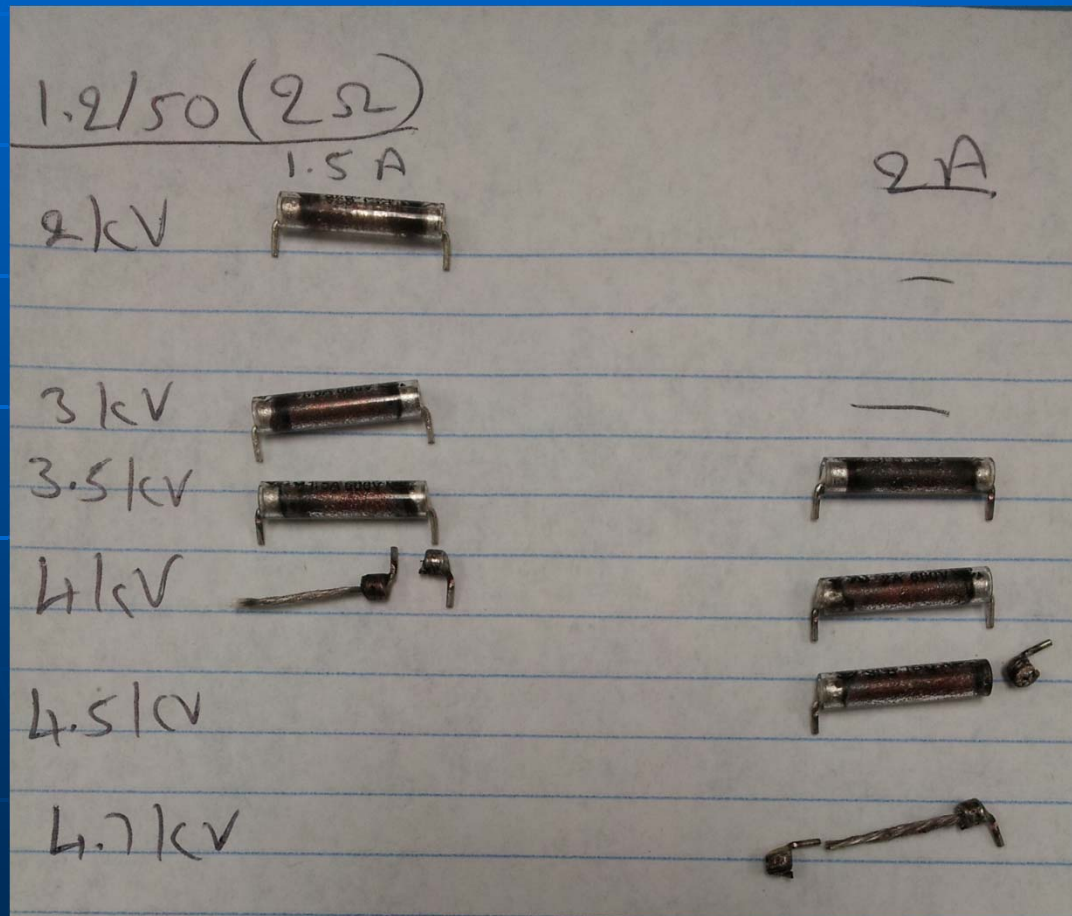
# Fuse Characteristics

- Lab analysis points to some surges seen are in the 4 kV to 5 kV 1.2/50 range.
  - Glass case breaking at 4 kV for 1.5A fuse.

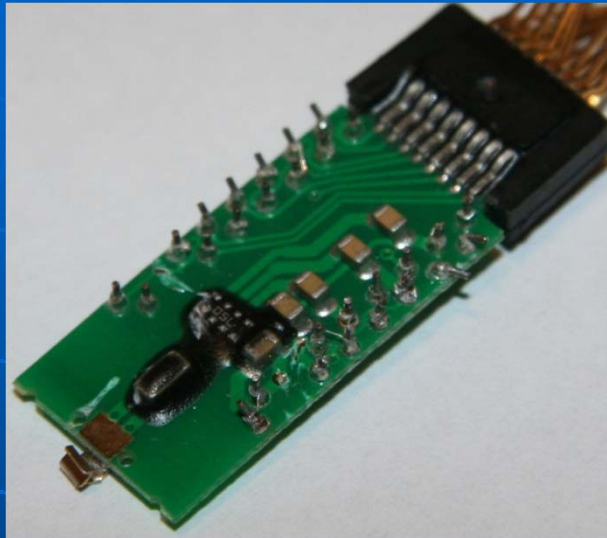
**Common to see chip resistor arrays that fail during longitudinal surges.**

**Sockets sharing a single high voltage Bob Smith capacitor to ground and therefore no isolation between ports.  
(Picture shows a PoE solution).**

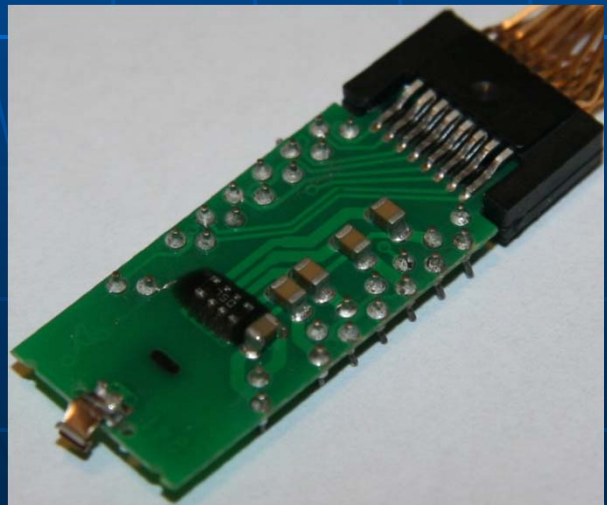
**Sealing the Smith components to try and combat isolation breakdown.**

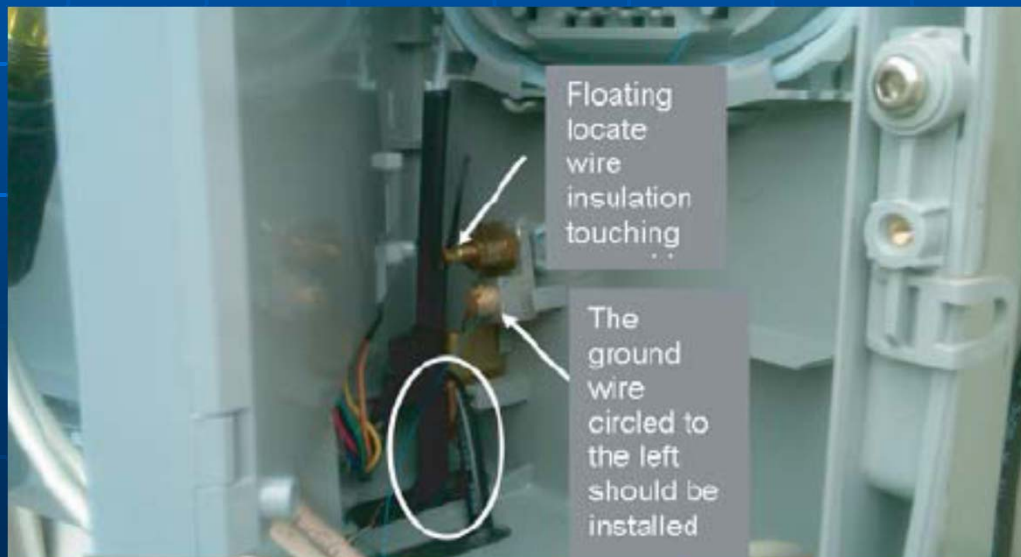
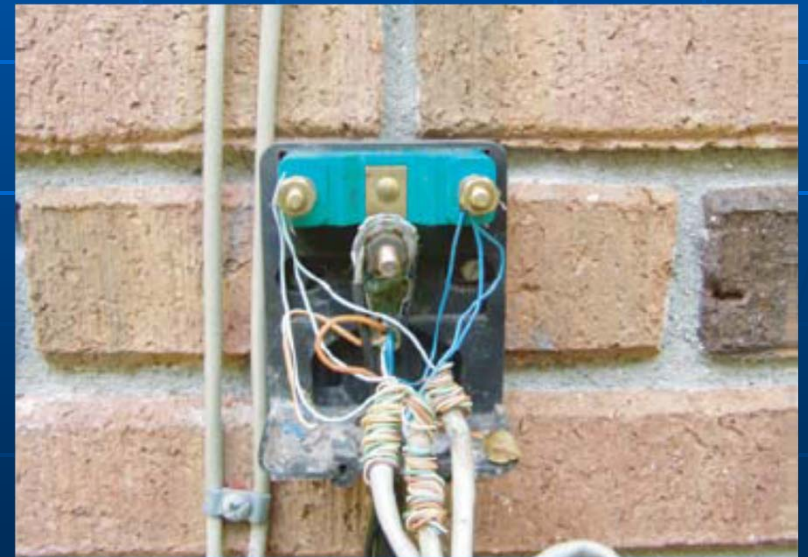
**Never assume things are done correctly**

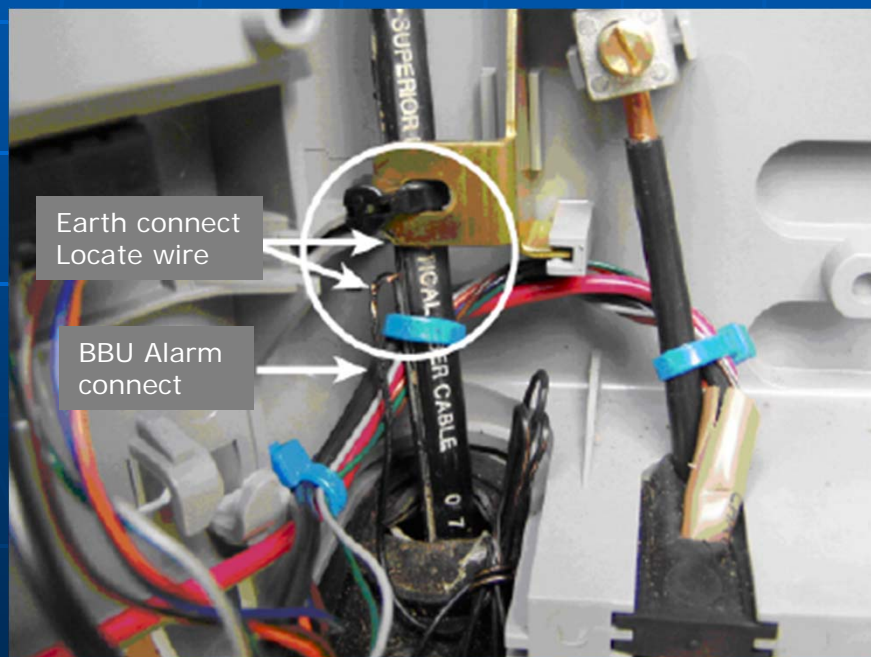
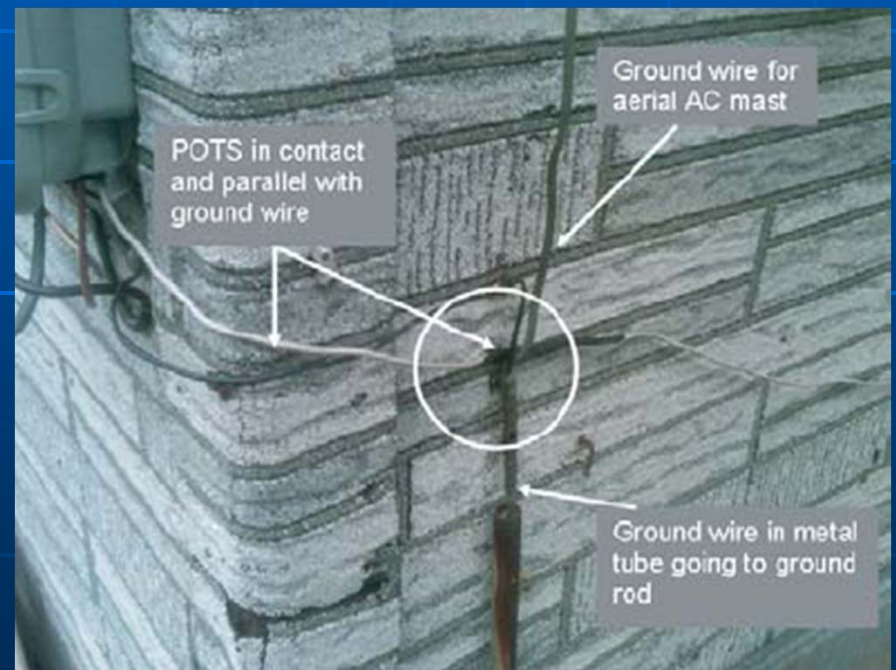
**Never assume you have asked all the correct questions.**

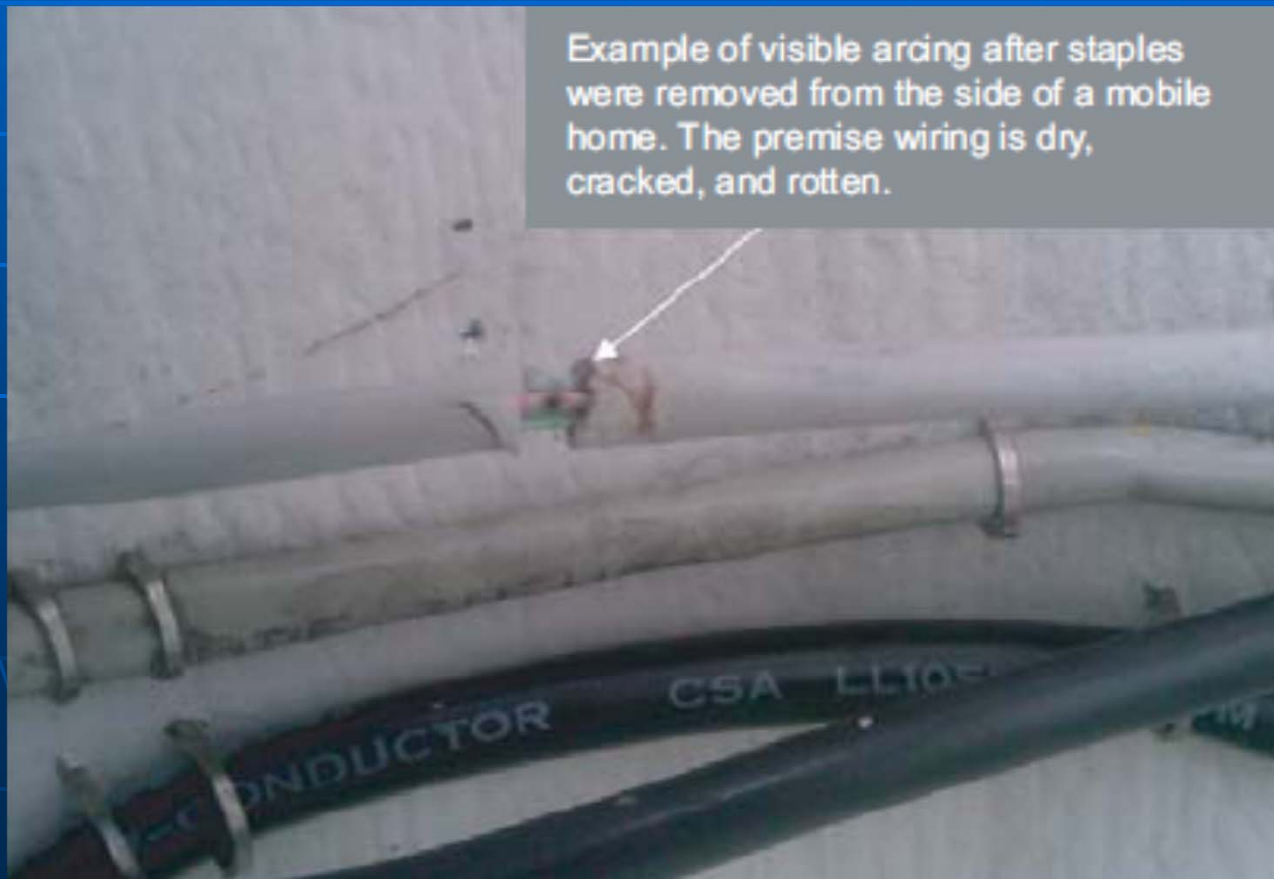
**You cannot protect from mistakes made by contractors.**

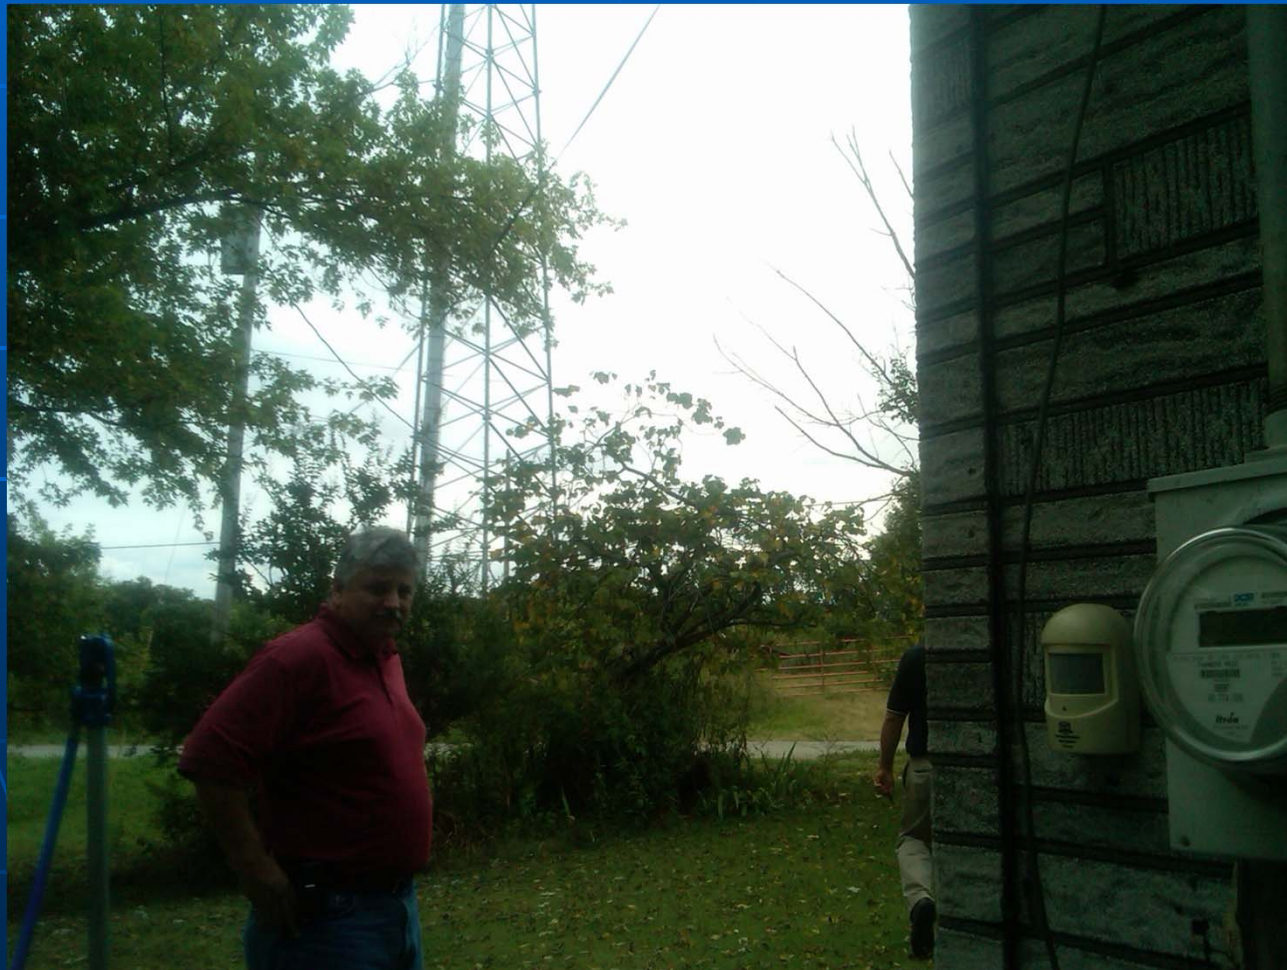
**You cannot protect the un-protectable!**
