# To Fuse or Not to Fuse? That is the Question:

Codes, Science, and Case Studies to Support the Unfused Battery Bus in 48 Volt Dc Power Plants

Dan McMenamin

March 19 - 21, 2013  
San Ramon, CA

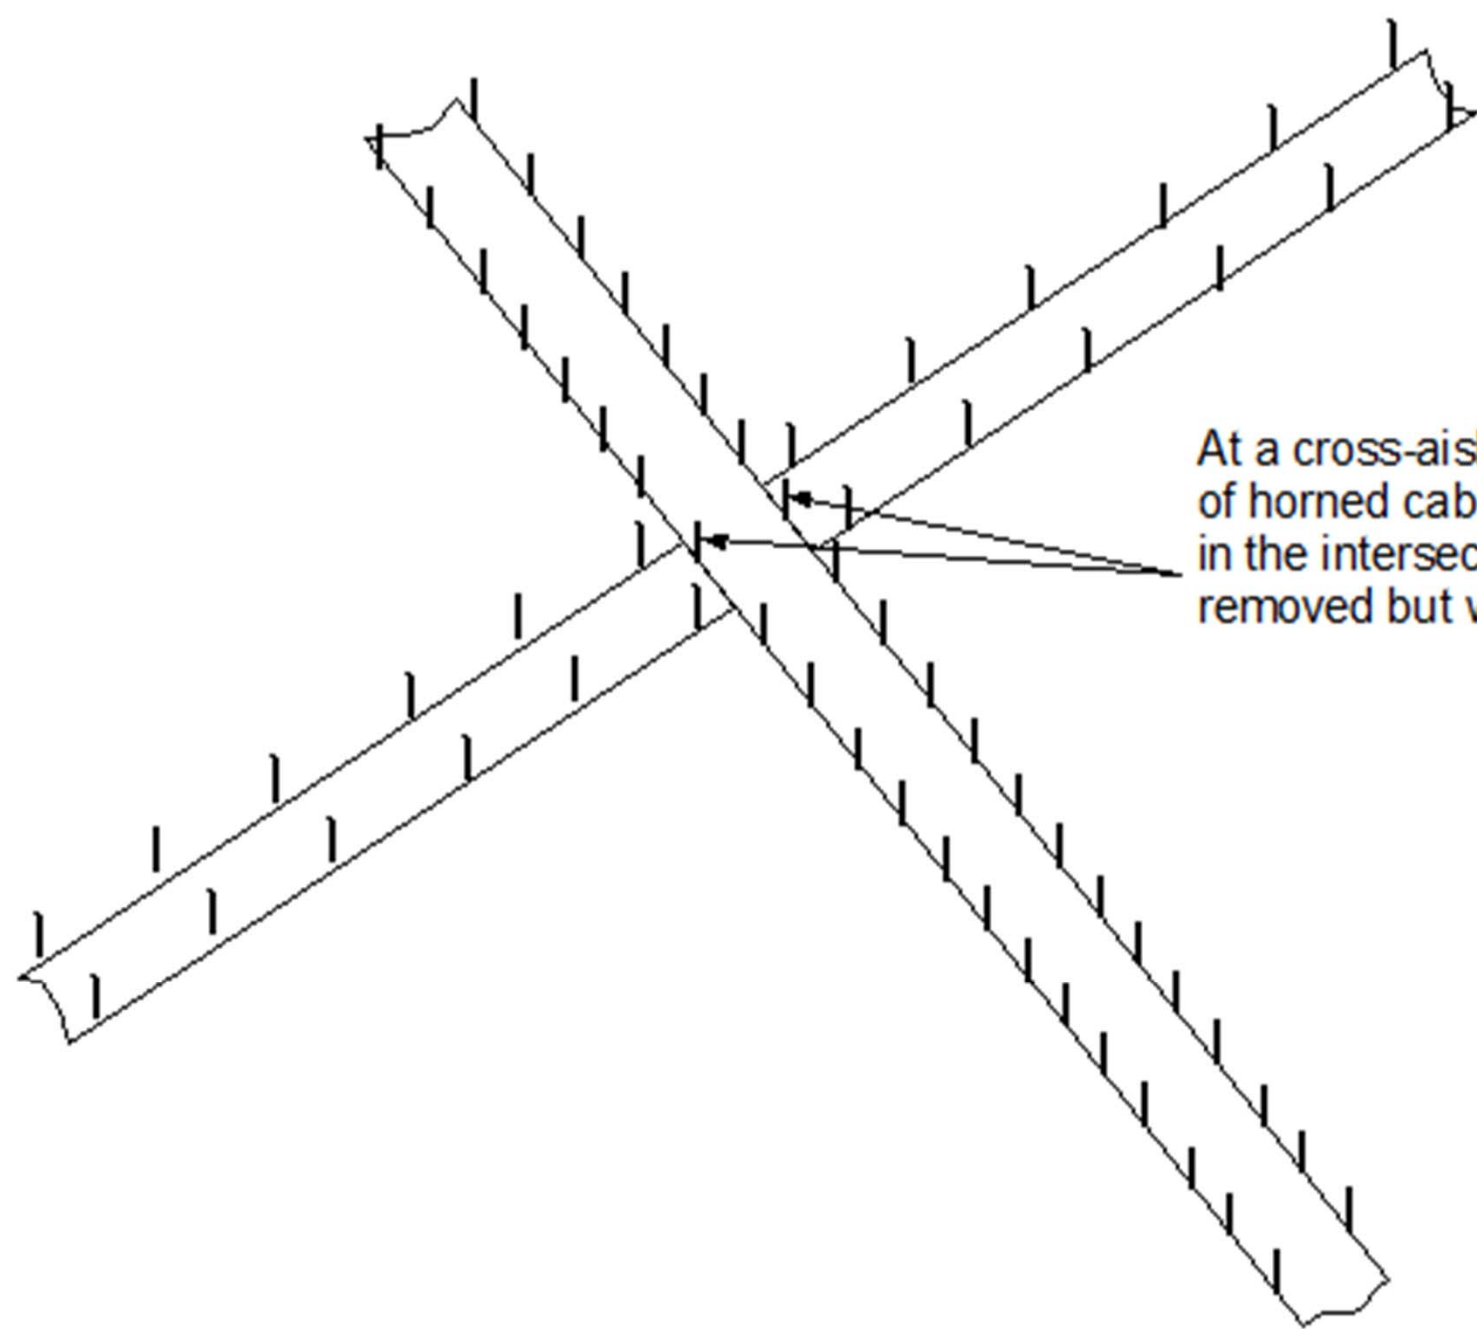
At a cross-aisle intersection of horned cable racks, horns in the intersection should be removed but weren't.

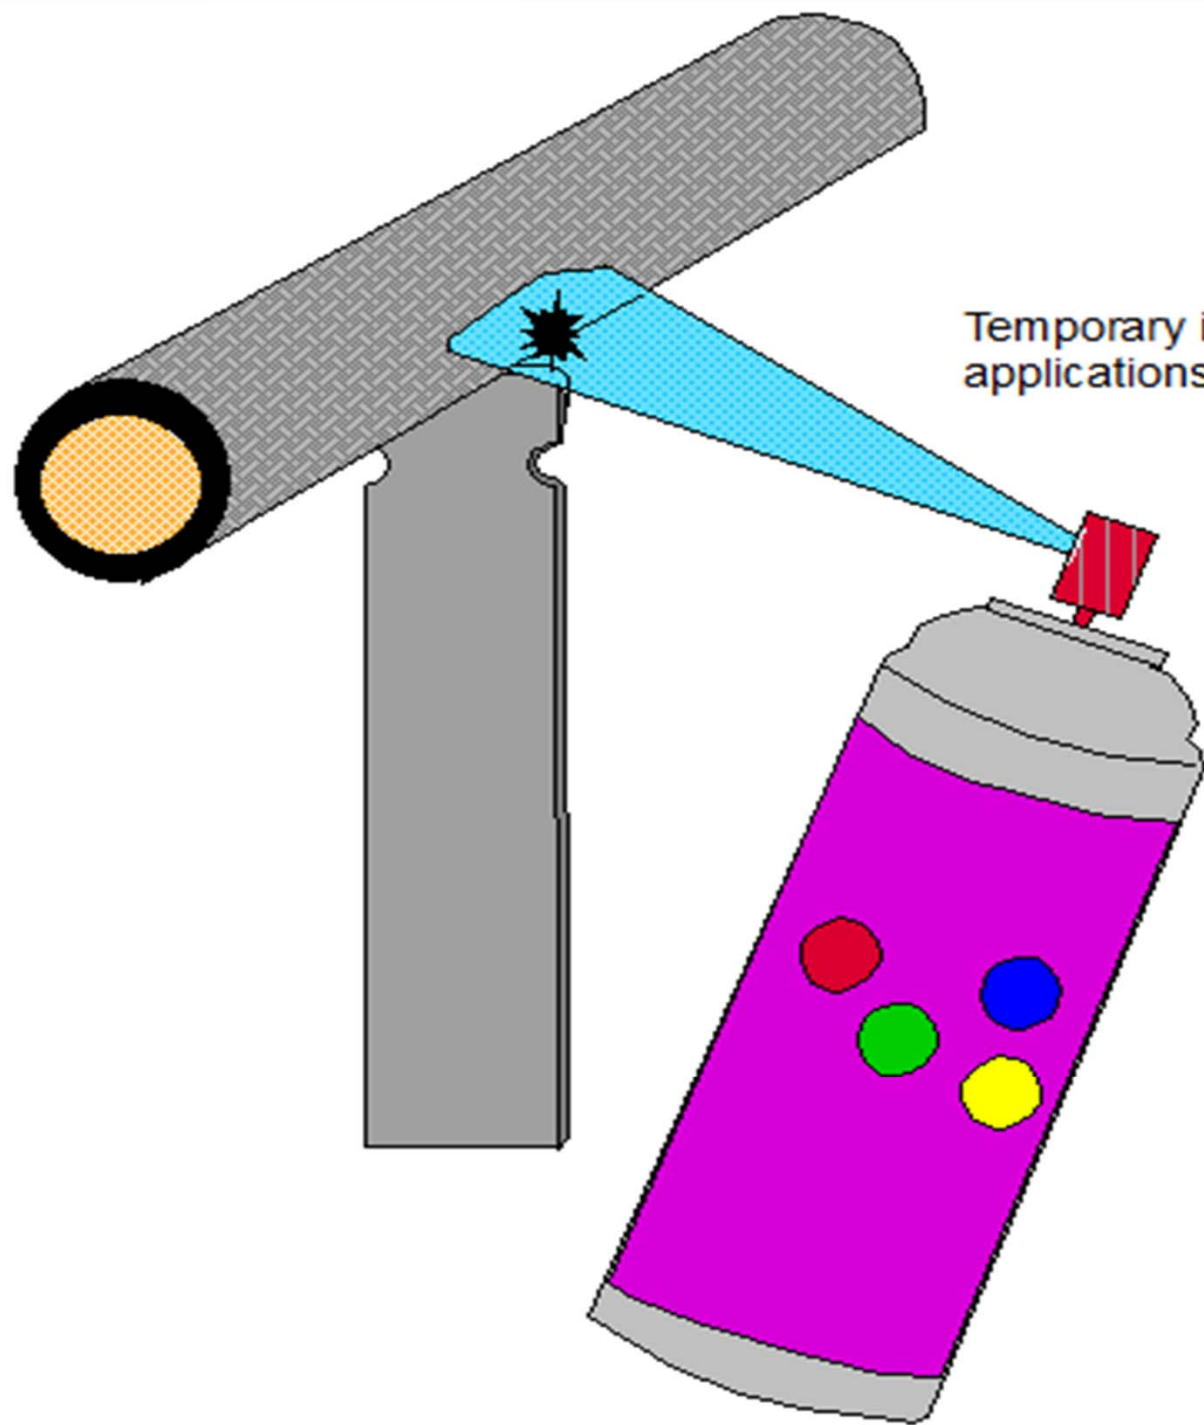
Temporary insulation from sprayed applications of clear acrylic

Stopgap measure: Spray several coats of clear acrylic into the cable 'wound' to provide a temporary layer of insulation until maintenance 'window' after midnight.

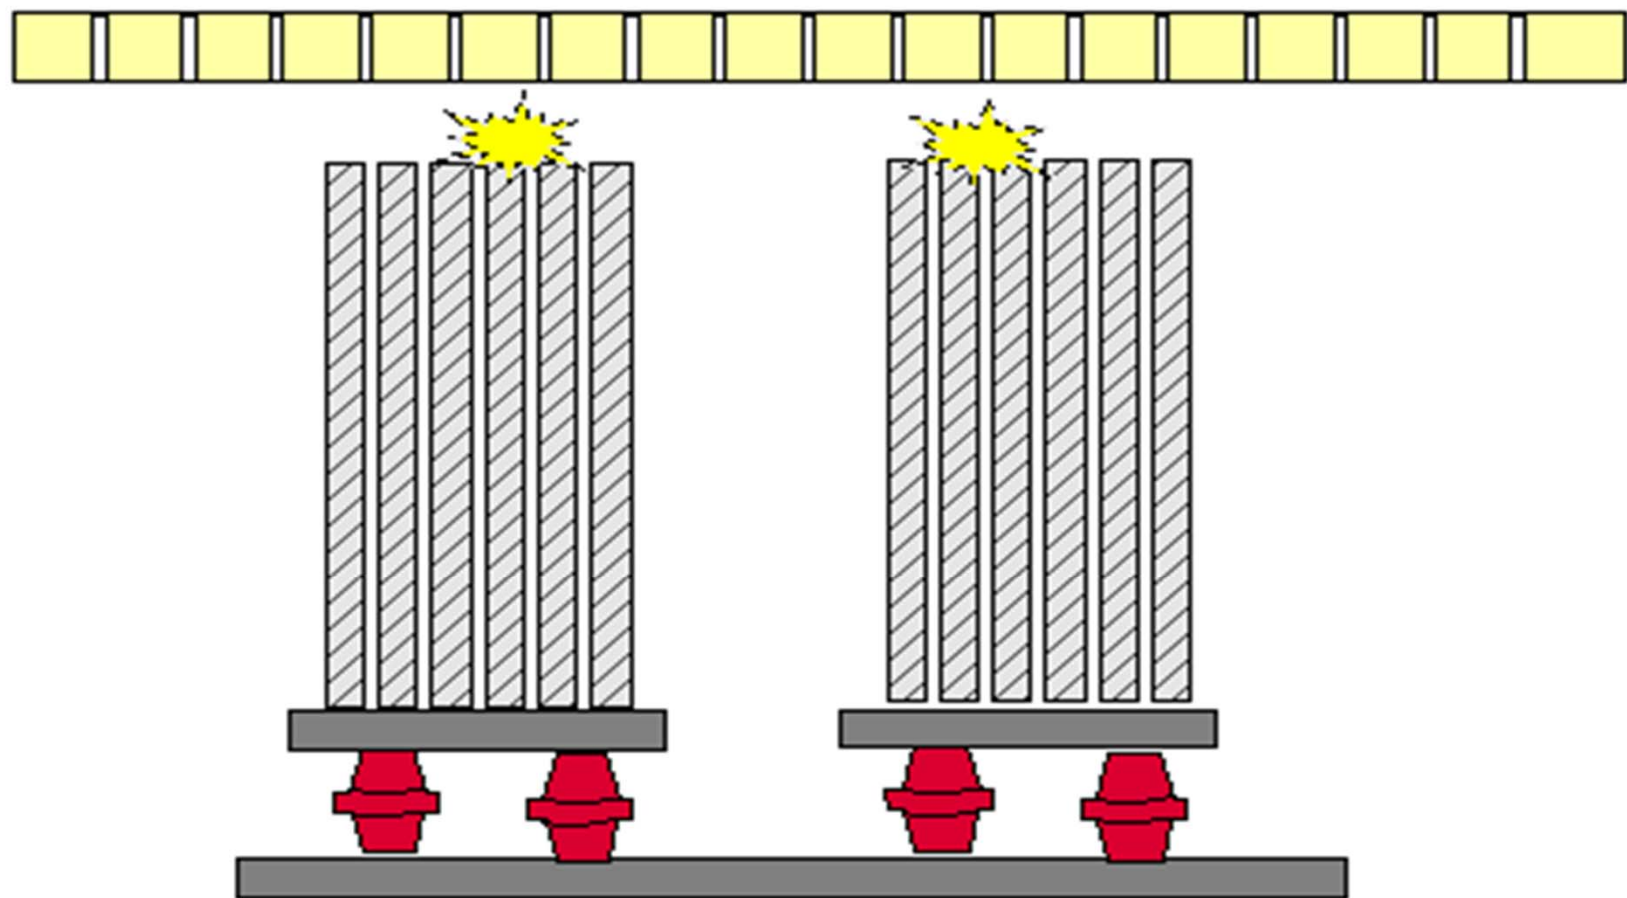
A painter mistook aluminum busbars in a 6,000 Ampere power plant for structural steel. He placed a 1 gallon paint can on the bus shorting the Battery side of the bus to grounded support items.

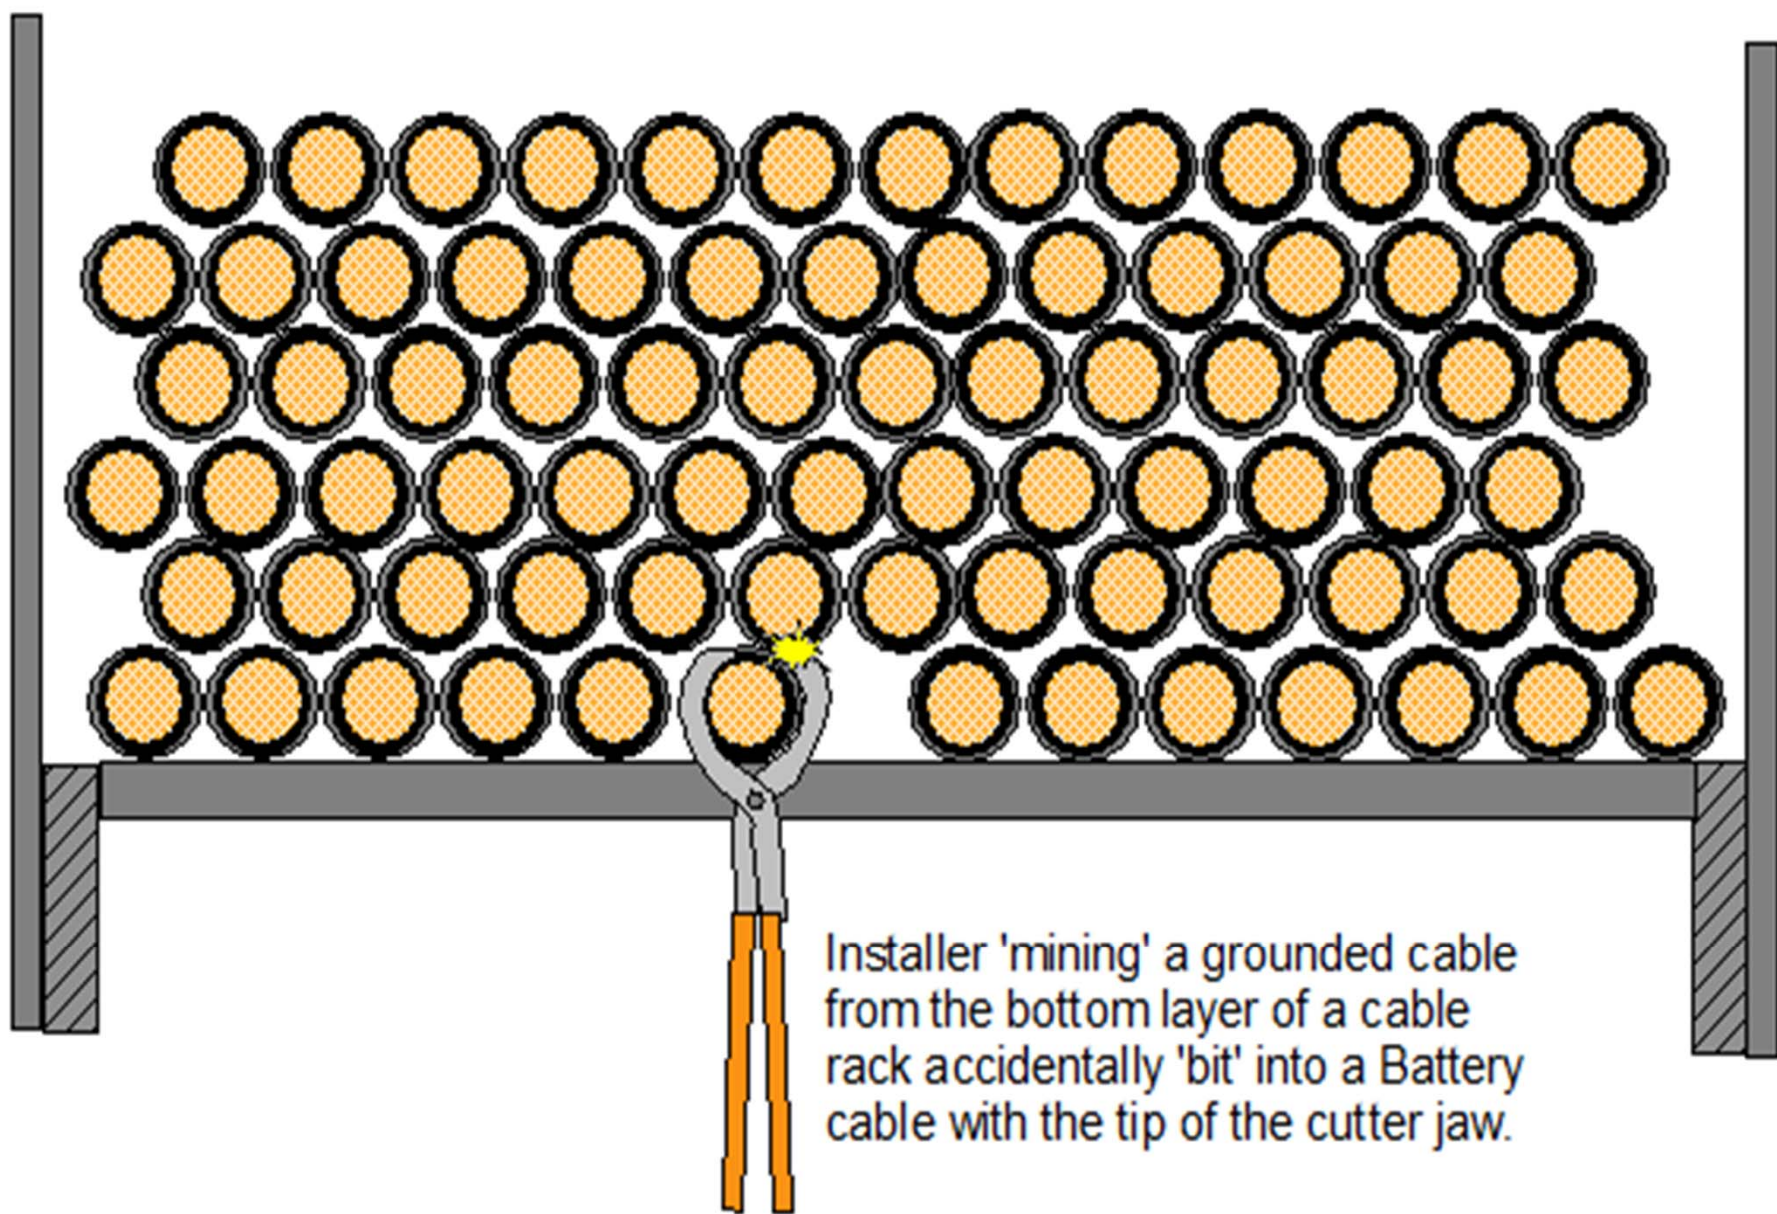
Installer 'mining' a grounded cable from the bottom layer of a cable rack accidentally 'bit' into a Battery cable with the tip of the cutter jaw.

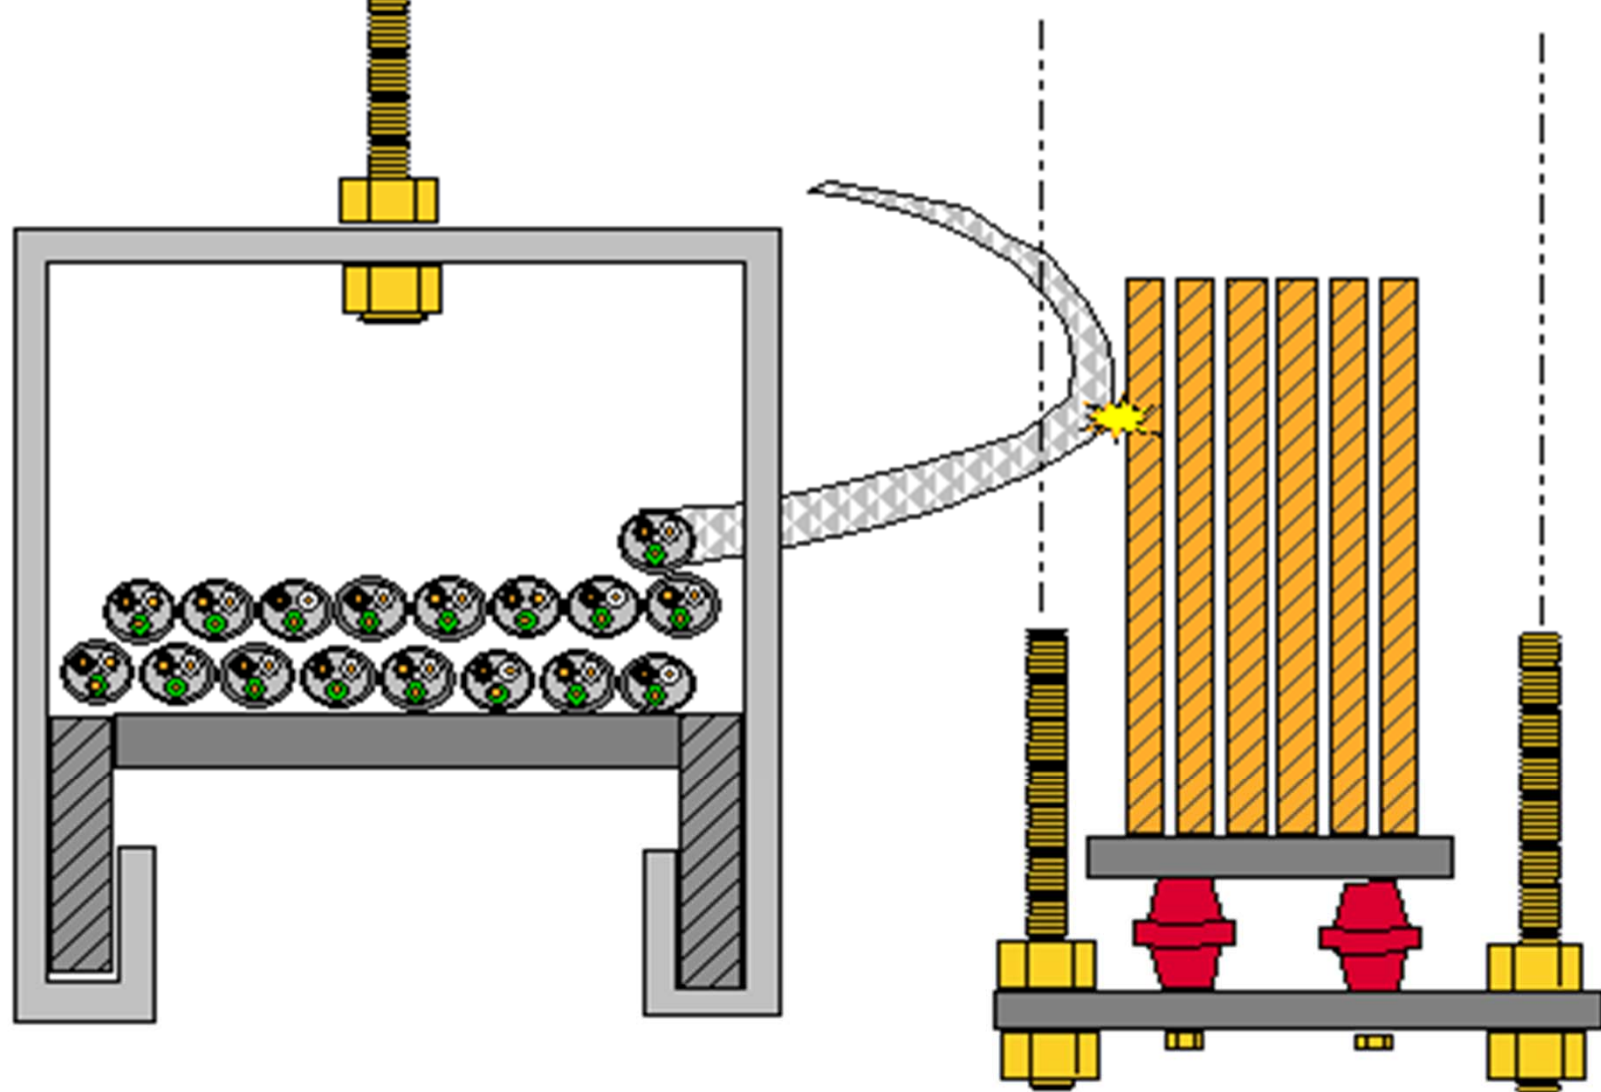
Installer running a new length of armored cable (MC cable) didn't realize that the cable had wandered off the side of the 5-inch rack until the cable struck a battery bus and welded itself into place.

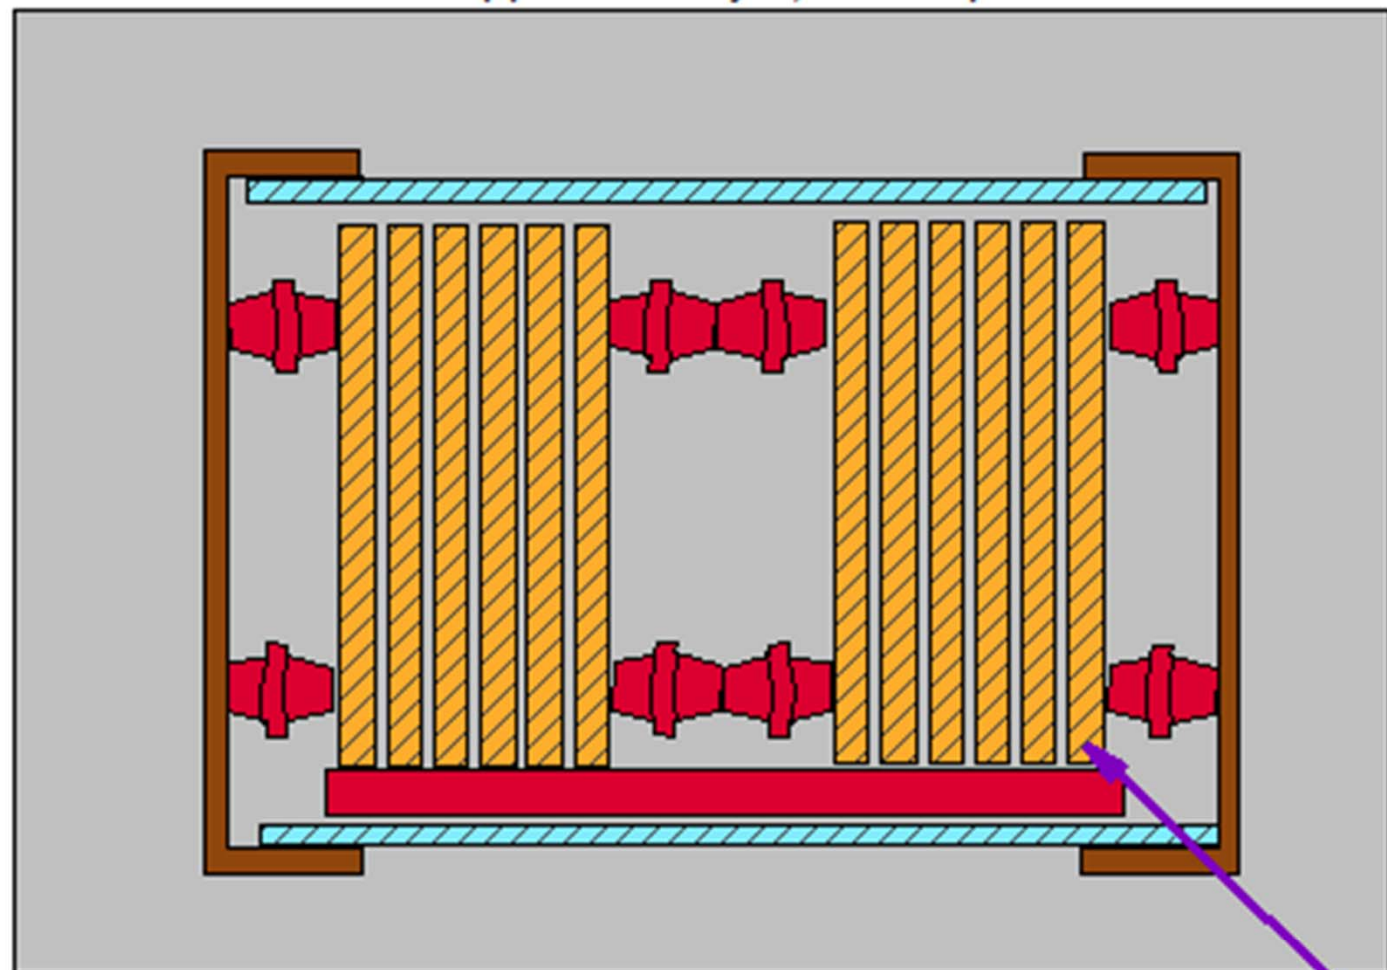
Installer closing the firestop at a wall penetration  
accidentally drilled into the bus, momentarily  
shorting the Battery side of the bus to Ground

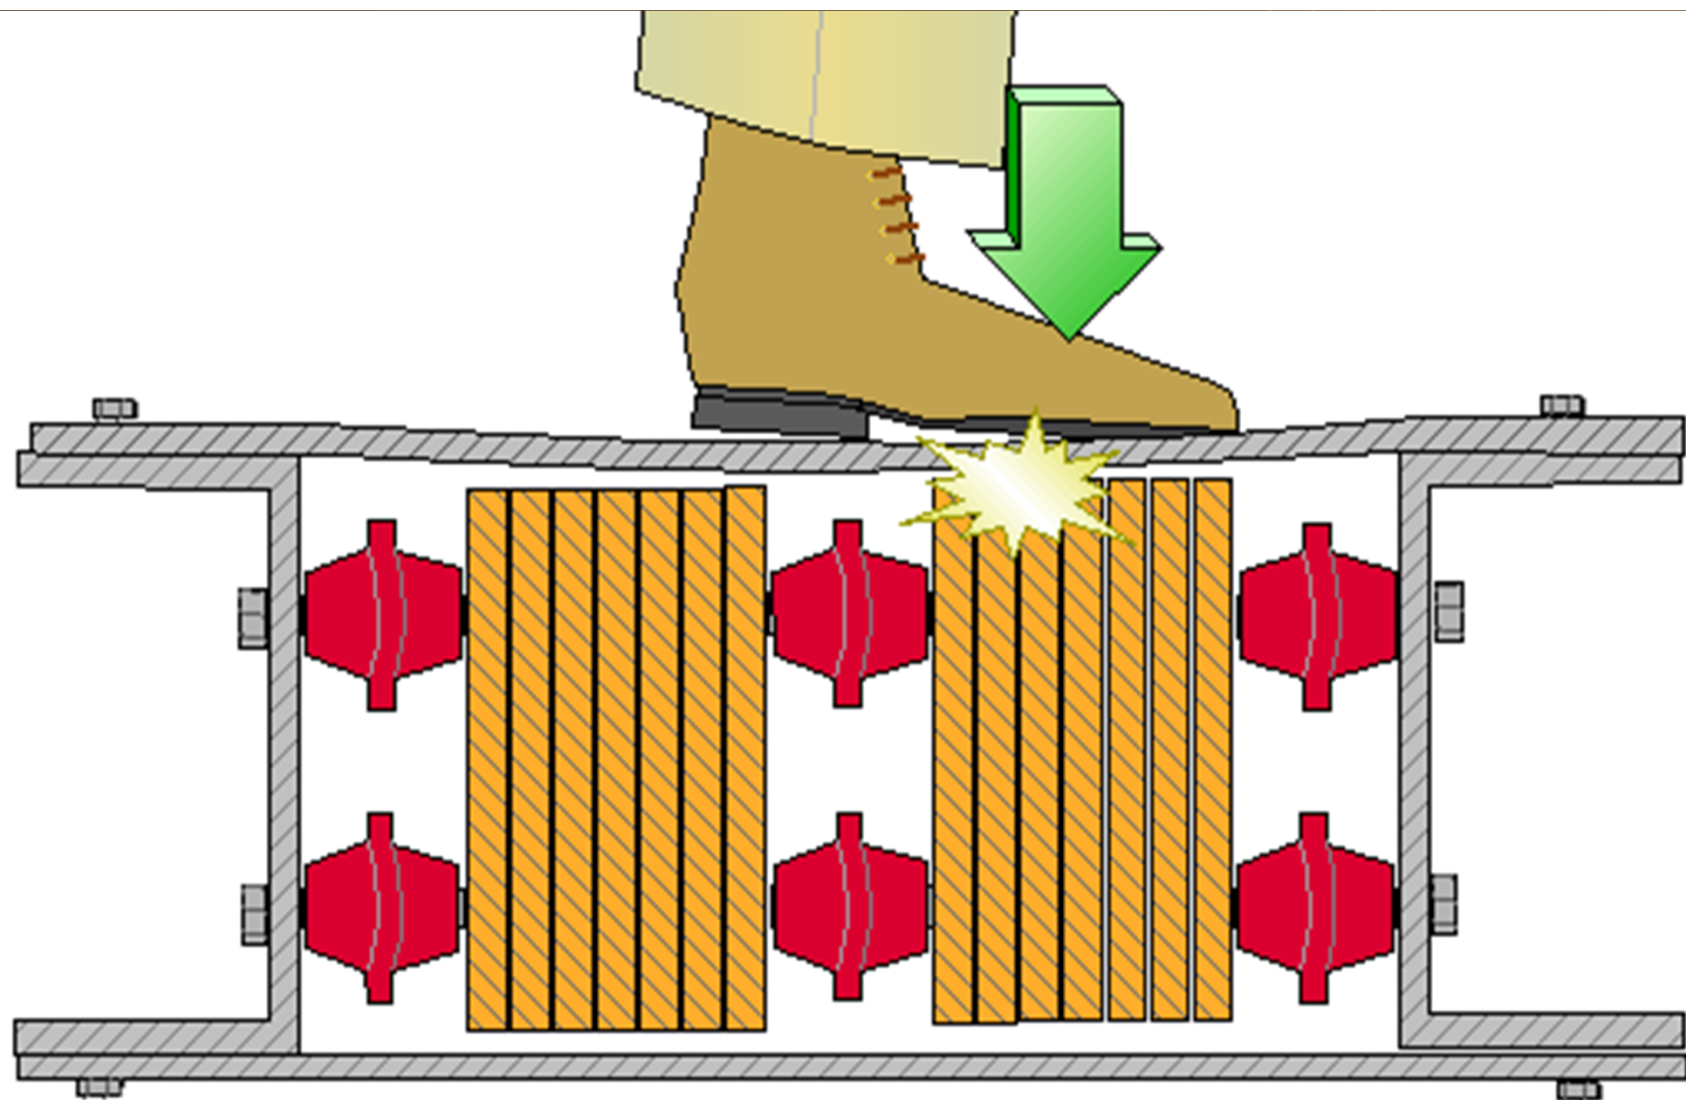
Installer drilling a concrete ceiling placed one foot onto the sheet steel cover of an enclosed dc busduct shorting the grounded cover into the battery bus of a 10,000 Ampere power system.
