Case Study

Electrical Protection & Grounding

United Illuminating Hqs. Facility

Orange, Connecticut

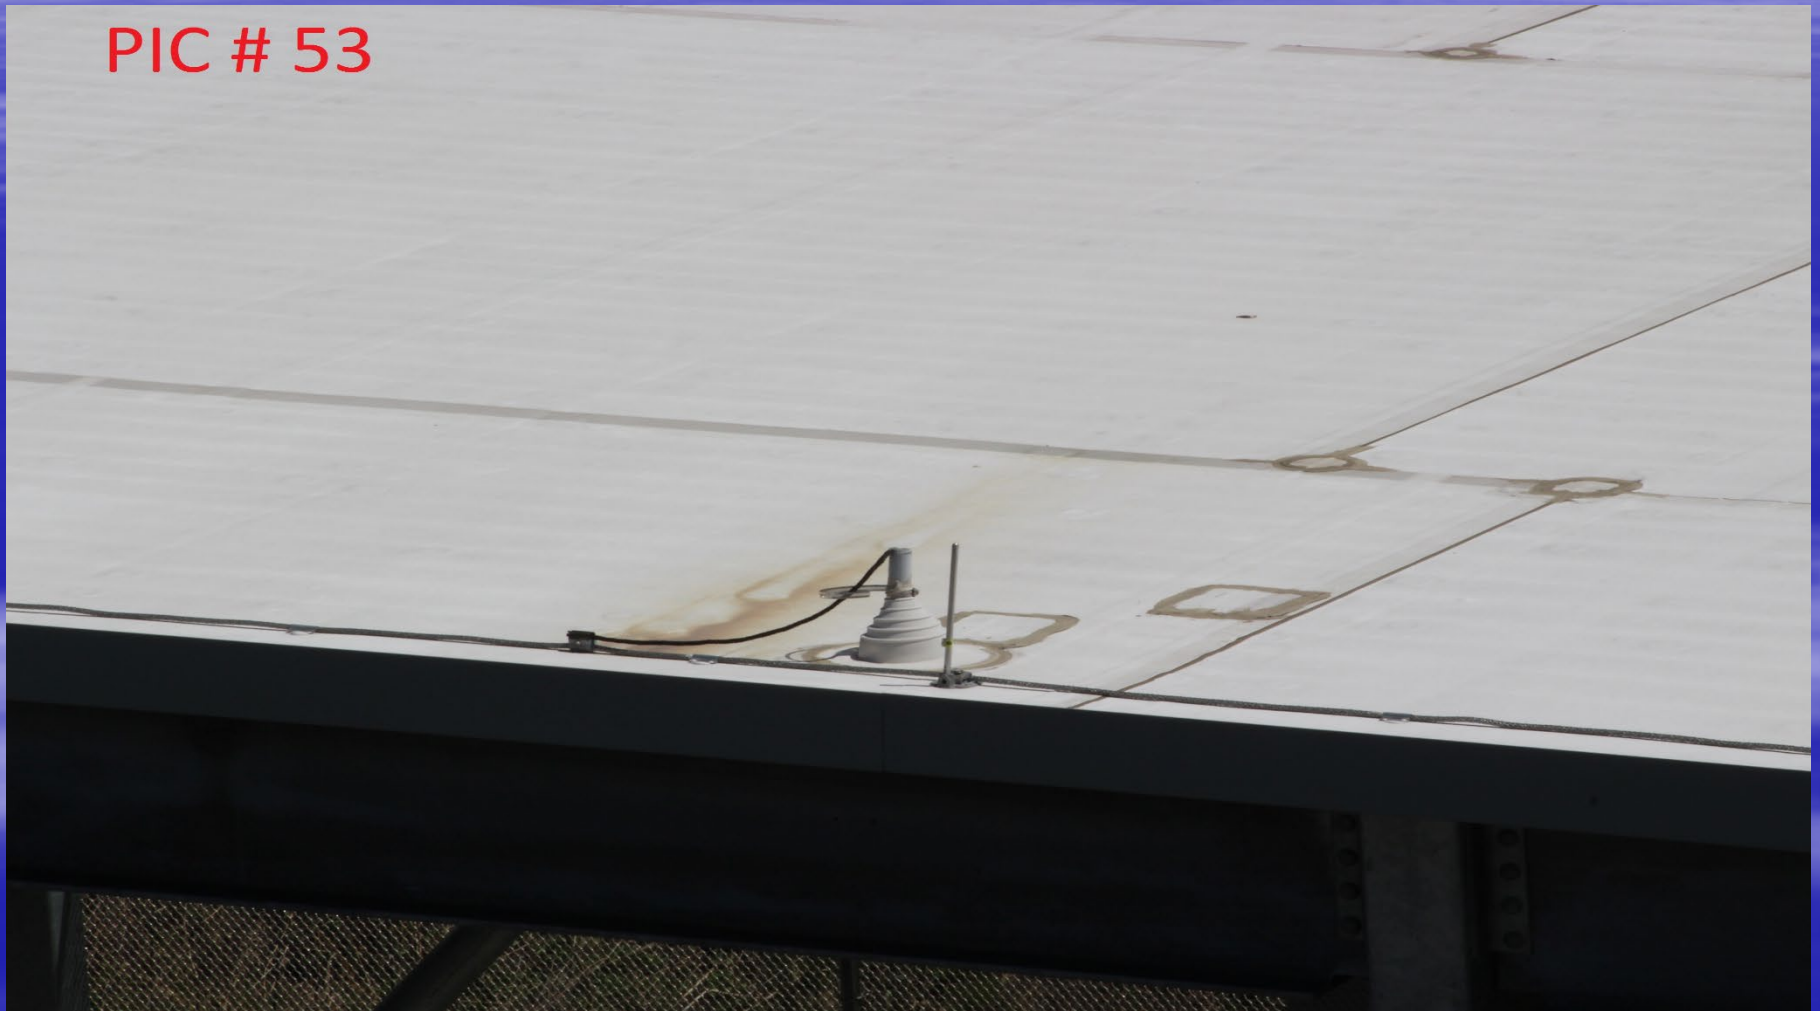
PIC # 53

- Roof lightning protection must be corrected as outlined by BV. The current installation will result in possible arching from a lightning strike and a possible fire to the roof.

- UL Master Label Certification should never have been issued, because the current roof installation for the United Illuminating Campus Facility fails UL96A and NFPA 780 cable and down conductor placement requirements.

One sample picture of many showing a bad installation on roof
