## Power GPR-Related Telecom Equipment Damages-Case Studies

John E. Fuller Larry Payne AT&T Global Engineering Support Common Systems Standards (see last page for contact info)

Presented To: Protection Engineers Group March 20, 2013

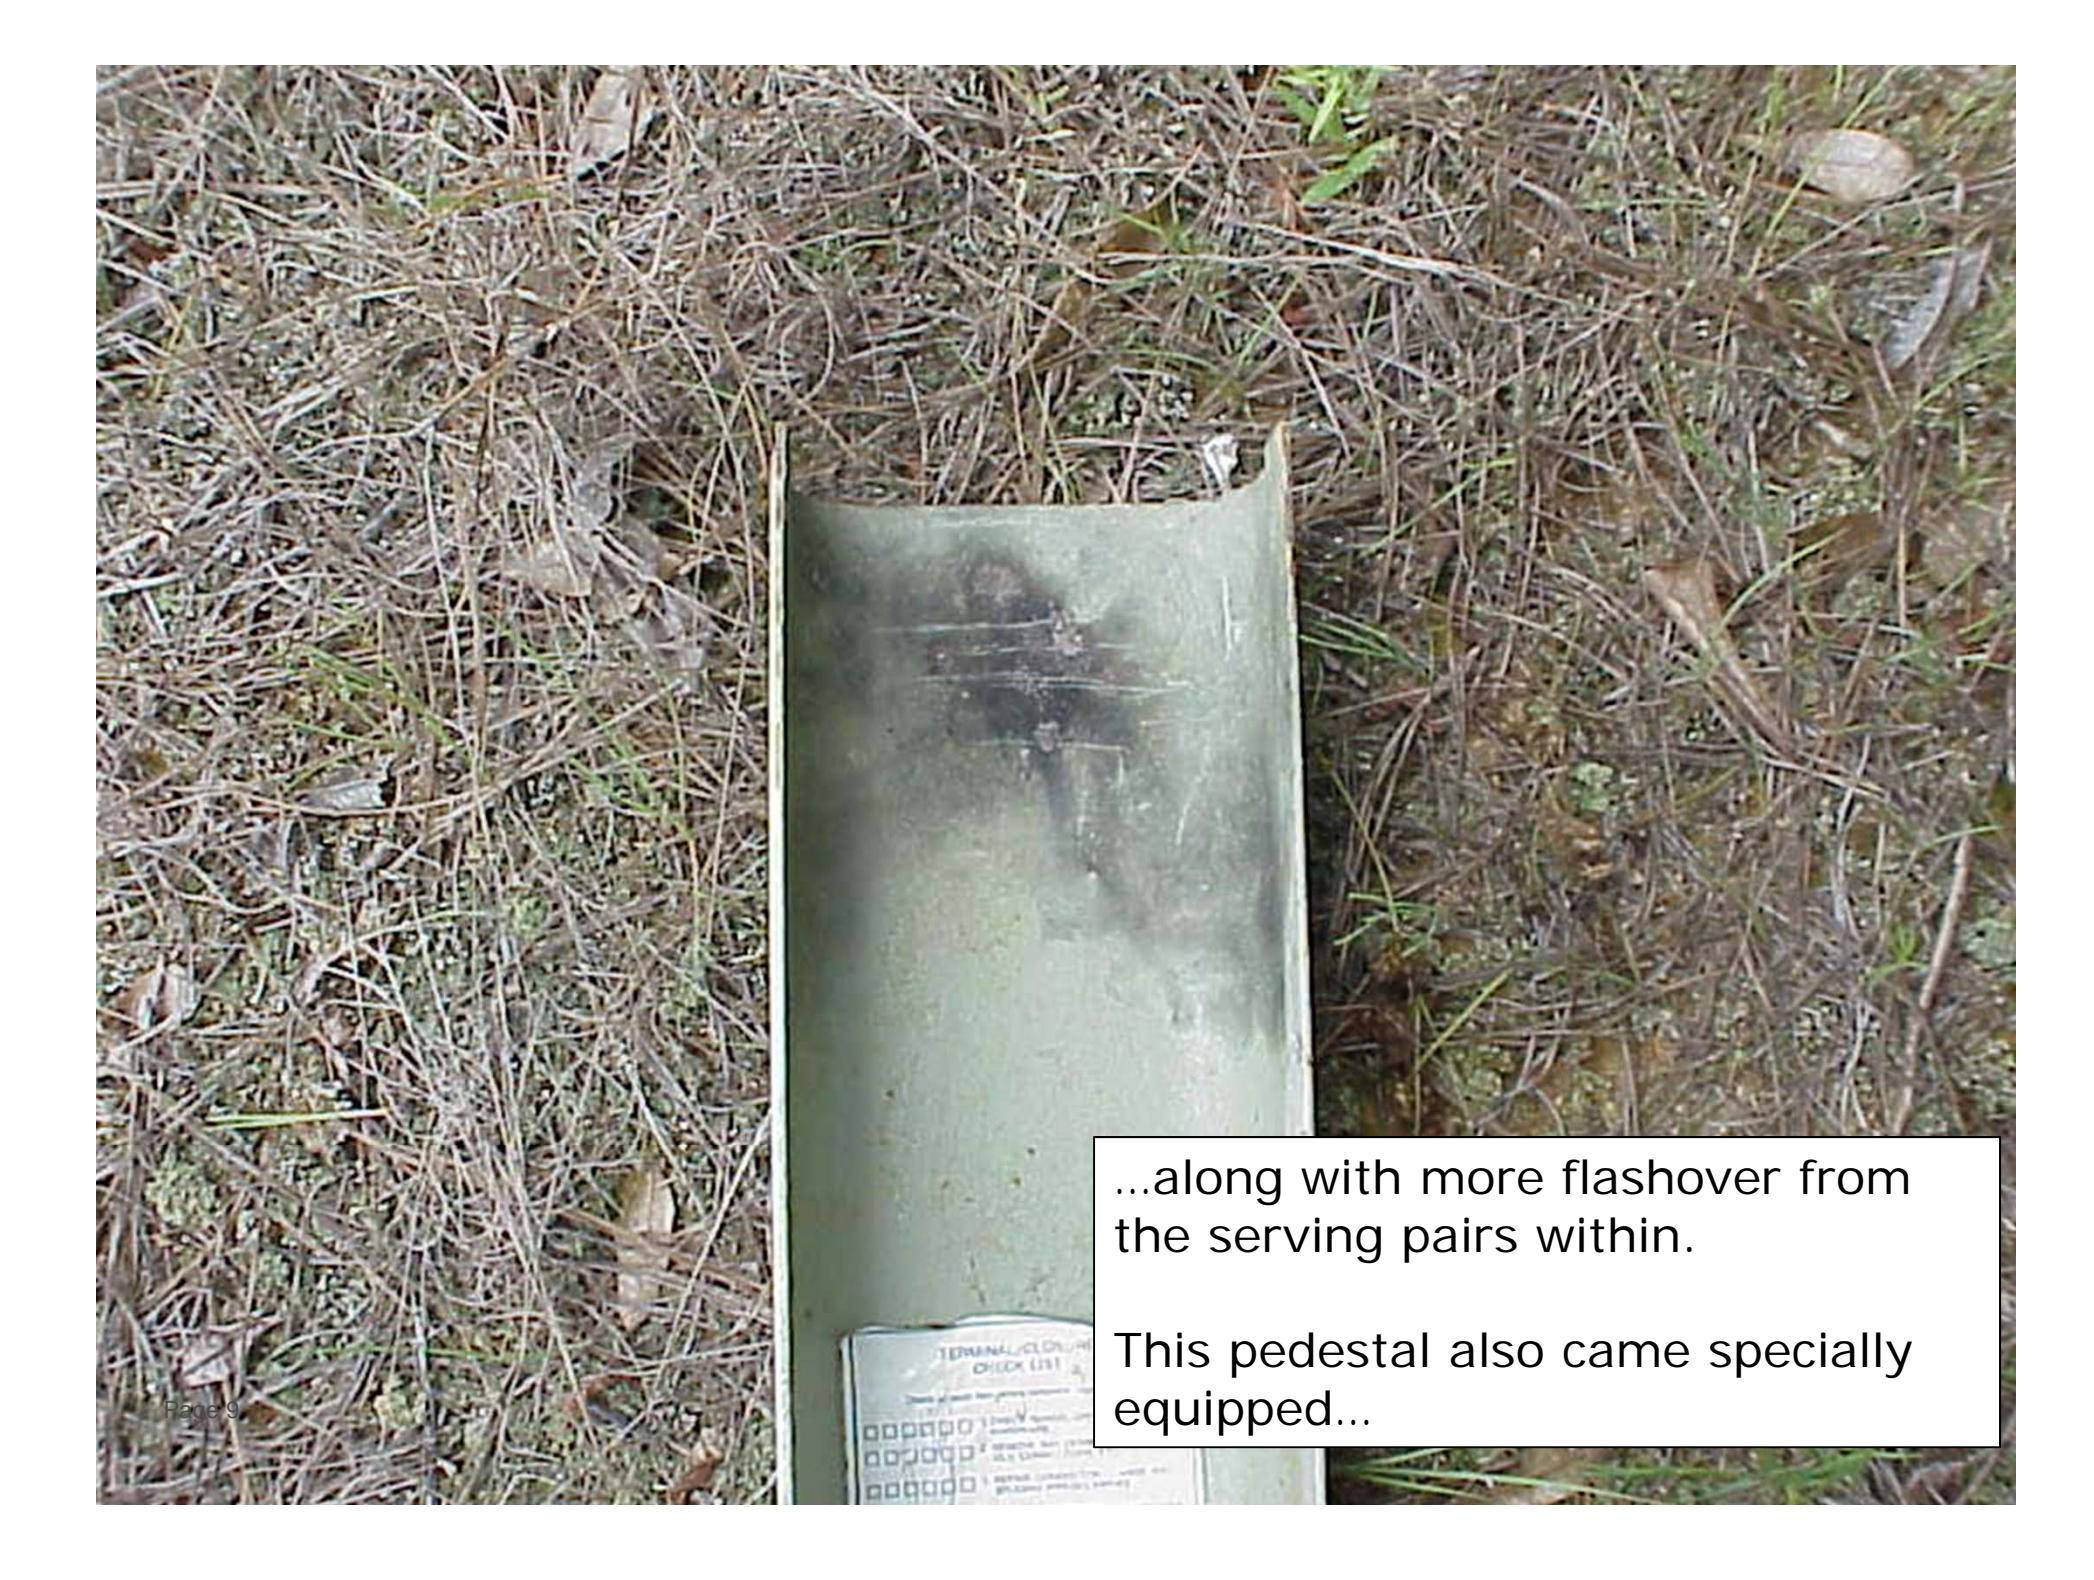
At the next pedestal toward the CO, rat's nests, spiders, and another local ground were confirmed...

#### ...with a reptilian cable fastening system.

Unfortunately, this inhabitant disappeared behind the splice plate before any successful removal attempts, so this pedestal now simply bears an additional label: **SNAKE !**

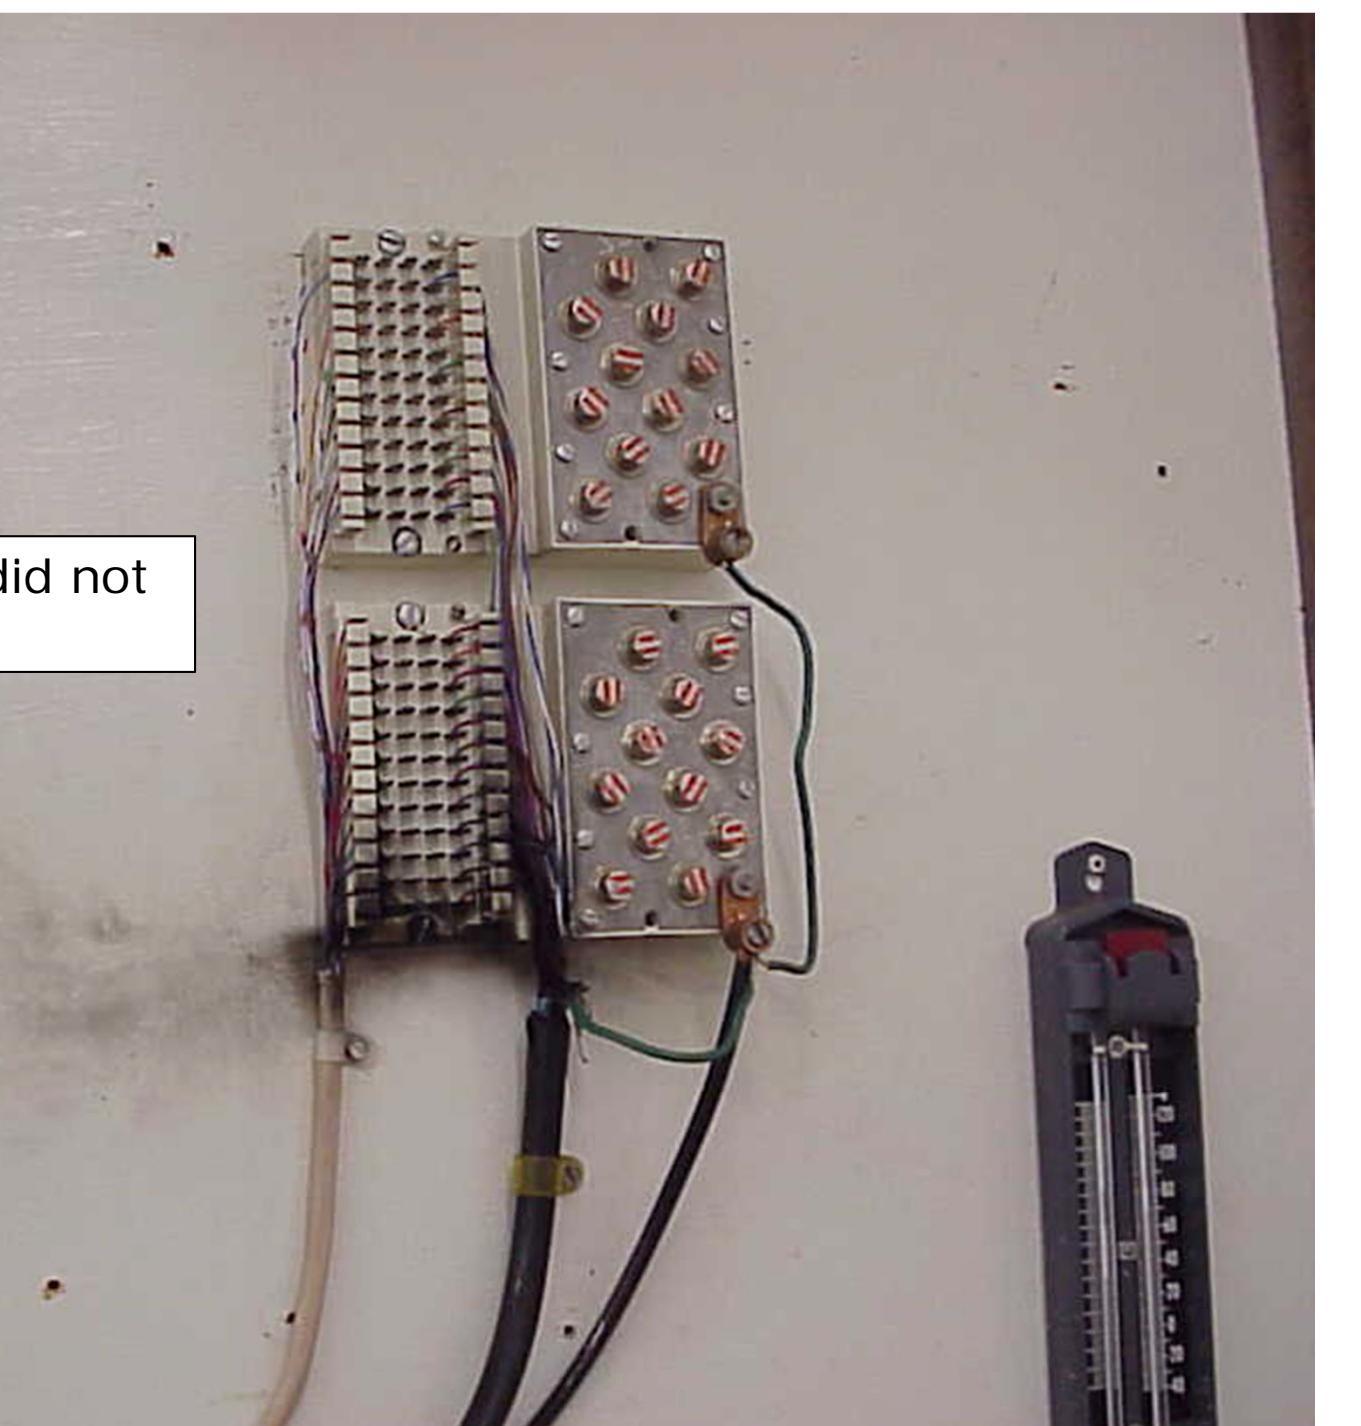
...and the facilities did not fare well...

Extensive damage to pairs and customer data equipment occurred with repeated arcing between station and remote ground potentials.

> After the installation of a hybrid fiber isolation system, no further damages or reported service interruptions have occurred at this station.

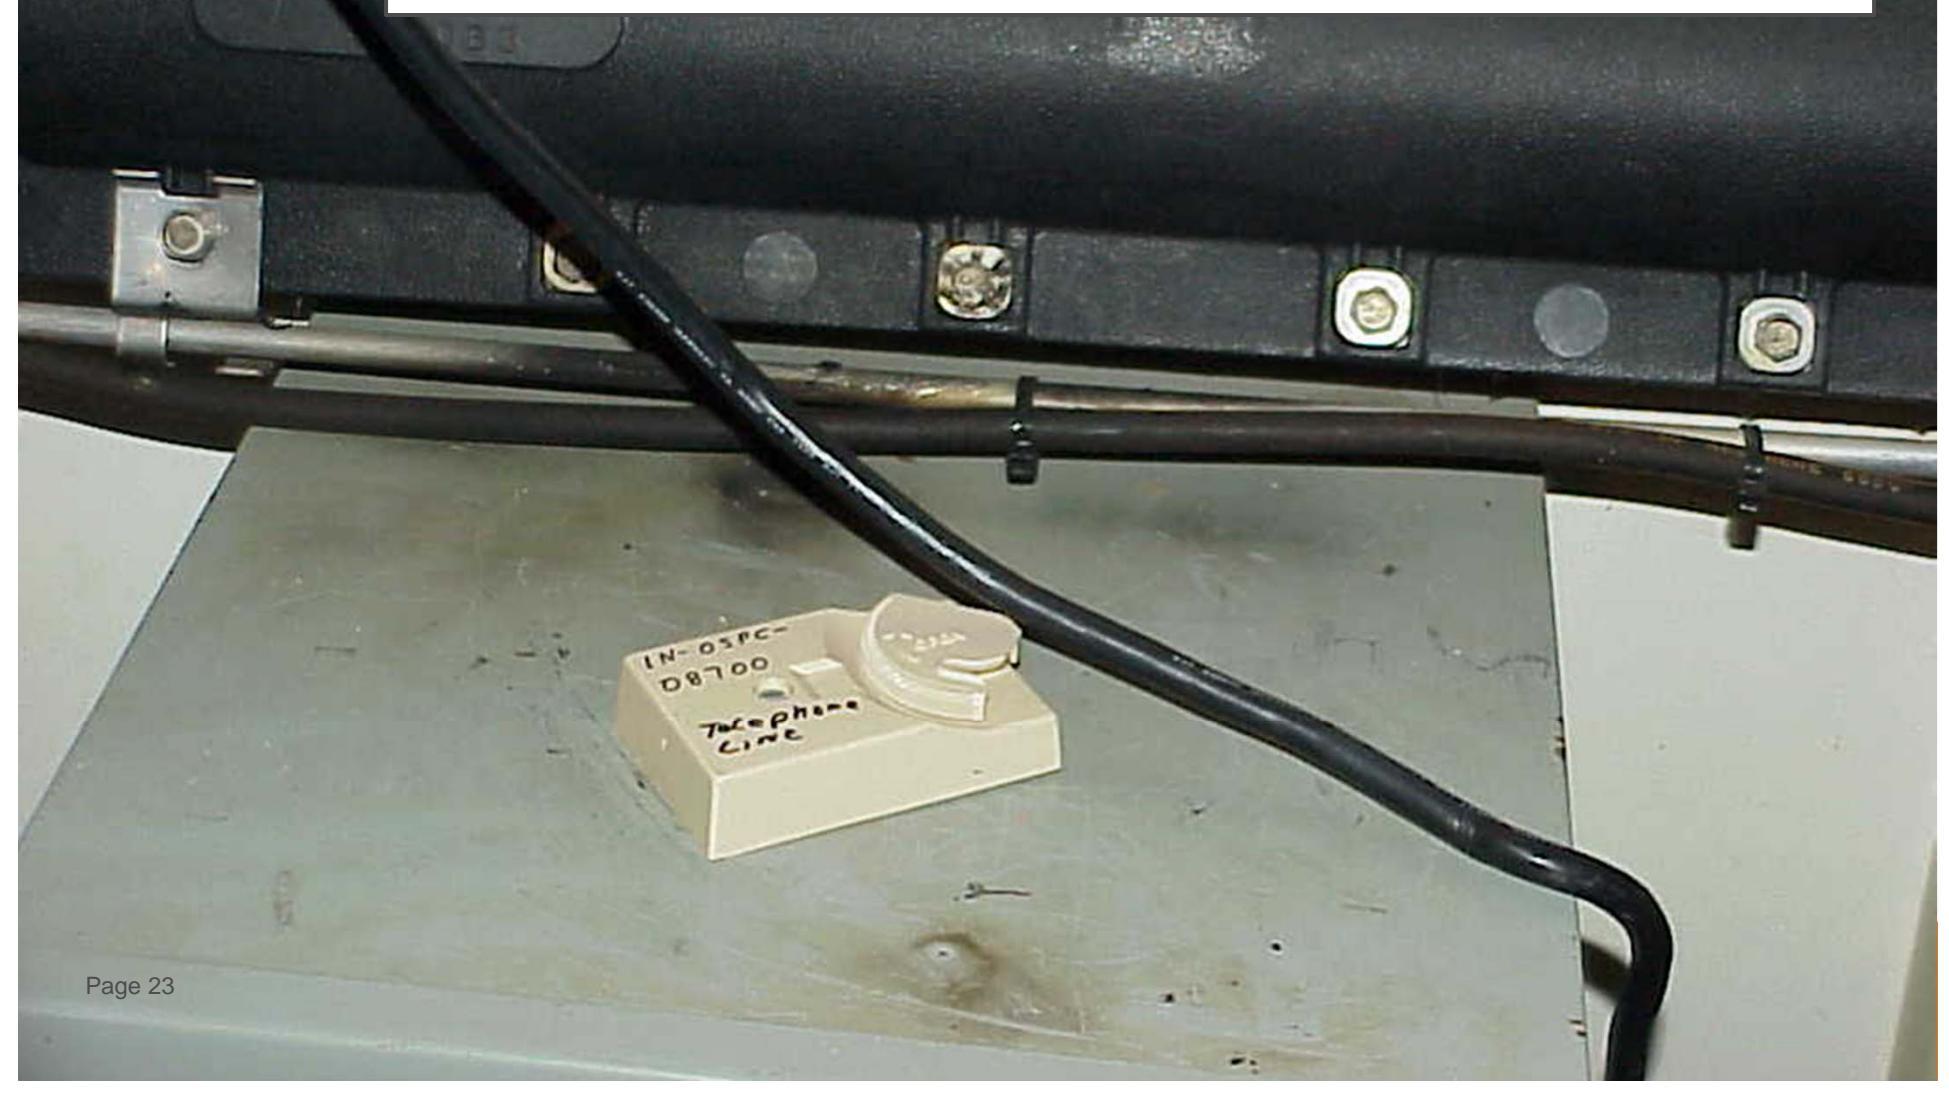
Splice case is non-metallic, but metallic bolts that are grounded to the shield and the metallic "towel-rack" mounting is also attached to the shield and has provided a path for current to flow. The result is the blackened marks on the top of the lightning arrestor, the "towel-rack" and the lower center bolt.

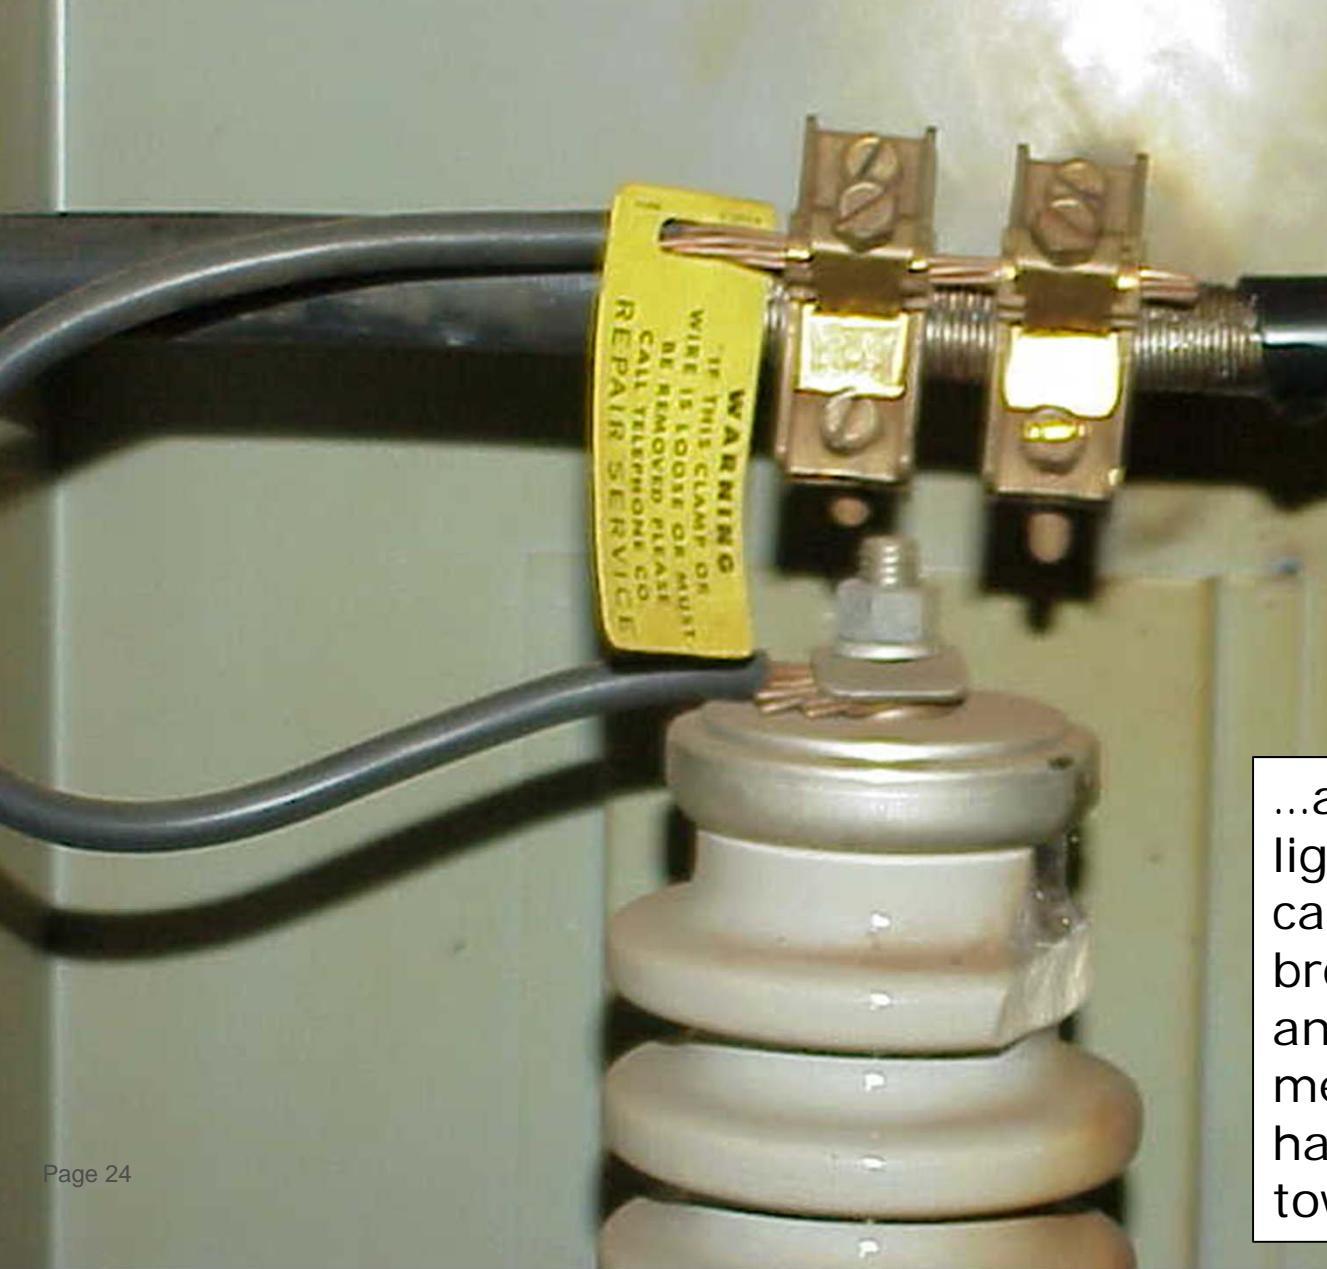
...and inside the lightning arrestor case, notice the broken insulator and arc soot. The metallic shield has no gap toward isolator.

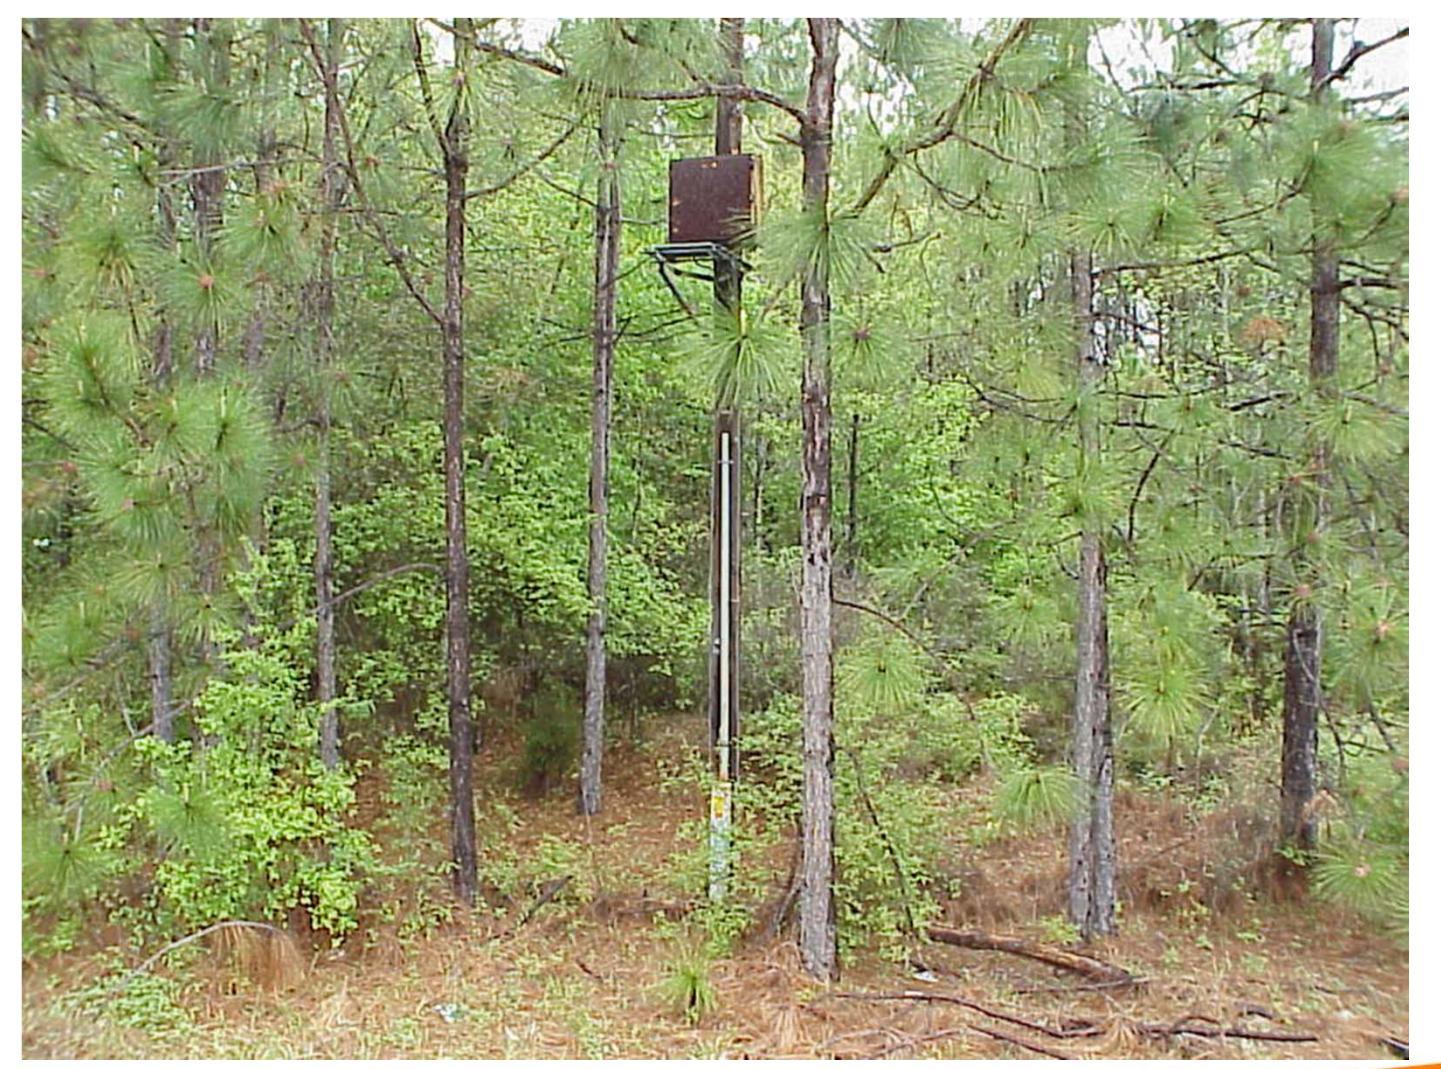
#### Is it an INT or a deer stand? Another forgotten HVI installation.
