Cases study: Road equipments facing surges in rough environment.

Presented by: Vincent Crevenat Director of Engineering Citel

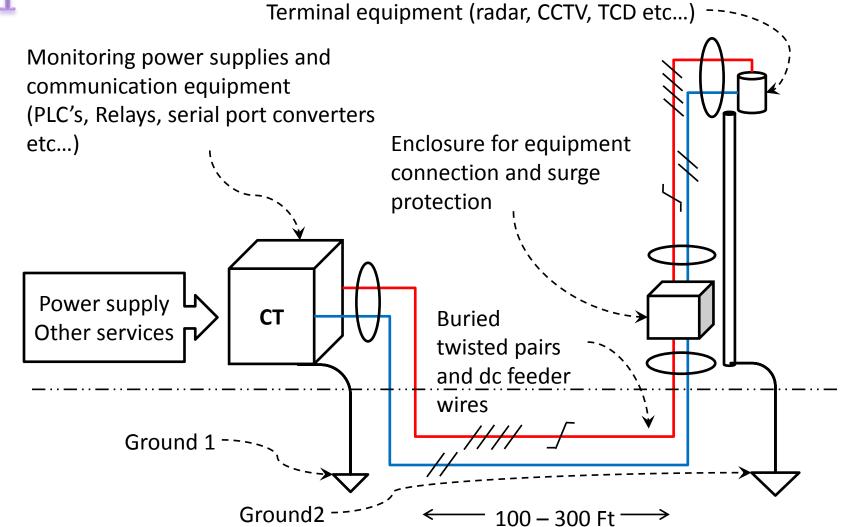
Case 1 Terminal equipment (radar, CCTV, TCD etc...) Power supply Other services **¬** Ground 1 Ground2 100 – 300 Ft⁻

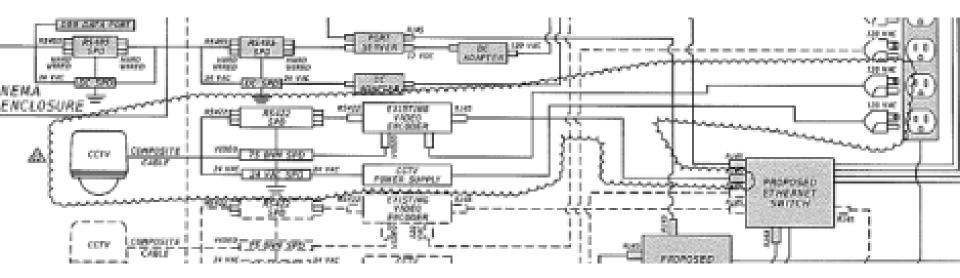
Case 2

Reports from a costumer stated the Impath Encoders are failing at multiple locations. The Impath Encoder is only device failing through serial (RS422) and video (BNC), the serial ports are protected by CITEL surge protective devices (SPD's). The CCTV camera is 30ft from Cabinet with CITEL SPD's then a run of 200-700ft to a second cabinet with CITEL SPD's and the Impath Encoder.

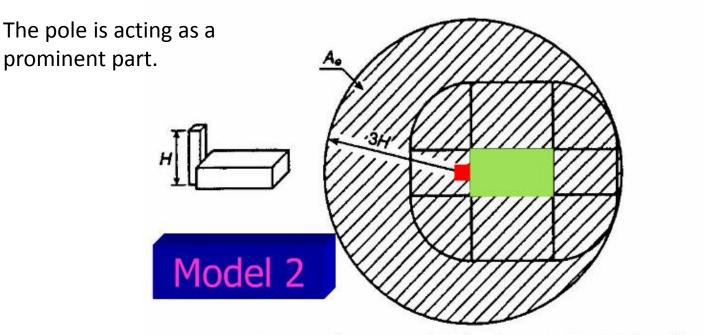
Risk assessment

Note: For a structure where a prominent part encompasses all portions of the lower part, $A_{\theta} = \pi 9 H^2$

Pole 16 meters (50')

- CCTV pole flash density location = 6
- Environmental Coefficient = 2
- Equivalent collective area = 0.000254 km^2
- >Average annual frequency of a direct flash (Nd) = 3.048 x 10^-3
- Matching the average annual frequency to the tolerable occurrence (Nc) which = 2 x 10^-3
 - NFPA 780

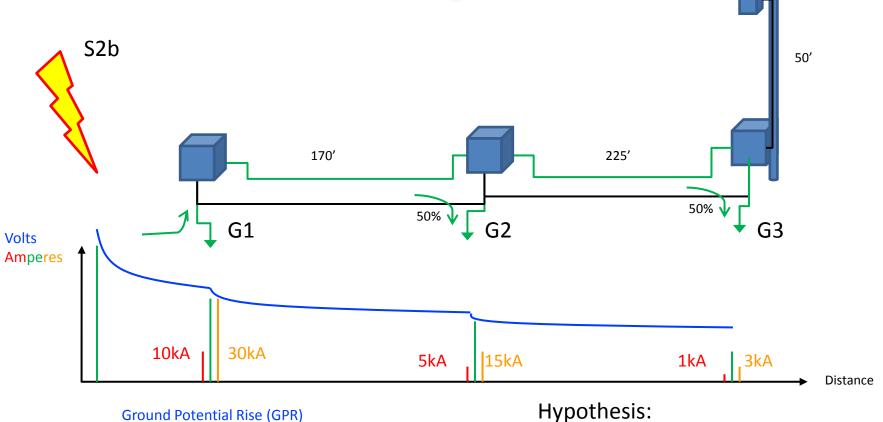
Scenario S2b with balanced ground's resistances

Current in ground Current in SPD if Grounds bounded Current in SPD if Grounds not bounded

- A. Grounds are bounded or
- B. Grounds are not bounded
- C. $G1 = G2 = G3 = few ohms (ex: 20\Omega)$

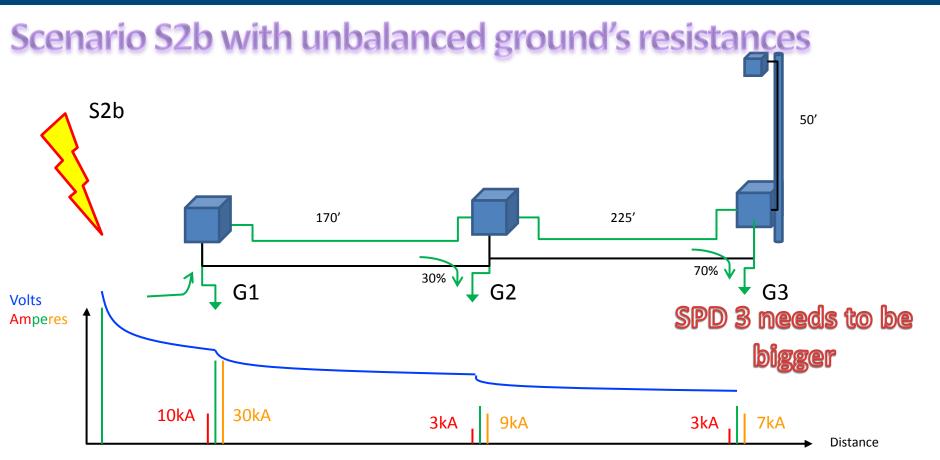
Ground Potential Rise (GPR) Current in ground Current in SPD if Grounds bounded Current in SPD if Grounds not bounded Hypothesis:

- A. Grounds are bounded or
- B. Grounds are not bounded
- C. $G1 = G2 = G3 = few ohms (ex: 20\Omega)$

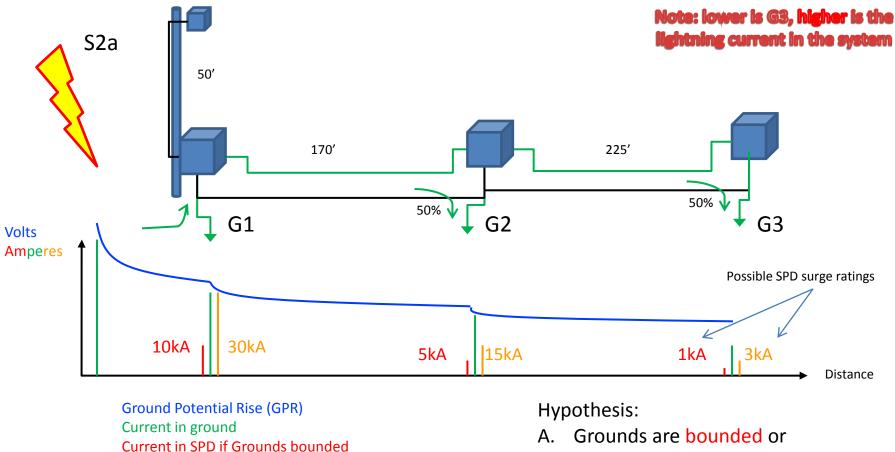
Scenario S2a with balanced ground's resistances

B. Grounds are not bounded

C. $G1 = G2 = G3 = few ohms (ex: 20\Omega)$

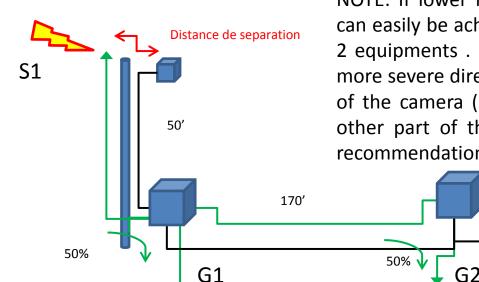
Scenario S1

• If separation distance is achieved, there is no need for extra protection at the camera's location. This means that several feet of air distance or clearance are between down conductor and other conductive parts (distance is depending of lightning current): For example and for a 50' pole, if 100kA lightning current is considered, a minimum of 2 feet air distance is necessary and 2 to 4 feet of insulating means (depending on material),

• If separation distance is not achieved, bounding of the camera to the down conductor is requested and SPD able to handle direct lightning current is necessary at Camera's location.

NOTE: If lower lightning current is considered, separation distance can easily be achieved by using non conductive housing and/or class 2 equipments . In that case, the most common risk is covered but more severe direct lightning current will lead to the total destruction of the camera (SPD in cabinet being still necessary to protect the other part of the system). This scenario being rare, it is still my recommendation.

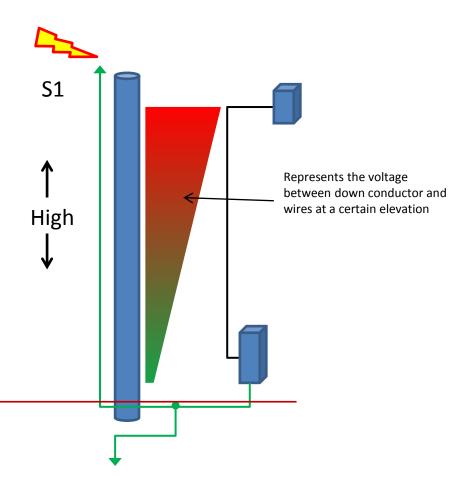
Scenario S1: Some values

From various field survey and statistical analysis, once can assume that typical dI/dt of the lightning current can be from around thousands of amperes per µsec to several hundreds of kilo Amperes per µsec. It is common to use medians as a parameter for simulation. It has to be noted that depending on the type of lightning (positive, negative, ascendant and descendant) and depending on the strike we consider.

Let's pick <u>**10kA/µs</u>** to ease our calculation for an example...</u>

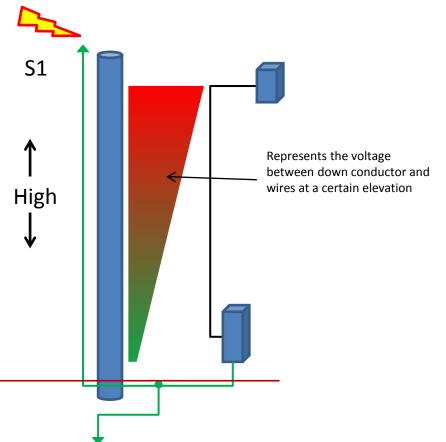
Scenario S1: Some values

Inductance of a wire can be set approximately from 0.1 to few μ H per meter (3'). When there is an attempt to estimate the impedance of the path from the air terminal to ground, it is then depending on the type of down conductor (shape), number of down conductor and if the pole can be considered itself as a down conductor... Let's use **0.5µH per meter** to ease the calculation. This leads to estimate the total inductance of our traffic pole to <u>8µH</u> (Pole high is 16m).

If we consider, that no SPD is installed at top of the pole, we can assume that the voltage between the down conductor and the equipment that is connected to an SPD in the bottom pole cabinet will be of 80kV.

$$U = L \cdot \frac{di}{dt} = 8\mu H \cdot \frac{10kA}{1\mu s}$$
$$U = 80,000V = 80kV$$

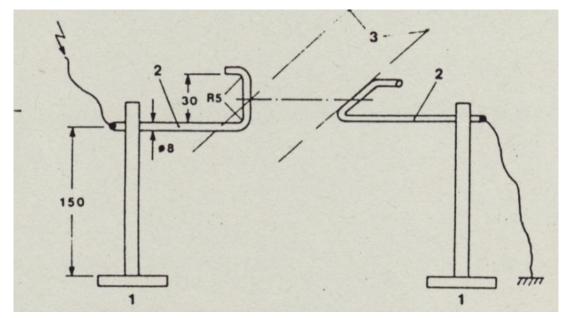
Example of test performed to determined arcing distance between 2 conductive parts when an impulse voltage is applied (approximately 1μ sec)

1: support insulator; 2: Electrode of metal rods 8 mm diameter; 3: Gap distance s

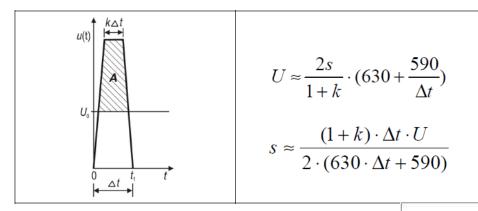
Various models can be applied here but this one gives a good idea of the distance to expect a breakdown when considering a lightning overvoltage. (dt=2 and k=0,3)

Once can estimate the distance breakdown on a surface material as equal if the material is not conductive and clean. In practice a coefficient up to 2 can be applied. For example, the safety distance for concrete will be set to 1.4 m for 1000 kV surge voltage.

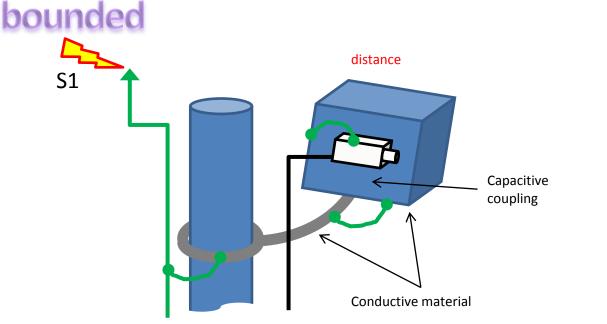
In that type of installation a local SPD is highly recommended. Surge rating of this SPD must consider the partial lightning current conducted through bounding.

Uwithstand = Equipment withstand (manufacturer declaration)

Example in this system : Uw camera = 2kV

Risk of destruction can be estimated to 99.9% of occurring events if no additional measures are taken (such as SPD installation)

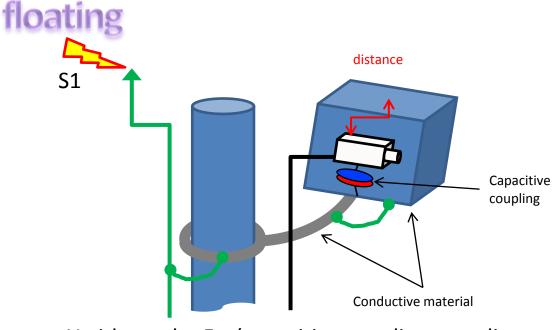
In that type of installation, the camera fixture may be insulating material to have a better control of the insulation between active parts (camera's internals) and the conductive housing.

Uwithstand = *Fct* (capacitive coupling and/or distance)

Example in this system : Uw camera = 50kV

Risk of destruction can be estimated to 90% of occurring events if no additional measures are taken (such as SPD installation)

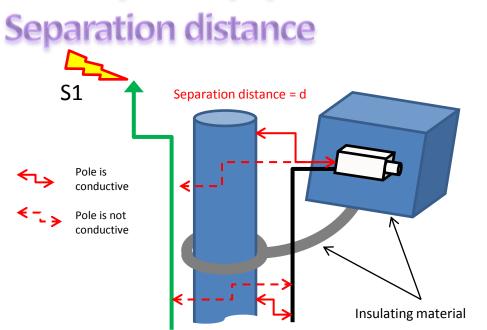
Static charges can accumulates and a mean to evacuate these is highly recommended (via the ground wire of the camera).

The selection, installation or routing of the wires is be considered in order to not break the insulation property of the system.

Uwithstand = *Fct* (separation distance and/or Insulation withstand)

Example in this system : Uw camera = 600kV (if 60cm) and considering some safety margin)

Risk of destruction can be estimated to 10 to 20% of occurring events.

- Separation distance
 - Withstand is depending on distance/creapage but can be in the range of worst case expected voltage (our example: 600kV).
 - SPDs at top are not existing.
 - ➢ For our example, large majority of lightning events are covered (80to 90%).
- Floating
 - Uwithstand is depending on distance/creapage but inside the top enclosure and will be limited by the size of the enclosure itself (our example: 50kV)..
 - SPDs at top could be needed
 - For our example, few lightning events are covered (10%)
- Bounded
 - Withstand is the one declared for the equipment to protect (our example: 2kV)
 - SPDs at top are requested and surge rating of this SPD must consider the partial lightning current conducted through the bounding (hundreds of kA)
 - For our example, almost all lightning events would destroy the equipment if no SPD!
