Part 2: The Continuing Challenges for the Contractor Working on Tier 1 Carrier Cell Sites: How to Ensure You Stay on the Air

QUALITY POWER, INC

What are the Challenges - Contractor Concerns

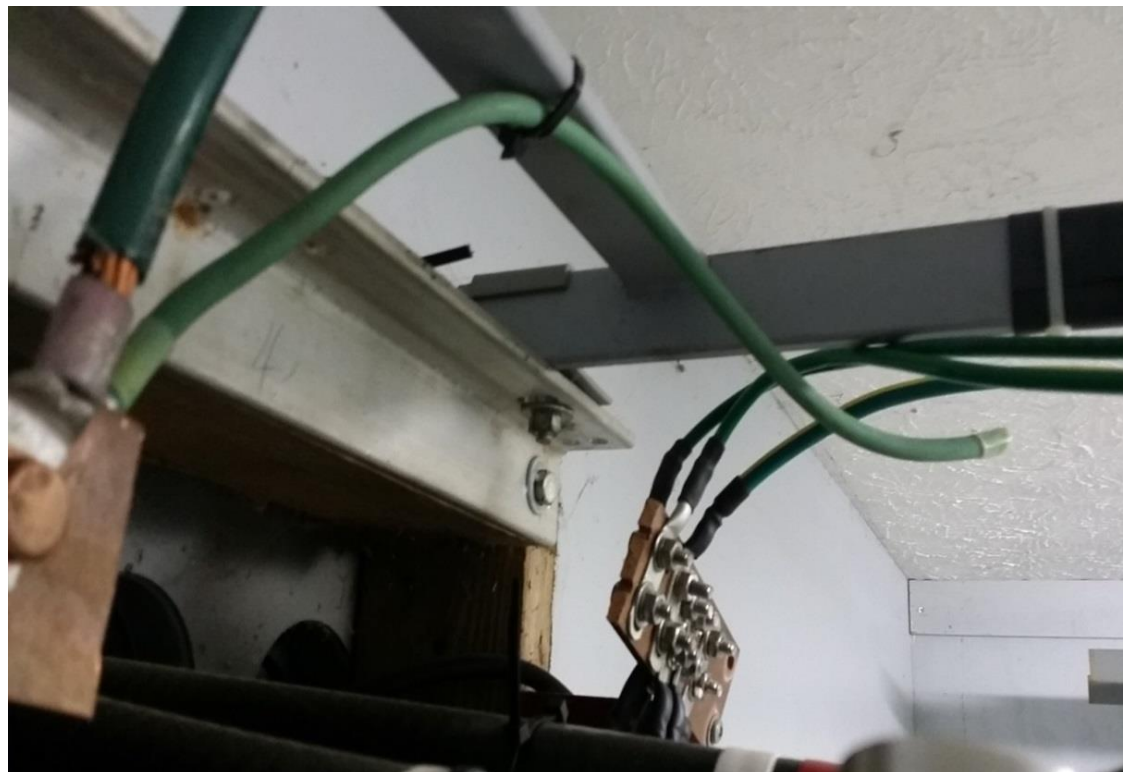
Challenges: Contractor “Engineering”

WHAT??? **WHY???**

- How does Telco insure contractor has read and understands standards and work guidelines?
- How are field modifications reported back to Carrier?

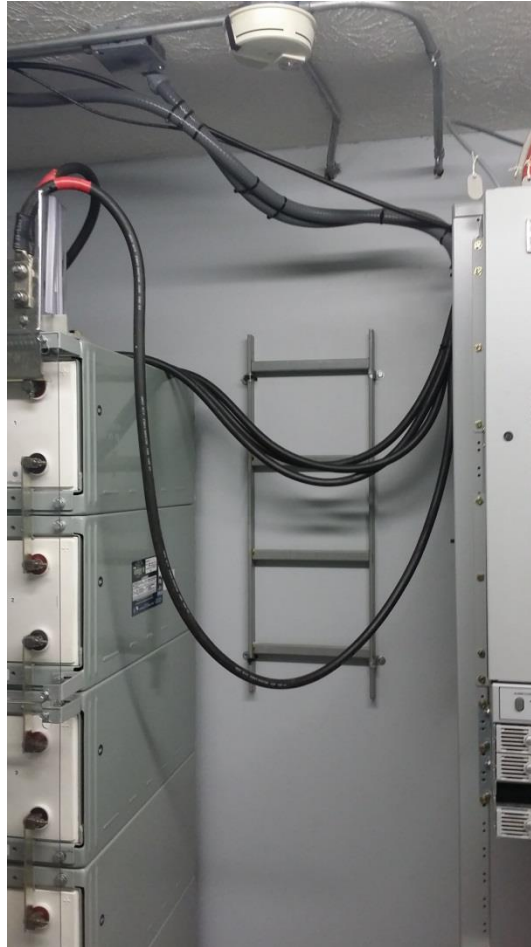
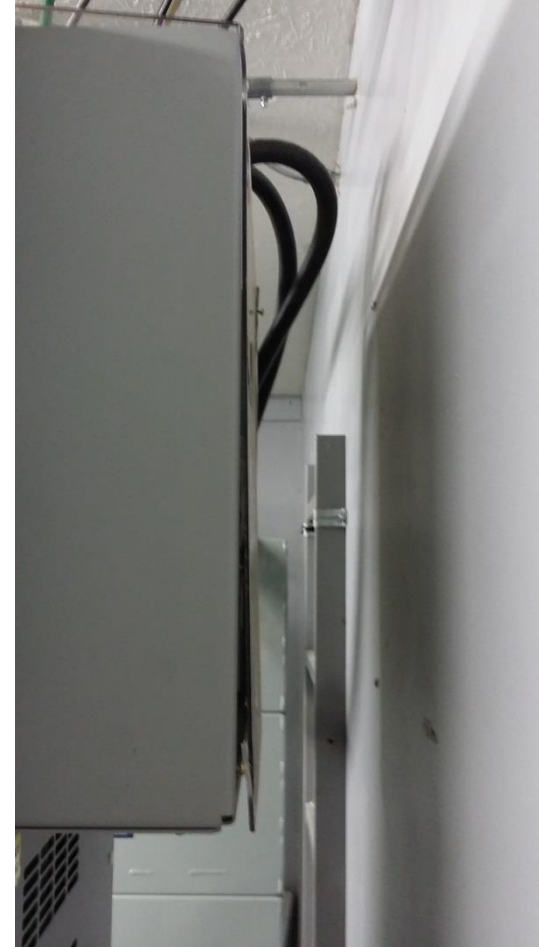
- How does the Telco ensure project has been completed properly (joint acceptance inspection)?
 - No Construction or Project Manager from Telco visited site
 - In this case, the rack makes a nice wall hanger, good luck servicing plant LV contactor

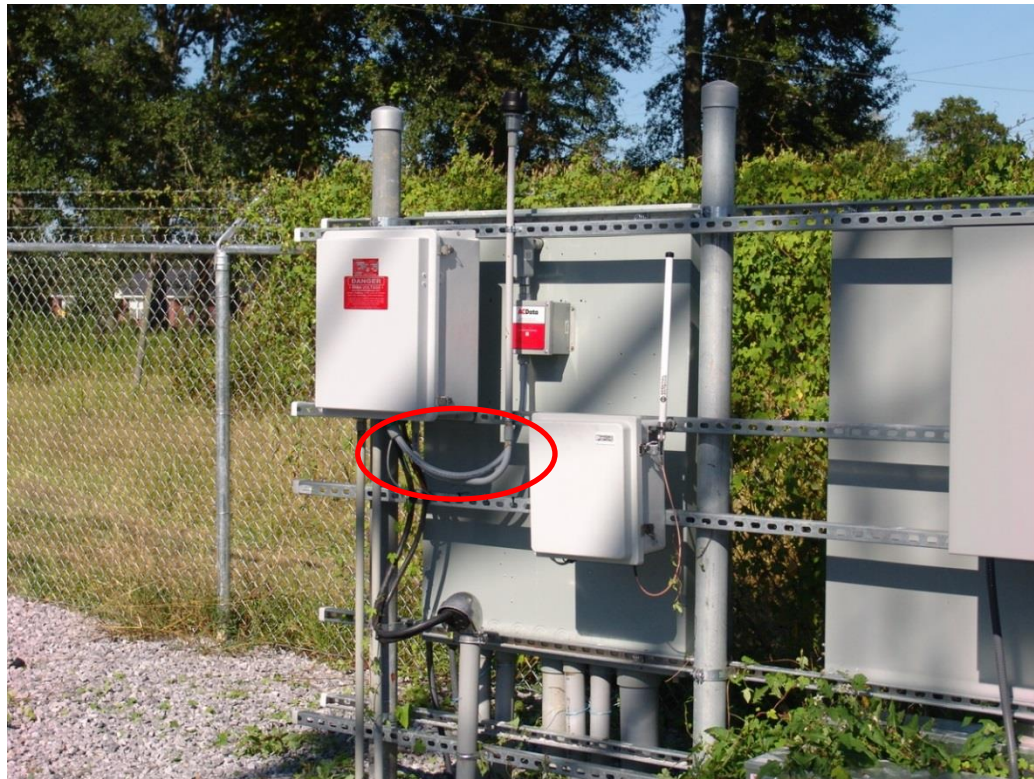
- (X) = Site was built.
- At time of our involvement, there were no known records of the installed grounding architecture.
- AC Service and controller installed on H-Frame.
- Alarm from SPD goes to the OBS (Obstruction Lighting) controller, they share same multi-conductor from H-frame to shelter

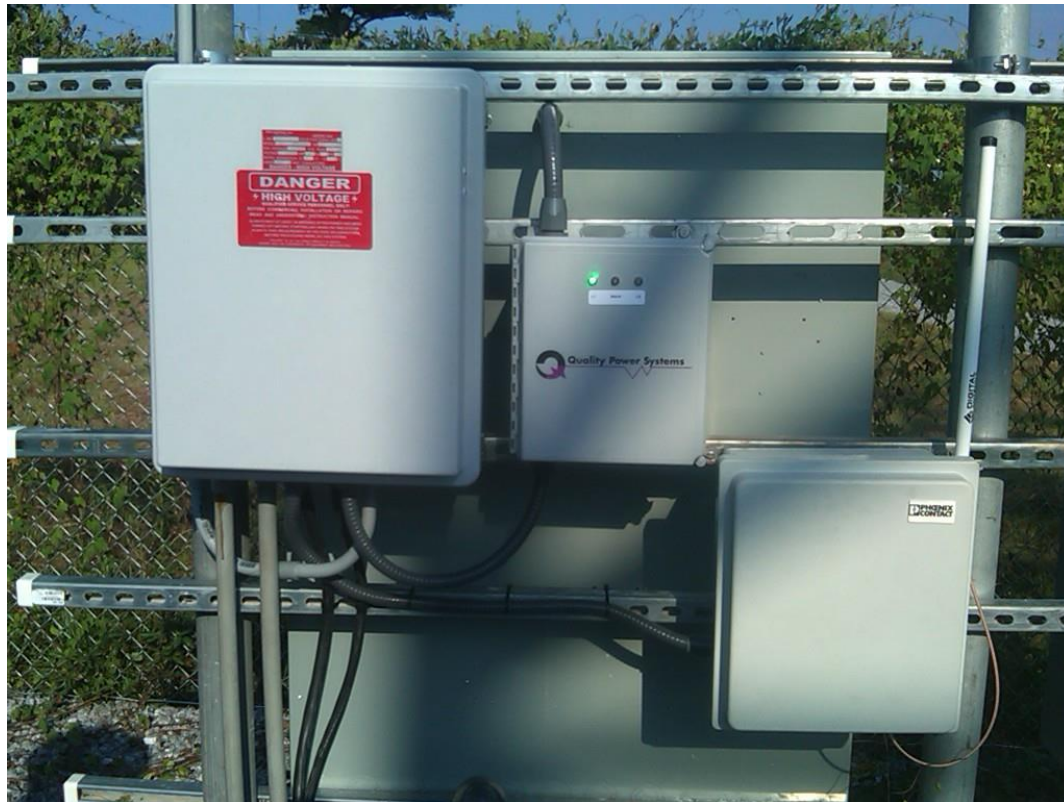
- Cellular equipment, AC SPD and OBS controller suffered lightning damage in first year.
- AC Power SPD Upgrade Solution was chosen.
- Additional grounding, alarm protection, and OBS lighting protection was not chosen.

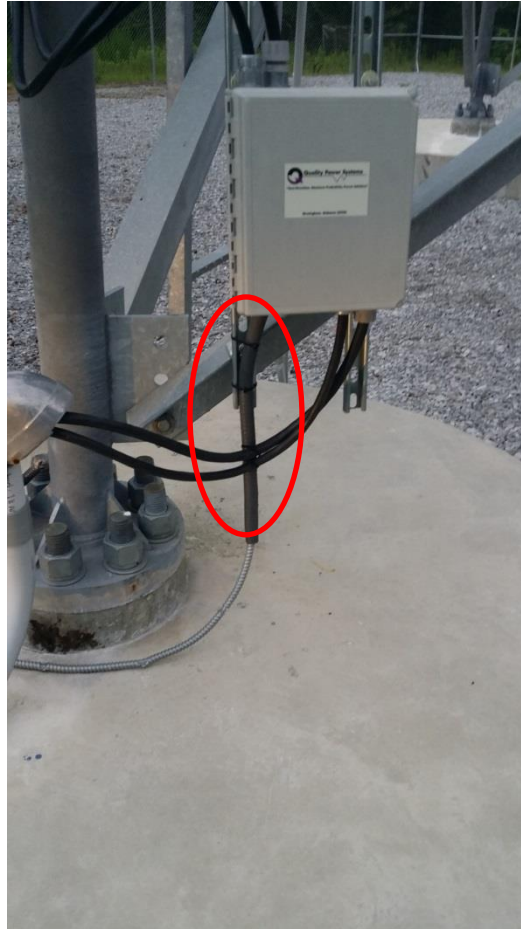
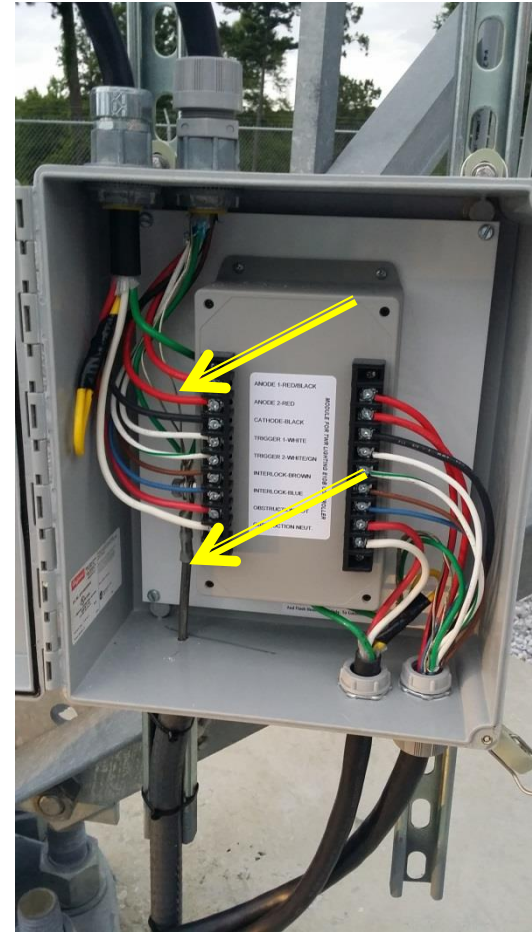
- One year later, lightning damages cellular equipment (alarms) and OBS controller.
- Tower light SPD installed.
- Additional bonding and alarm SPD not chosen.
- Note: Shield of cable bonded to SPD module and 2AWG SBTC going to buried ring

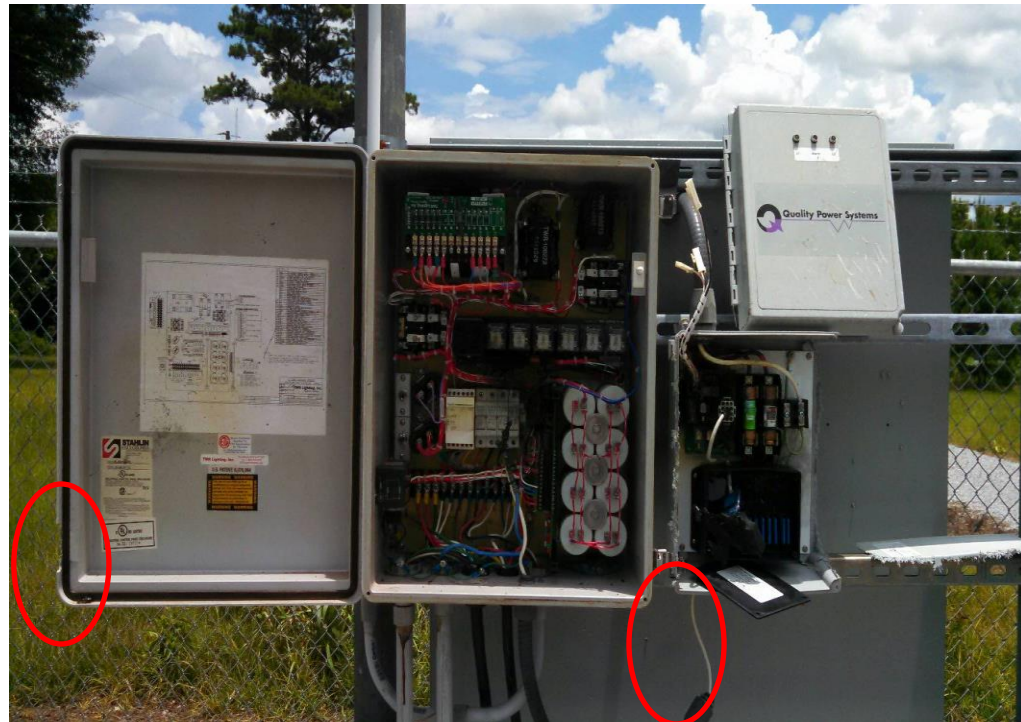
- Less than one year, Cellular equipment (alarms), AC Power SPD along with OBS controller destroyed during thunderstorm.
- OBS SPD not damaged.
- **How did OBS controller and AC Power SPD get destroyed and yet no damage to OBS SPD mounted on the tower?**

- Note Alarm Cable.

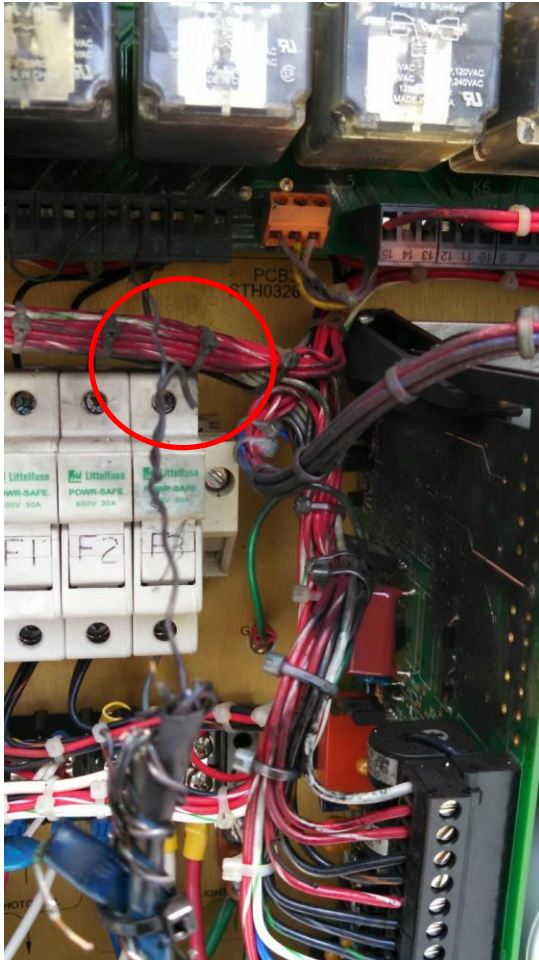
OBS ALARM VAPORIZED

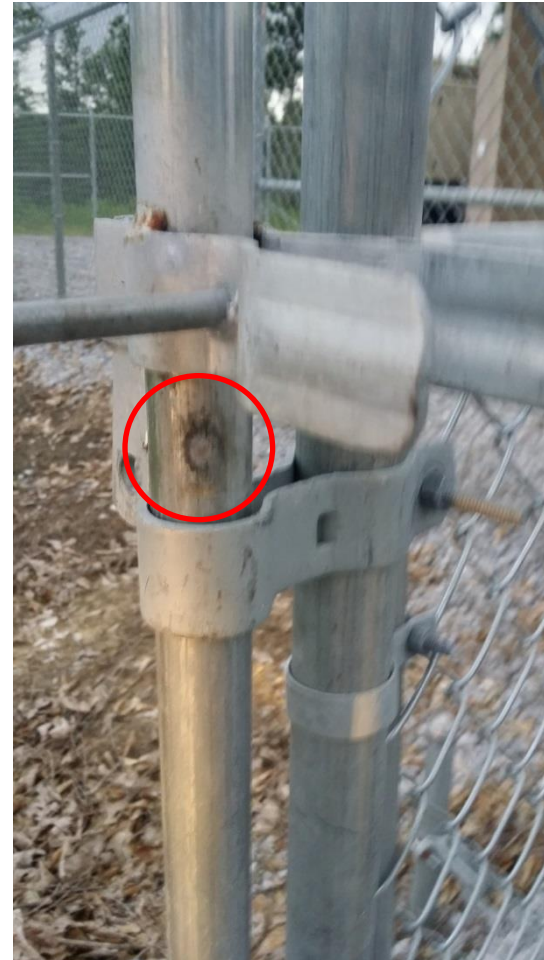
ARC ON GATE POST

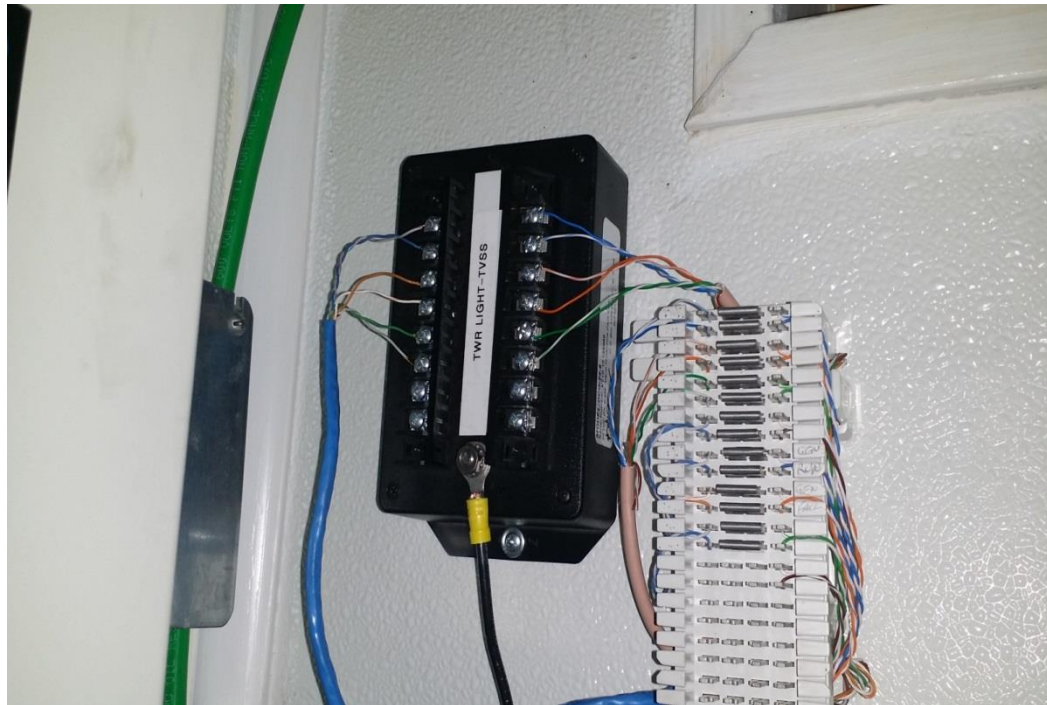
- Additional Bonding added from H-frame to tower ring.
- Additional bonding from H-frame to shelter ring.
- AC power SPD and OBS controller replaced.
- Alarm protection added.
- No more damage.

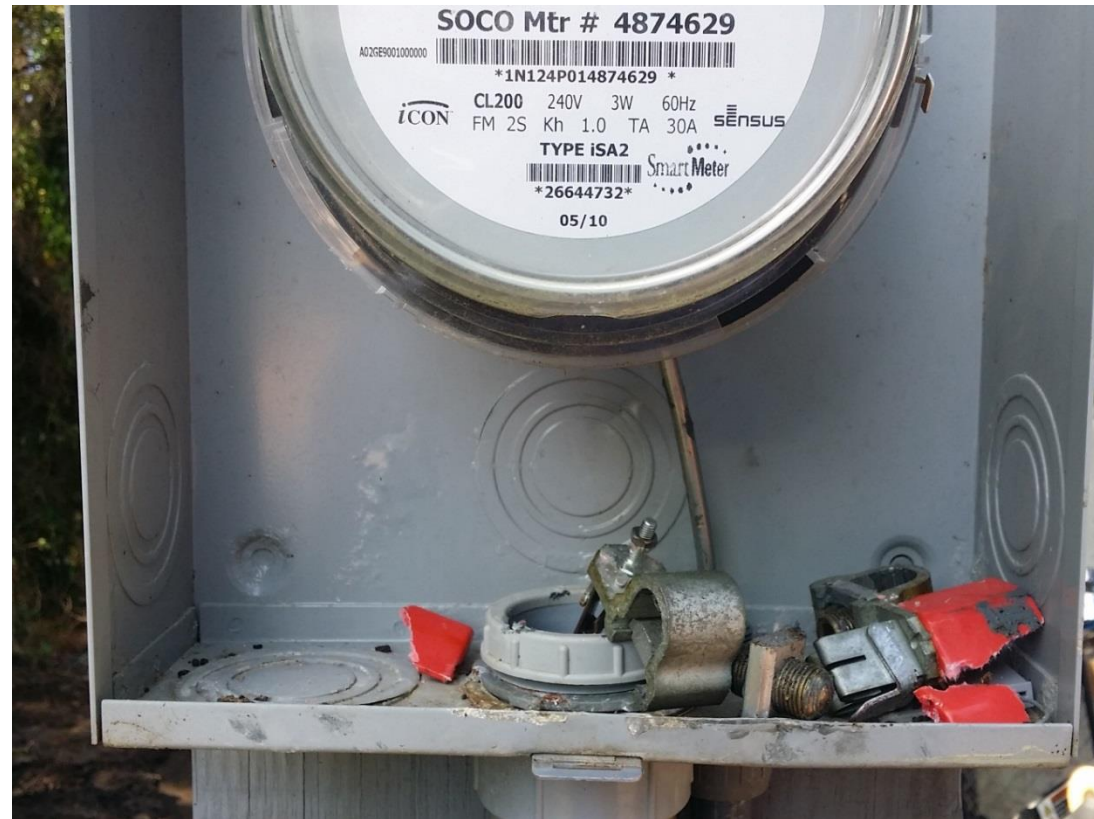
- Carrier reported Loss of Power.
- Carrier Tech dispatched to site.
- After they verified the outage, repair crew arrived at site <2 hours.
- By then the site was off air.
- GC was still working on their project with no attempt to get site back on the air.
- Pulled conductors out of meter socket

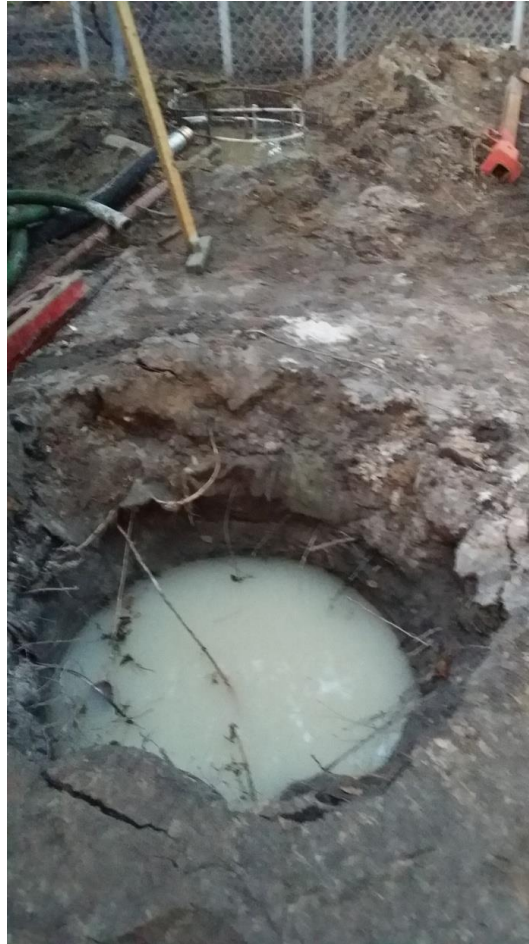
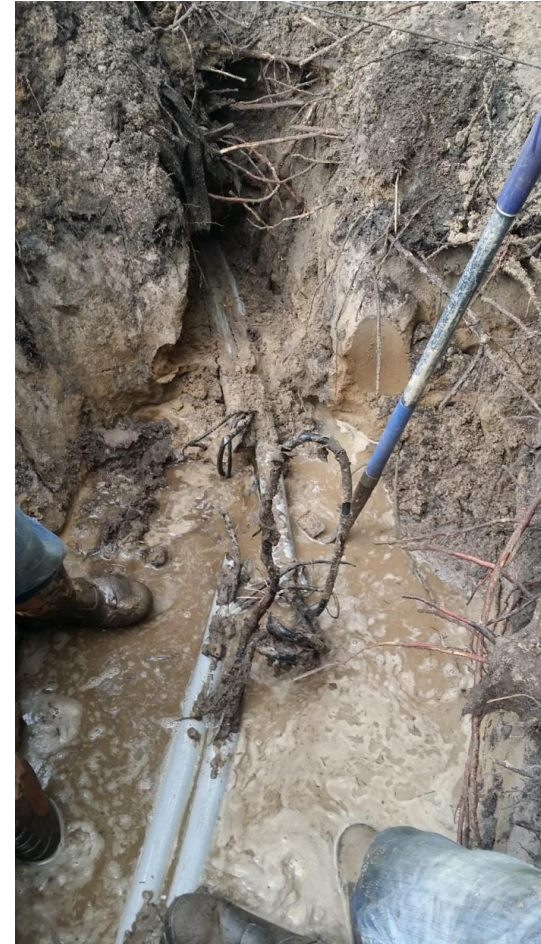
- Contractor did not have a MOP.
- Contractor did **NOT** follow basic procedures to identify buried utilities.
- Contractor did **NOT** take any ownership to get site back on the air.

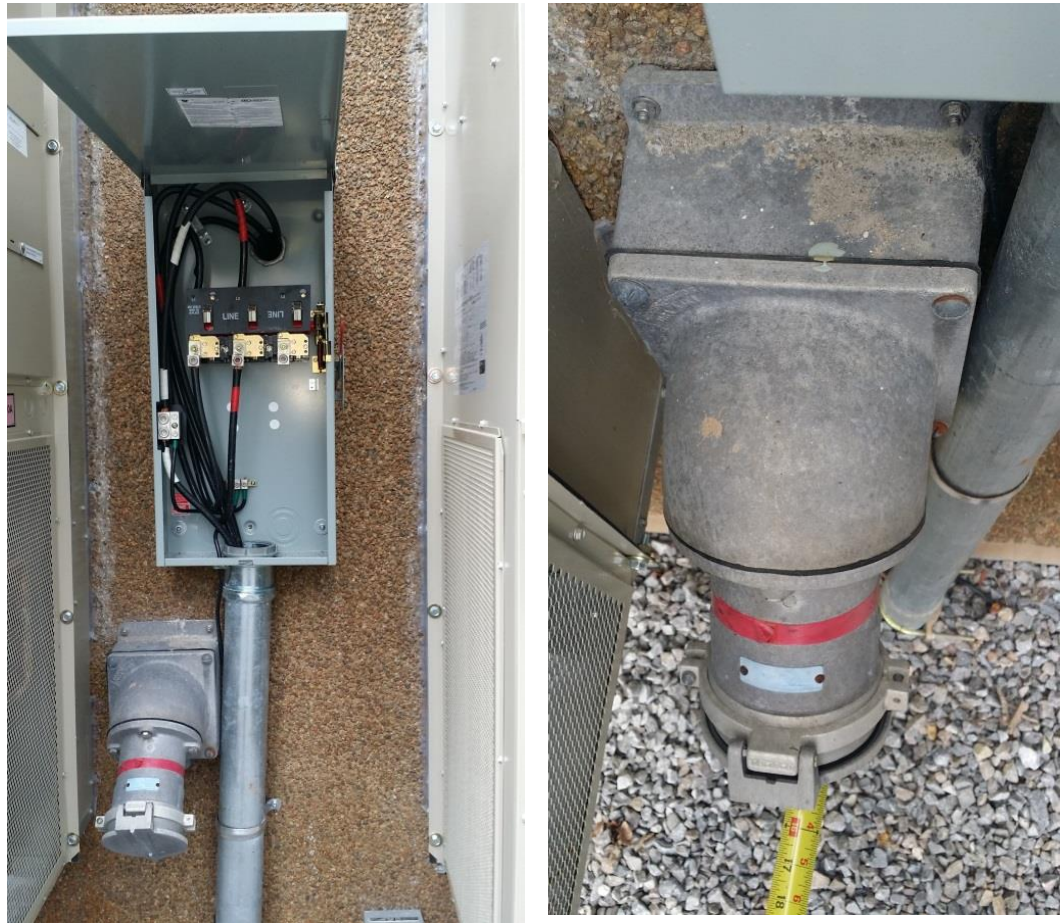
- EC installed electrical system with numerous NEC violations.
- Article 110 Working Clearance
- Unfused service disconnect.
- AHJ accepted work and issued Certificate of Occupancy.

- NEC Article 110 violations

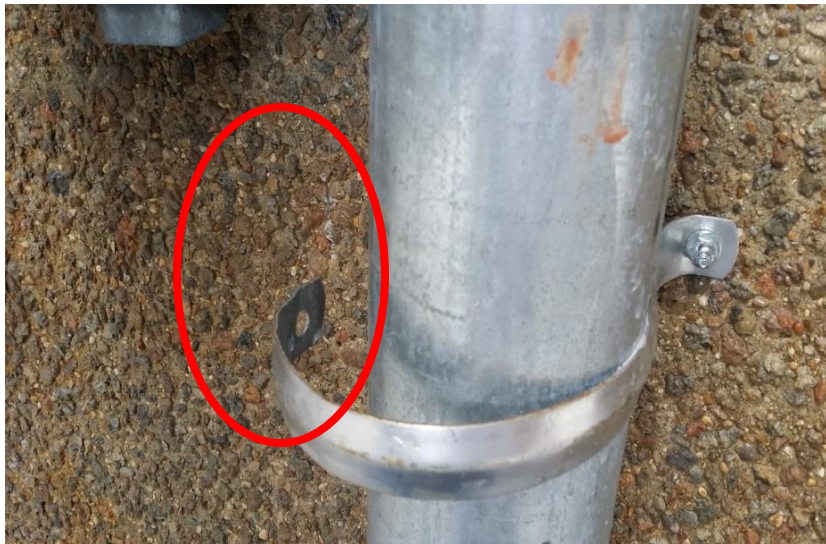
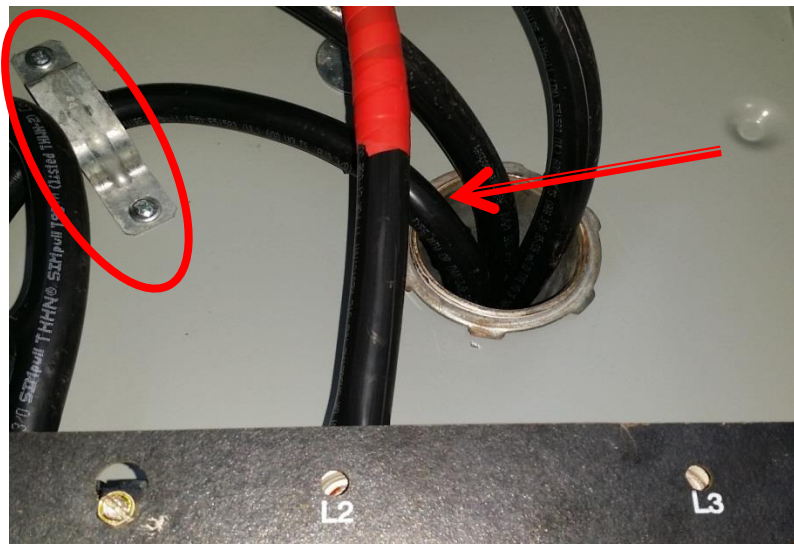
- 2 hole strap for smaller conduit was used as 1 hole strap
- Service entrance (SE) strap was used in disconnect to keep ungrounded conductor secured.
- No bushing on steel nipple with ungrounded conductor digging into nipple wall.
- I don't make this stuff up folks.

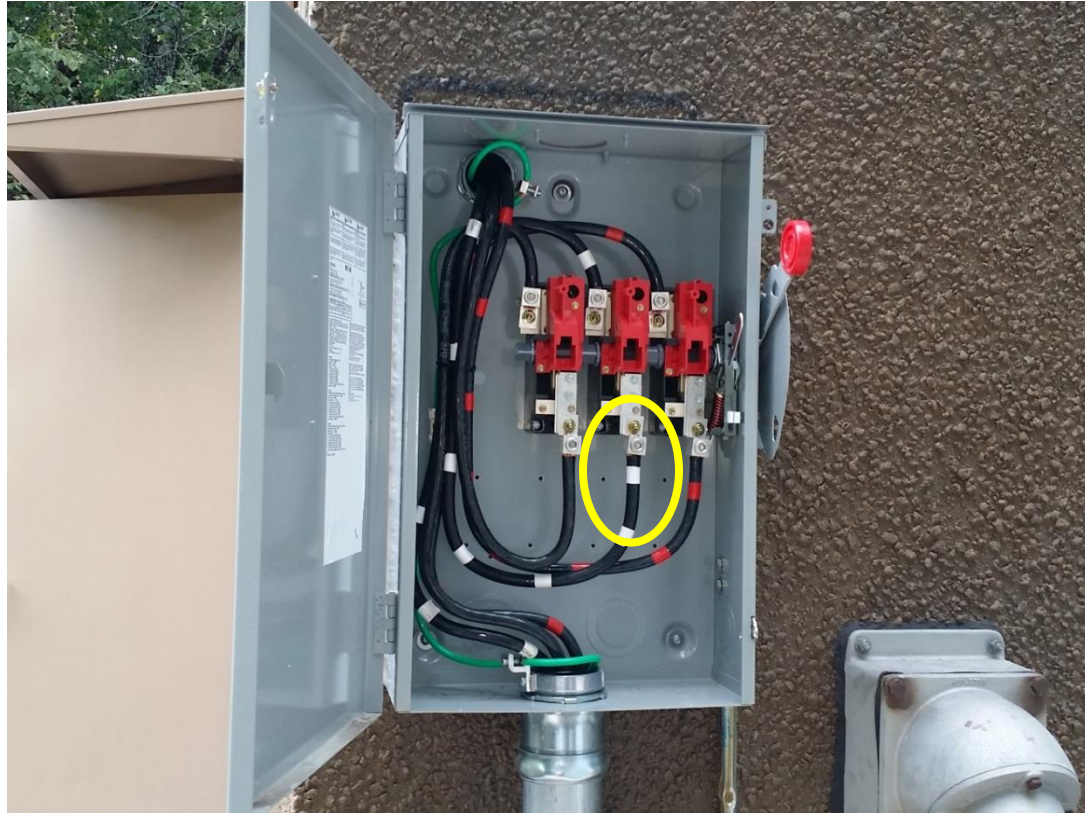
- Shelter disconnect wired with switched neutral.
- GC upset that NEC violation was called out.
- No More work was awarded from the GC after calling them out.

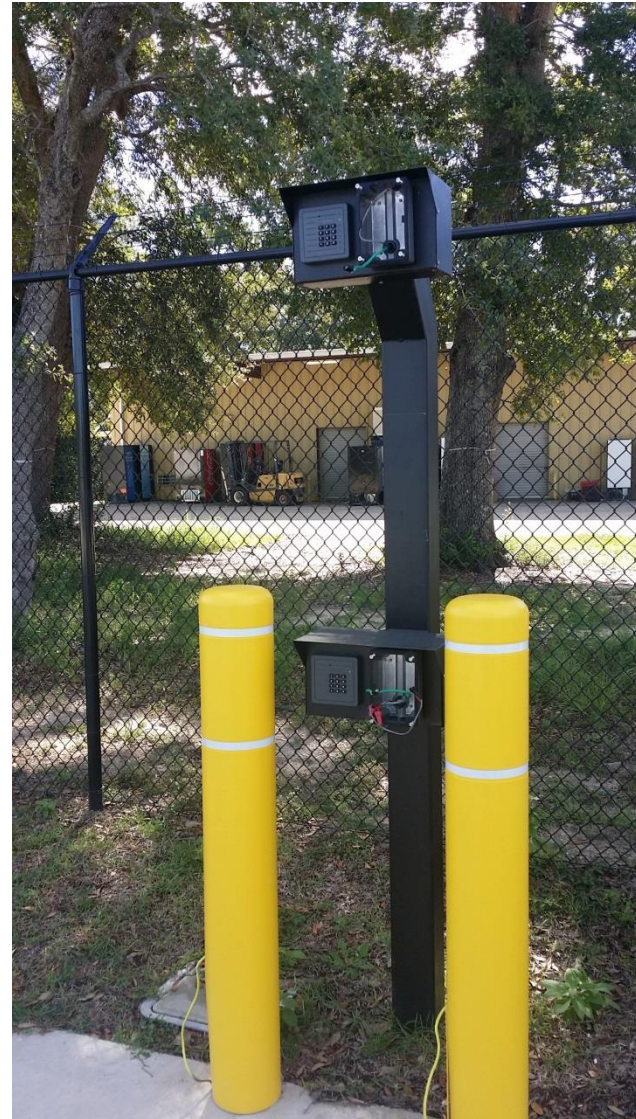
- **MSC in FL has two gates, East and West side of the switch**
- **No tower, 2 services**
- **Next to railroad tracks**
- **PoE Intercom and gate controller damaged repetitively.**
- **Stations located inside and outside compound.**
- **Where trucks bring COWS, COLT into lot, upper and lower station required at each pole.**
- **8 stations total**
- **Note bonding on bollards**

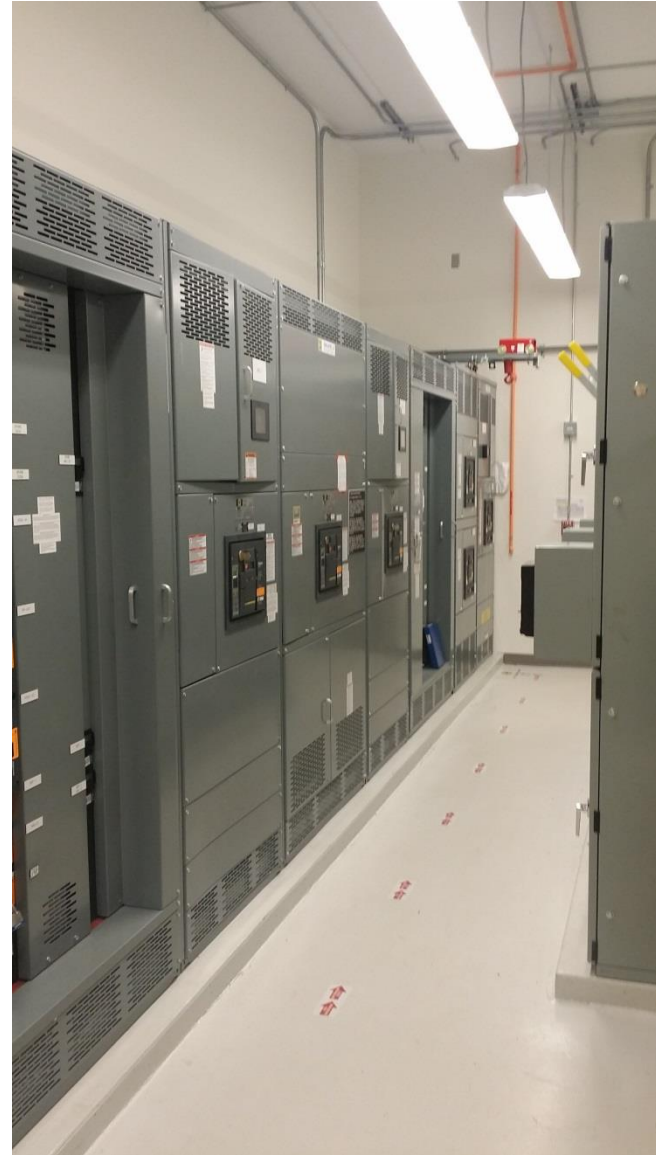
- **MSC electrical service fed by service lateral from pad mounted transformer.**

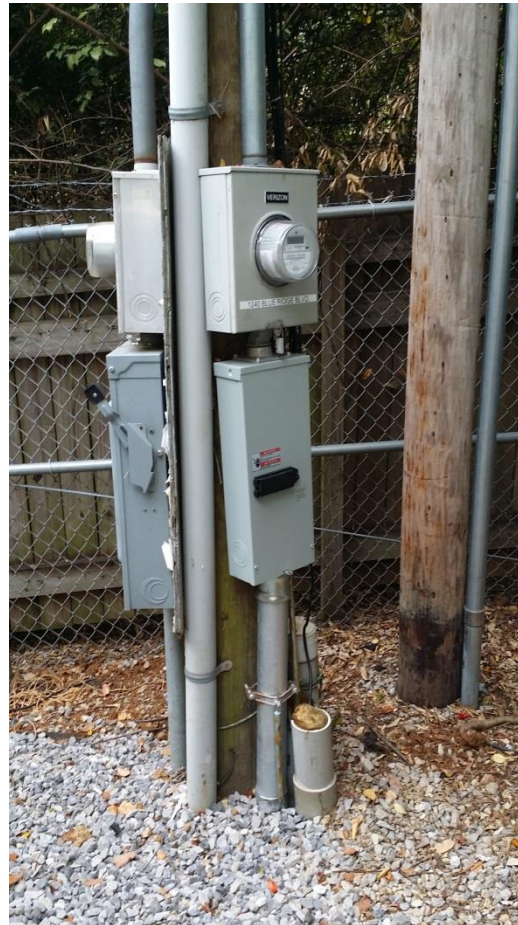
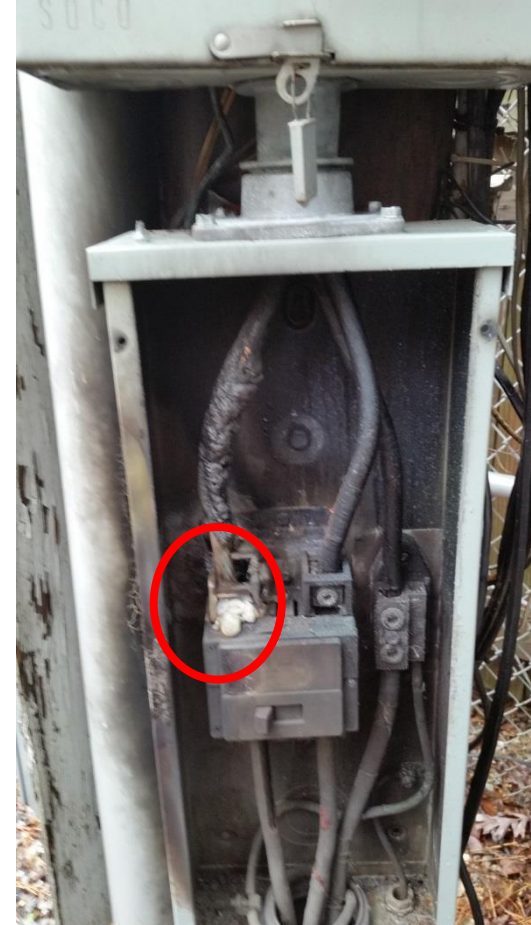
- AHJ issued CO without getting a final inspection.
- 3 months after installation, the service disconnect burnt up.
- During repairs, AHJ wanted to know why final inspection had not been called in.

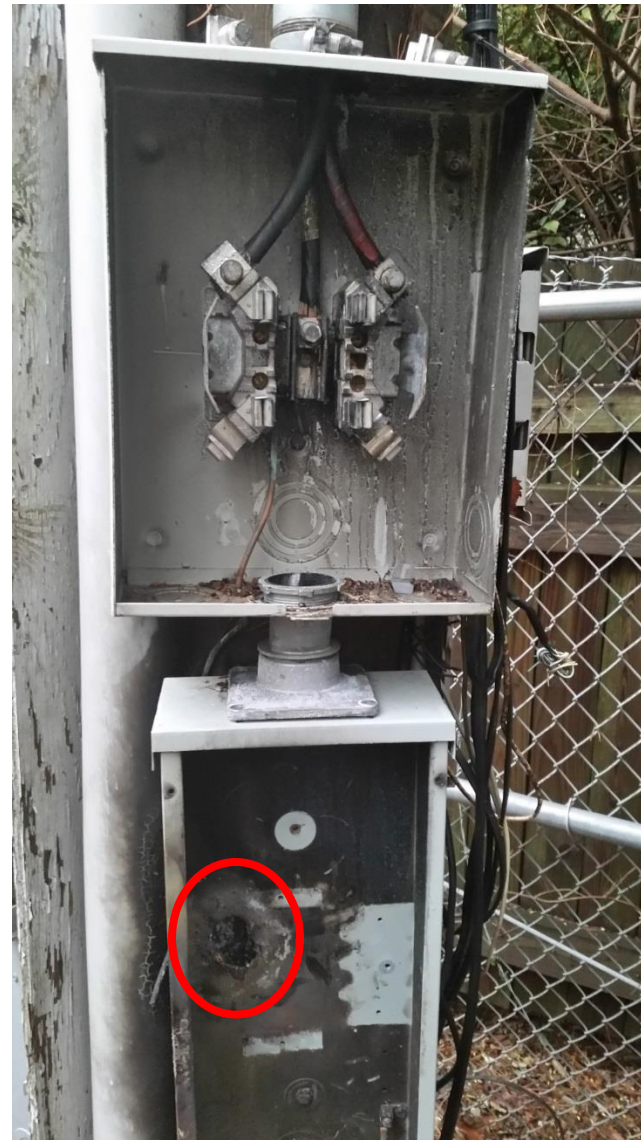
- Hole blown through back of enclosure

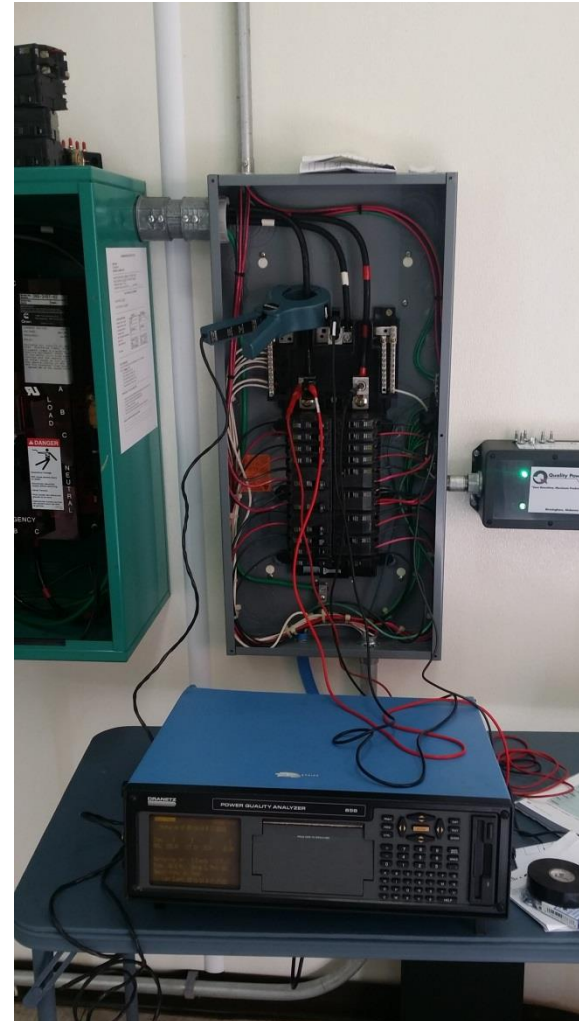
- Elected to use PQ analyzer for AC power monitoring.
- Monitoring setup performed using a Dranetz 658 disturbance analyzer
- Channel setup (1, 2, & 4) for voltage L-L, L-N, and a clamp-on CT on L-1.

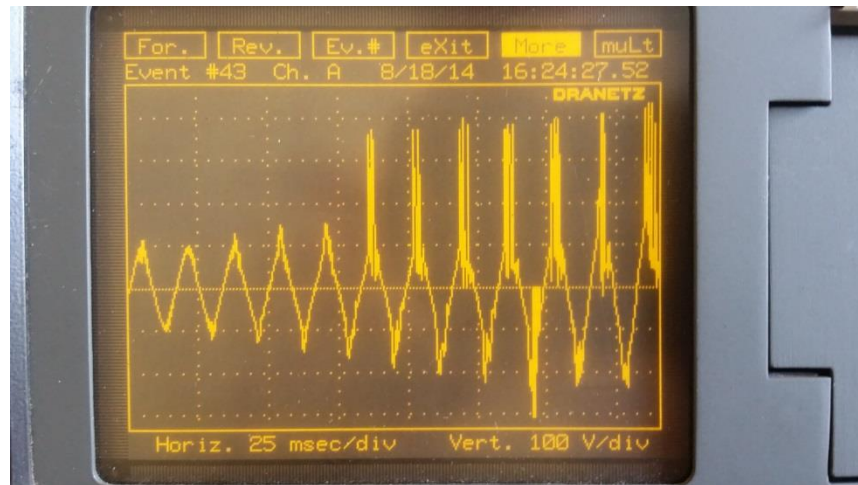
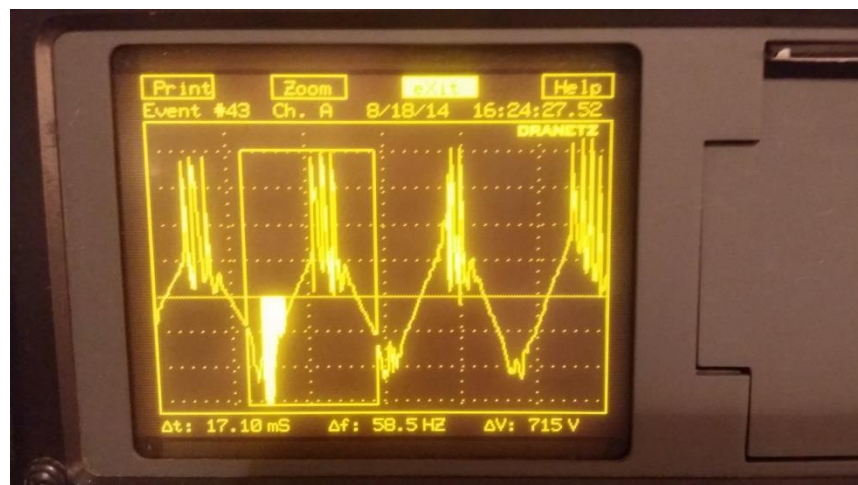
- Commutation from SCR's could be seen as the voltage came up.
- Transients were occurring in positive and negative polarity.
- Lower picture is a zoom feature of the transients.

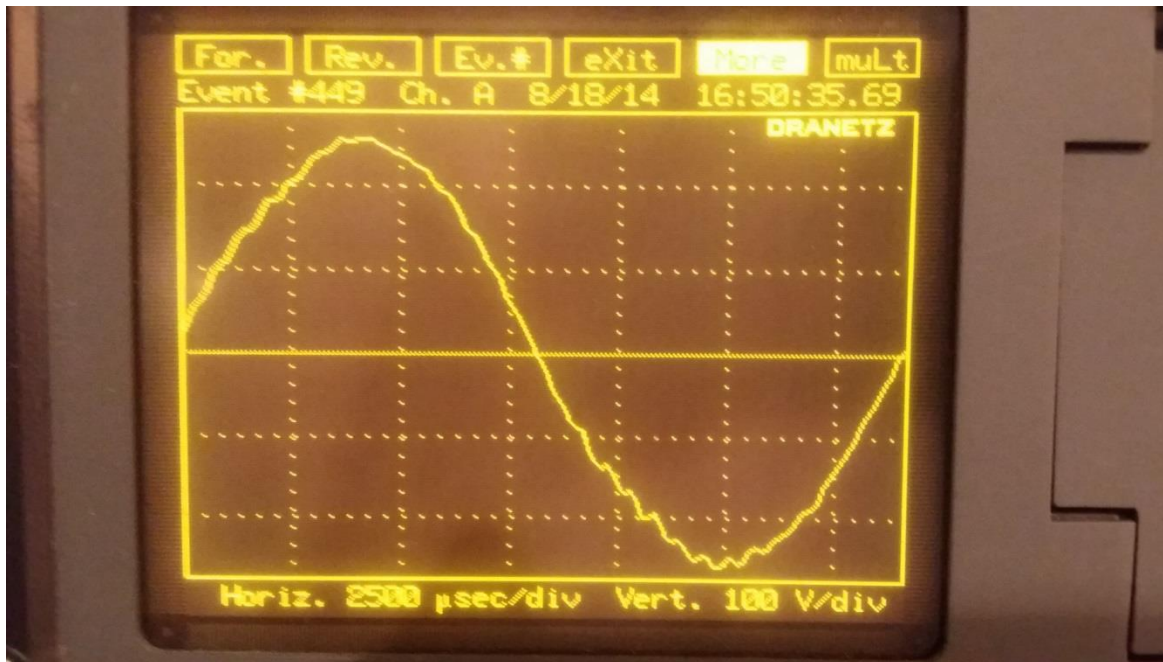
- Added surge protection with 100kHz filters and sine wave smoothed out.
- There was still some hunting with the generator controls but site stayed up.

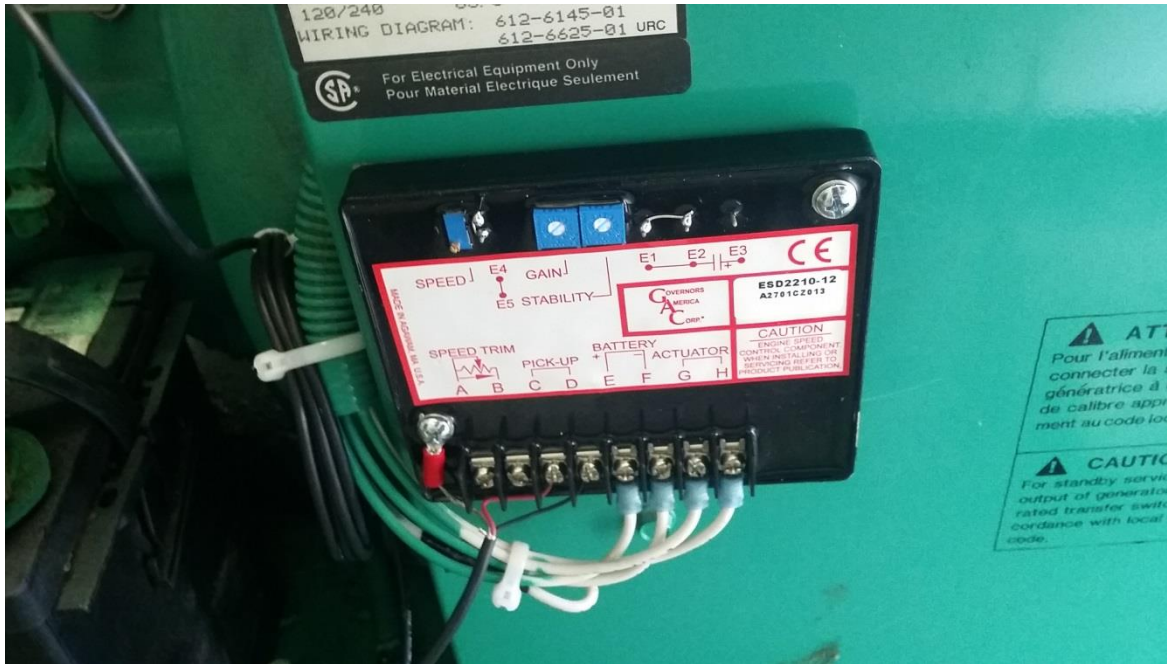
- Installed new solid state speed control and Mag pickup
- Adjusted throttle linkage

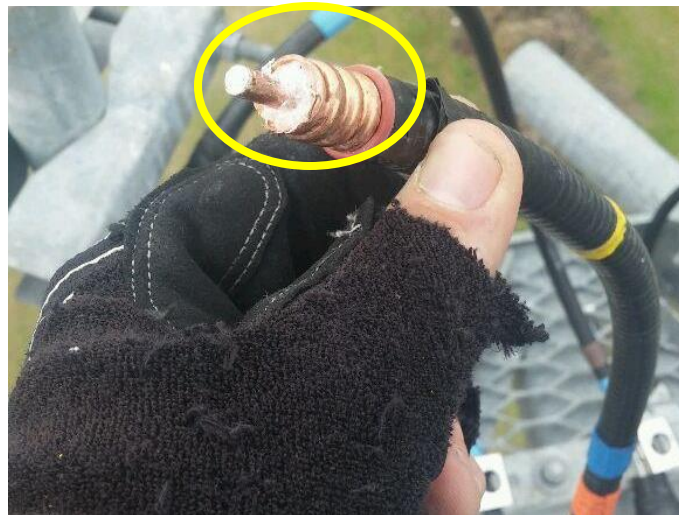
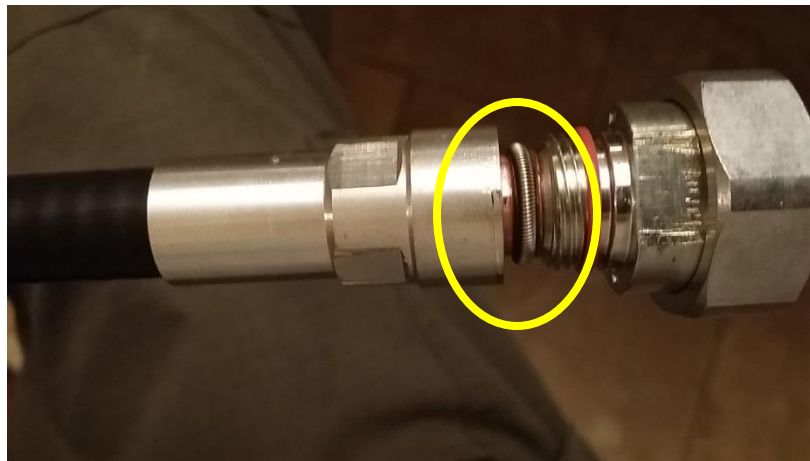
- **Two Other Vendors previously called to Repair PIM issues**
- **Discovered poor connector repair.**
 - **Retaining spring on back nut was missing in jumper causing center pin to move on front fitting creating PIM issues.**
