Can Two-Wire Systems Coexist in a Three-Wire World?

Safety, performance and reliability parameters of mixing Grounding Topologies

Dan McMenamin

Dan McMenamin and Associates, Inc.

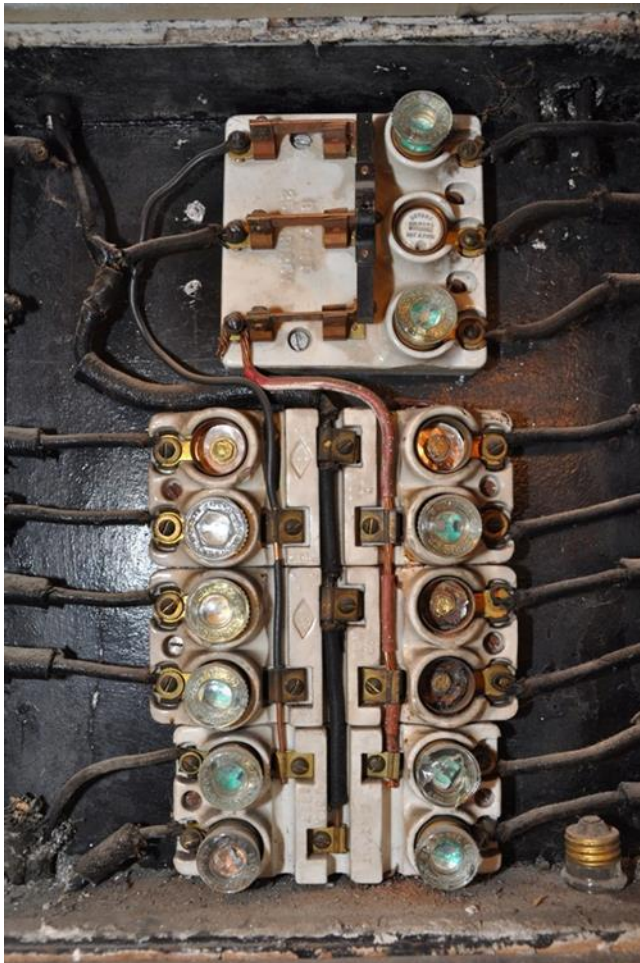
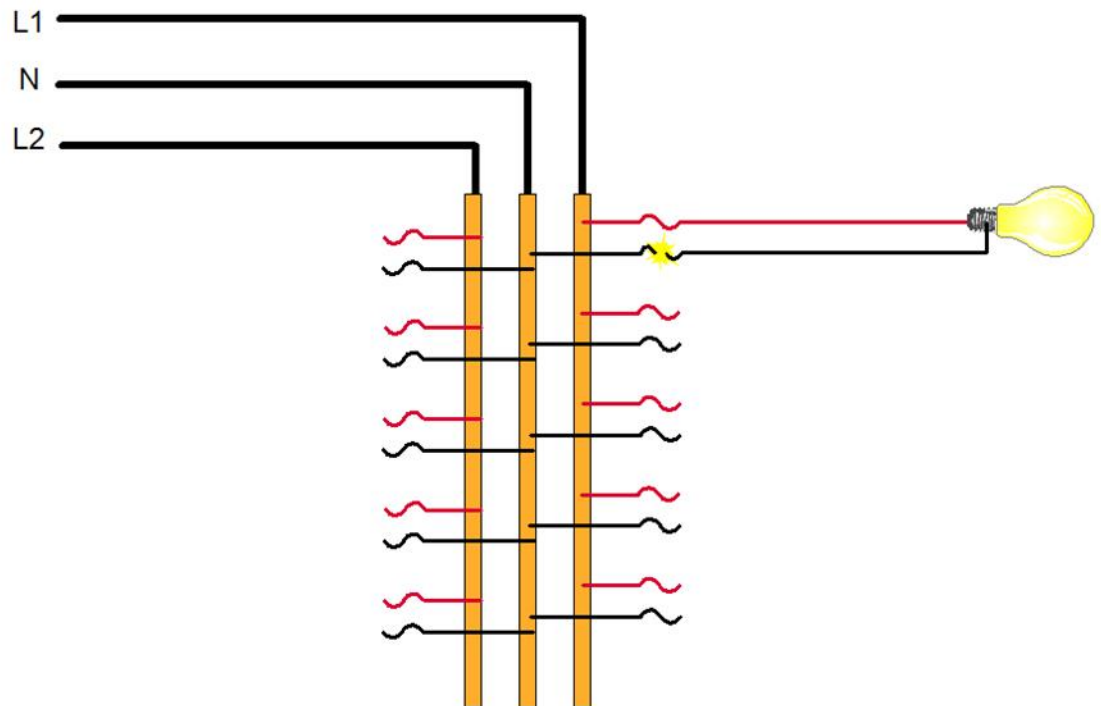
Hot & Neutral were fused (Dangerous)

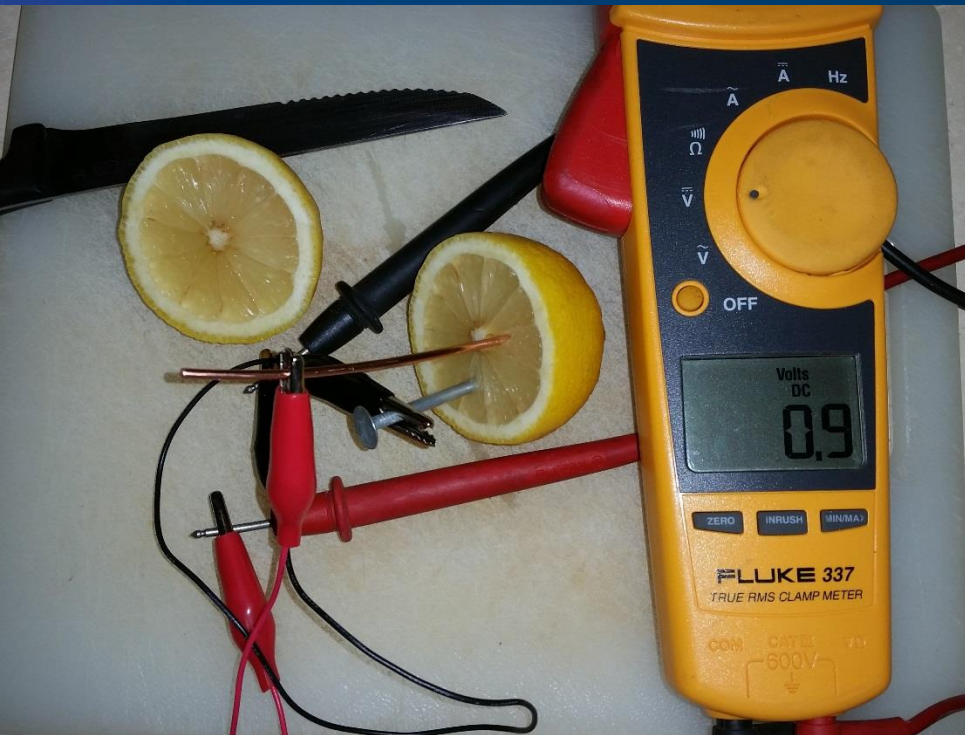
- If dc Battery Return current is carried on the tower structure there are serious concerns about the impact of electrolytic corrosion exacerbating galvanic corrosion on the underground structural elements of the tower.

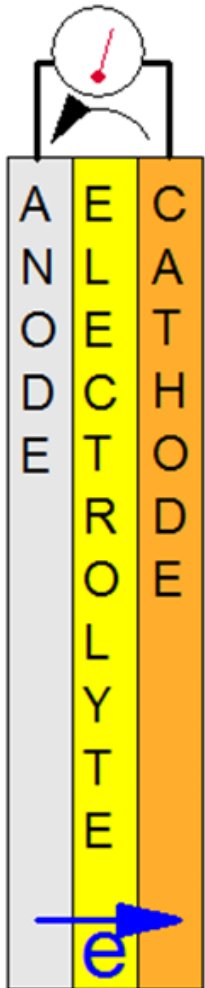
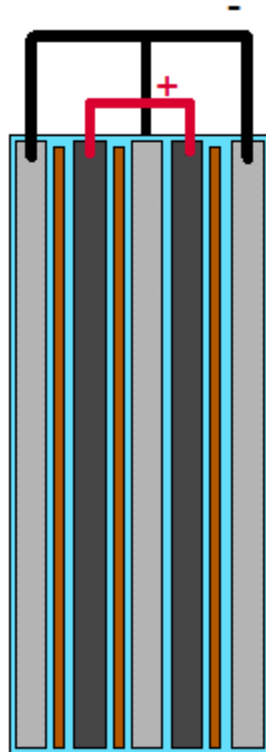
Negative plate
-

Plate Separator
-

Positive plate
-

Electrolyte

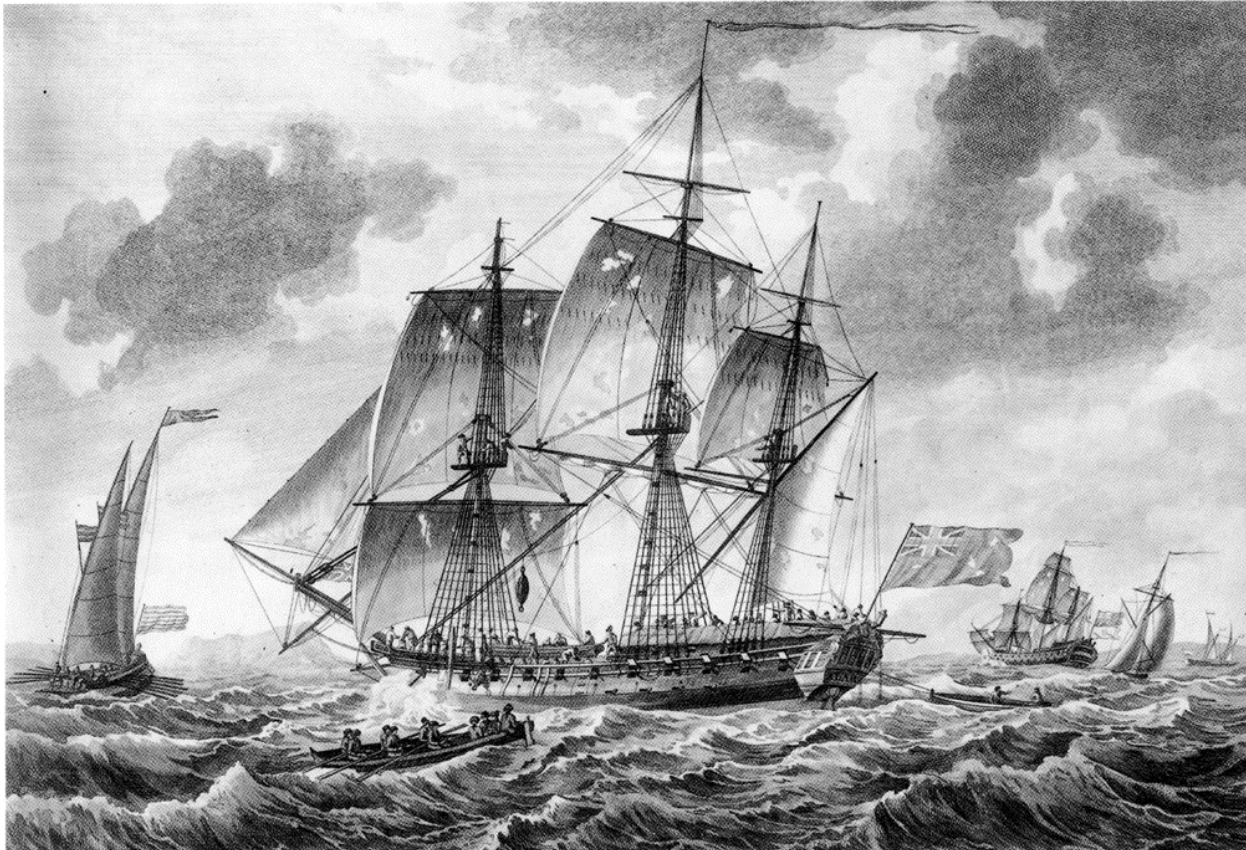
HMS Alarm Circa 1758

Sheet copper nailed to the sides creates a film of oxychloride which is toxic to wood worms and marine growth. This improvement made the vessel faster and reduced maintenance.

Corrosion however, "ate" the iron nail heads, causing the sheet copper plates to fall into the sea.

Some of the copper sheets were wrapped in brown paper which was not removed.

Where the brown paper remained under the nail heads, there was less corrosion because the iron was not in direct contact with the copper.

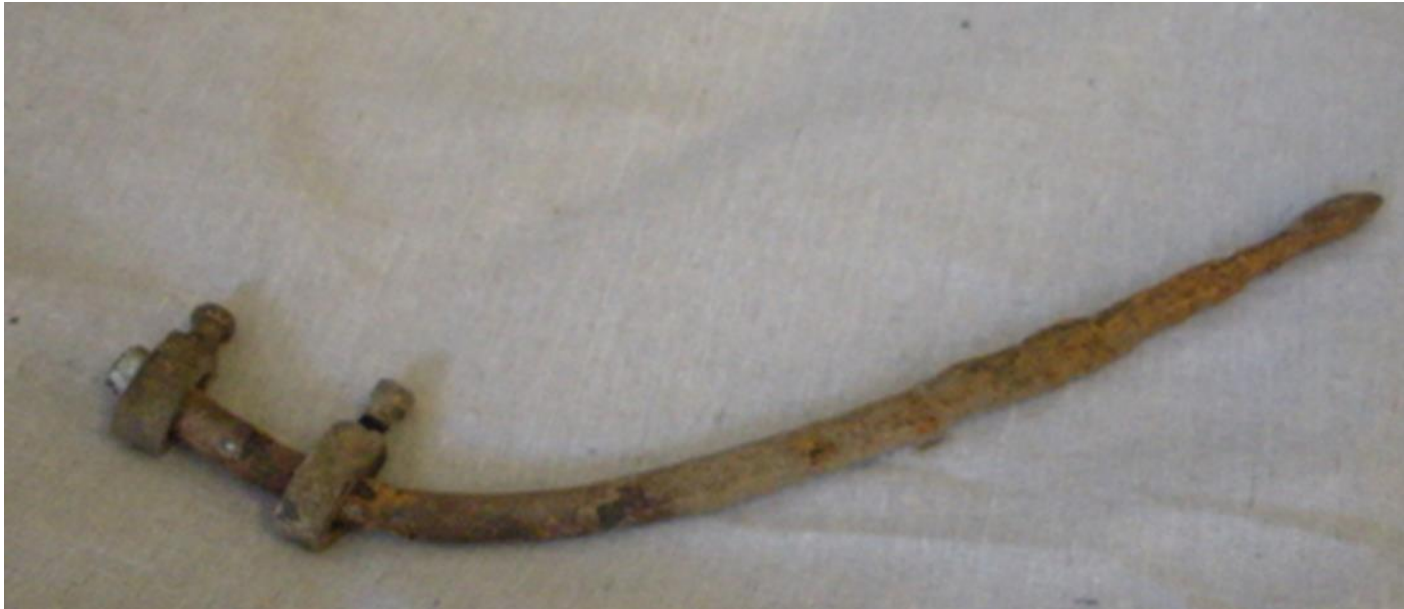
Products of corrosion cause the rod to swell and cause small cracks in the concrete.

Water enters the cracks where freeze/thaw cycles spall the concrete.

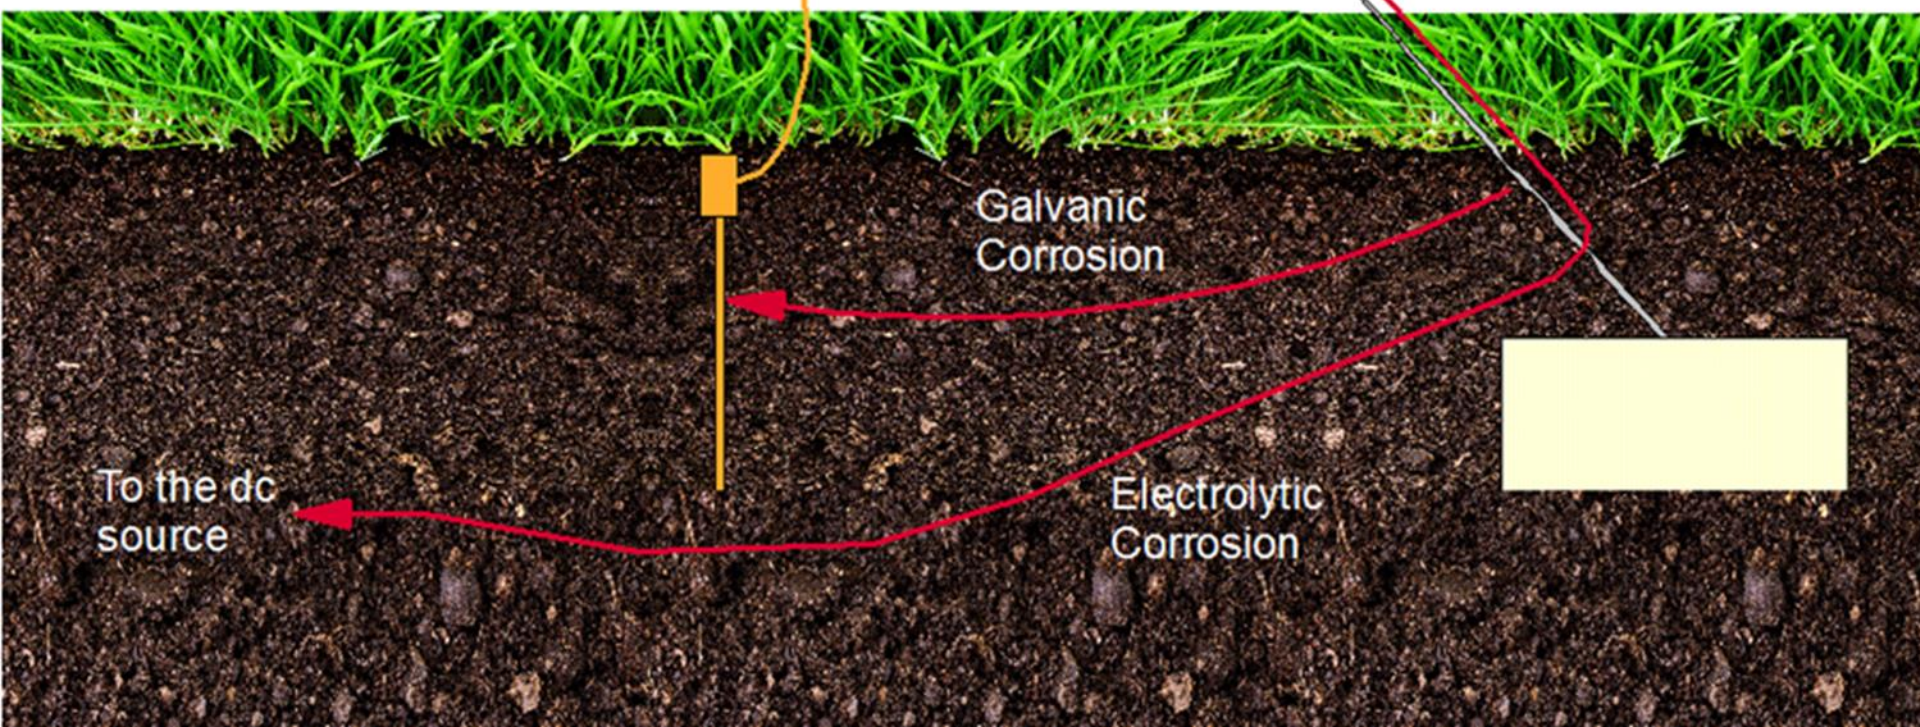
In the case of electrolytic
corrosion galvanic corrosion or
both, the galvanized steel
anchor rod is the less noble
metal and it corrodes.
