Noise in the Wind

A Practical Approach to Mitigating Power Influence Related Noise Problems in Copper Telephone Cable Created by Wind Farm Collector Systems and the Affects of Stand Alone Wind Turbines on the Local Power Distribution System

- Case 1- Induced Harmonics From Wind Farm Collector System
- Case 2- Induced Harmonics From a Wind Farm 420 Megawatt Transmission System Between the Wind Farm and Point of Interconnect.
- Case 3- The Affects of Stand Alone Wind Turbine Generators on the Local Power Distribution System That Appears to Cause System Resonance.

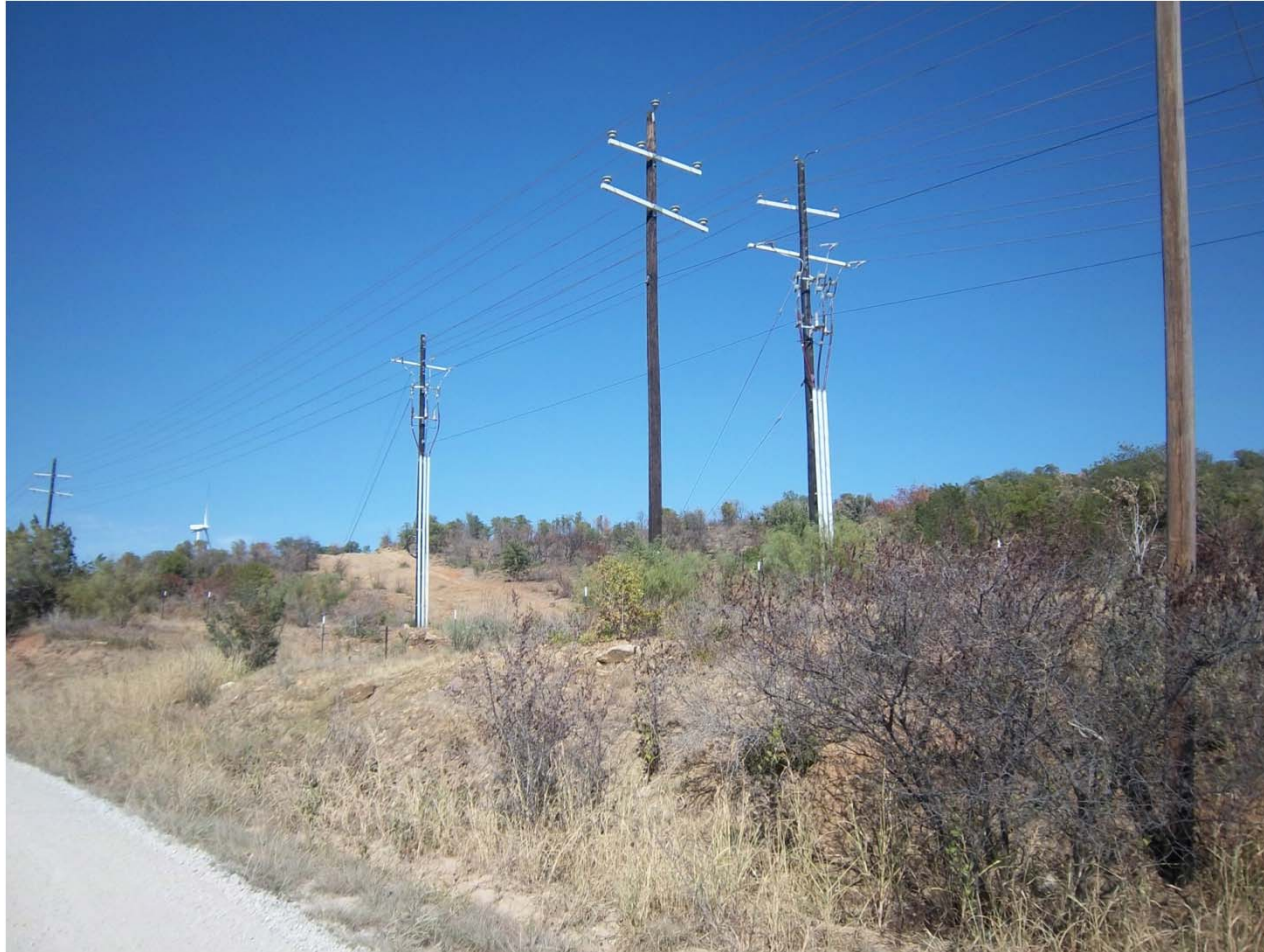
What NOT to bond to! Collector system is a three phase delta power system with an intersystem bonding/ static wire which is bonded to a ground electrode at every pole.

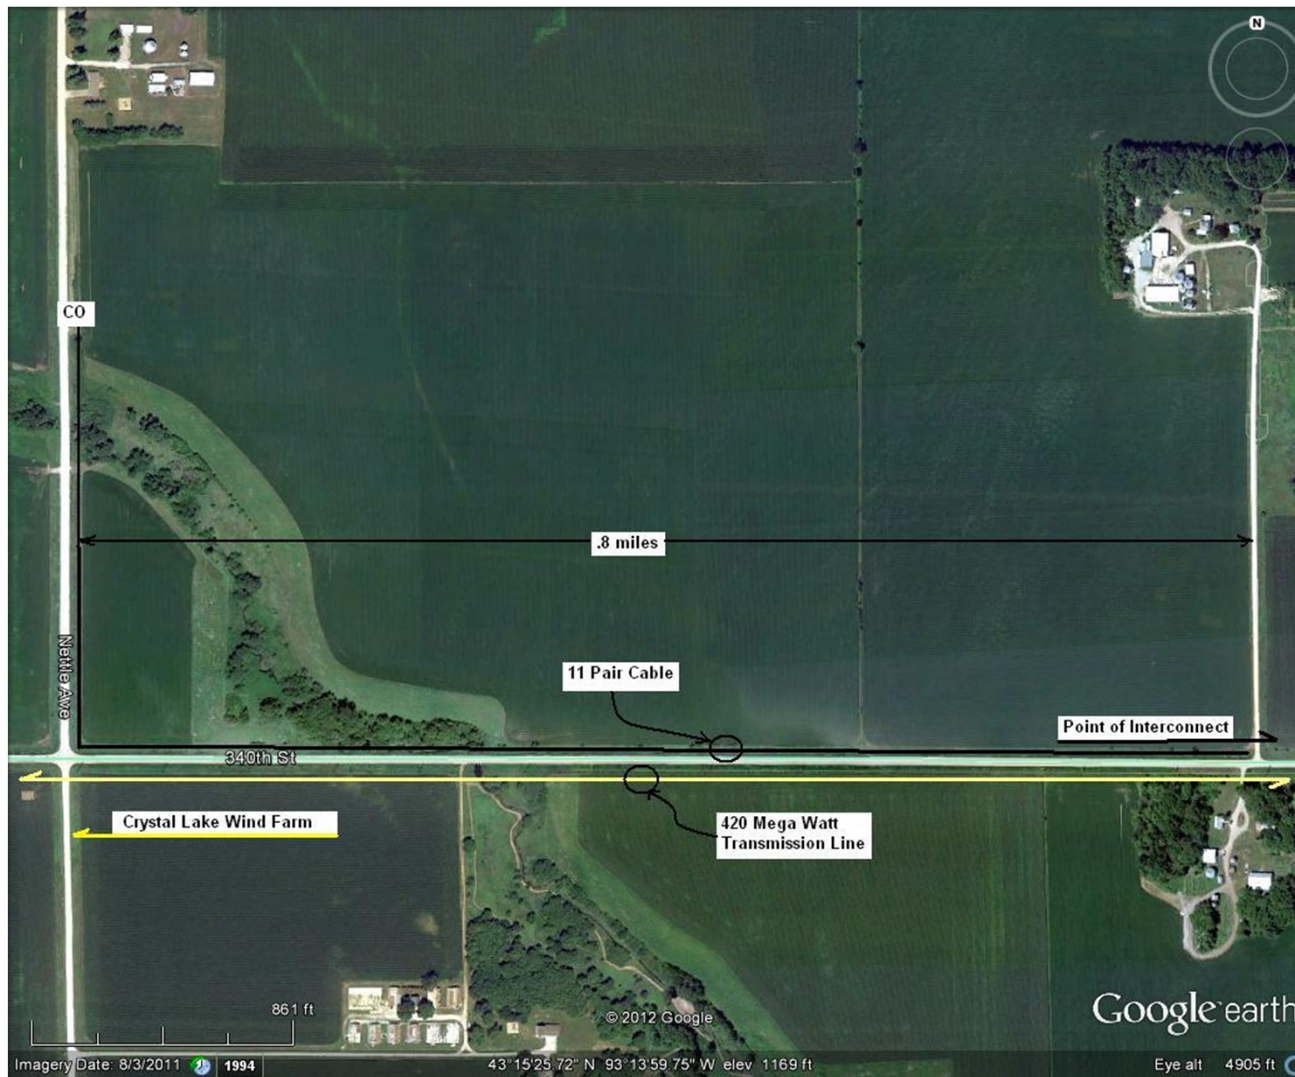
Parallel exposure to 420 megawatt transmission line between the Crystal lake Iowa Wind Farm and the Point of Interconnect. Verified with spectrum analyzer -13th harmonic predominant.

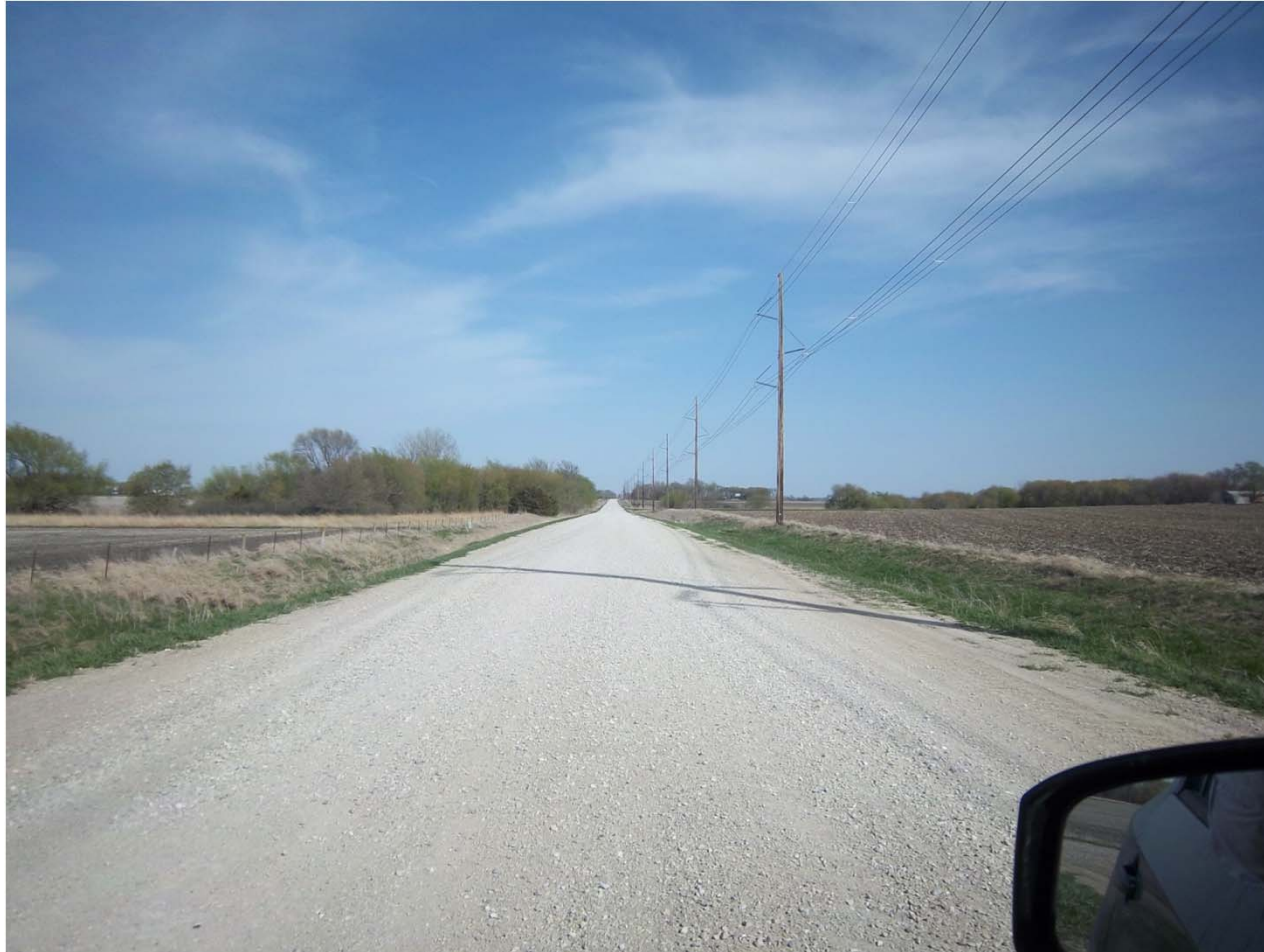
Looking east on 340th Street, transmission line on right, buried phone cable on left
No “local” power distribution system to provide MGN bonding.

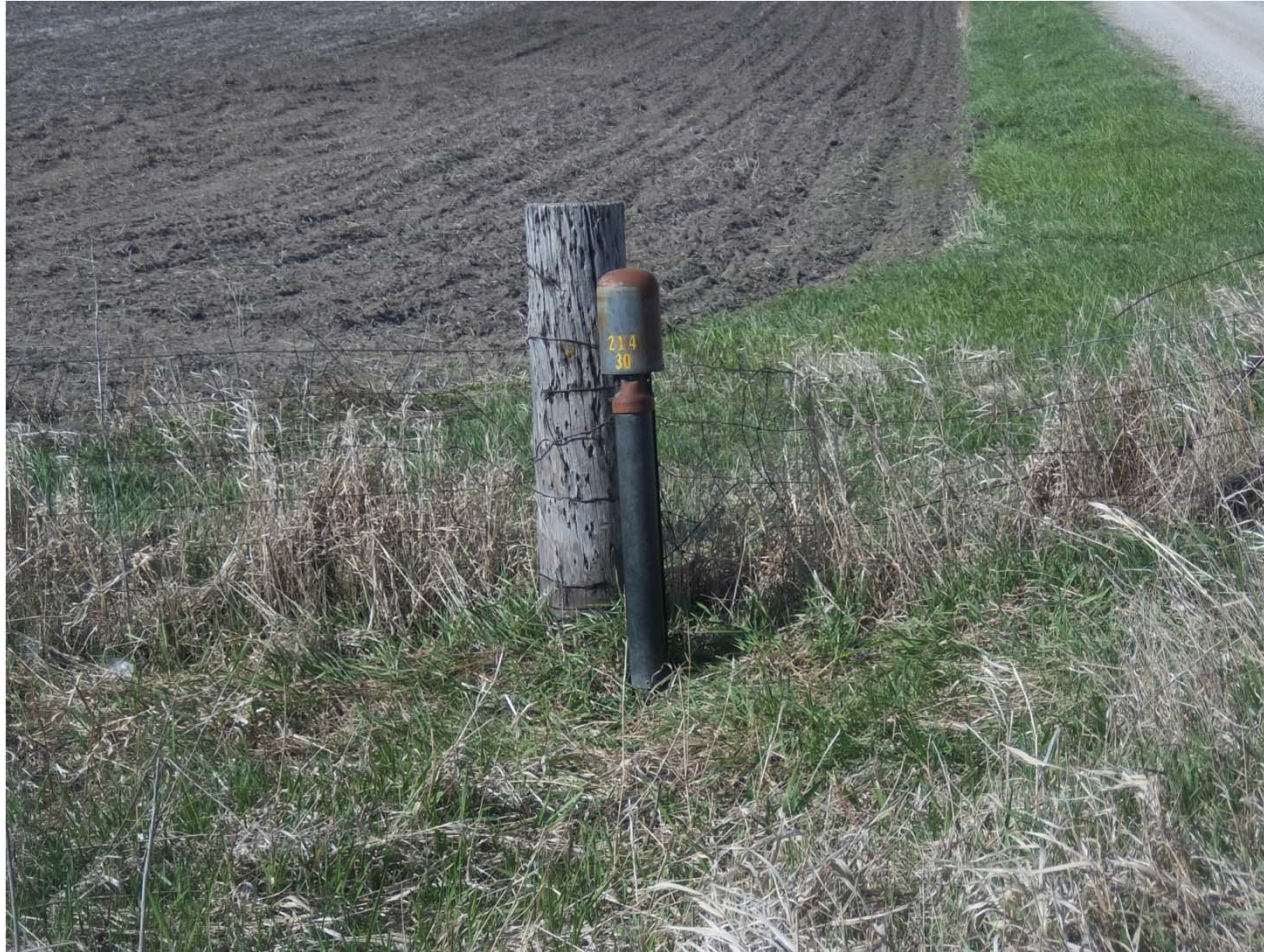
“State of the Art” telephone cable terminal

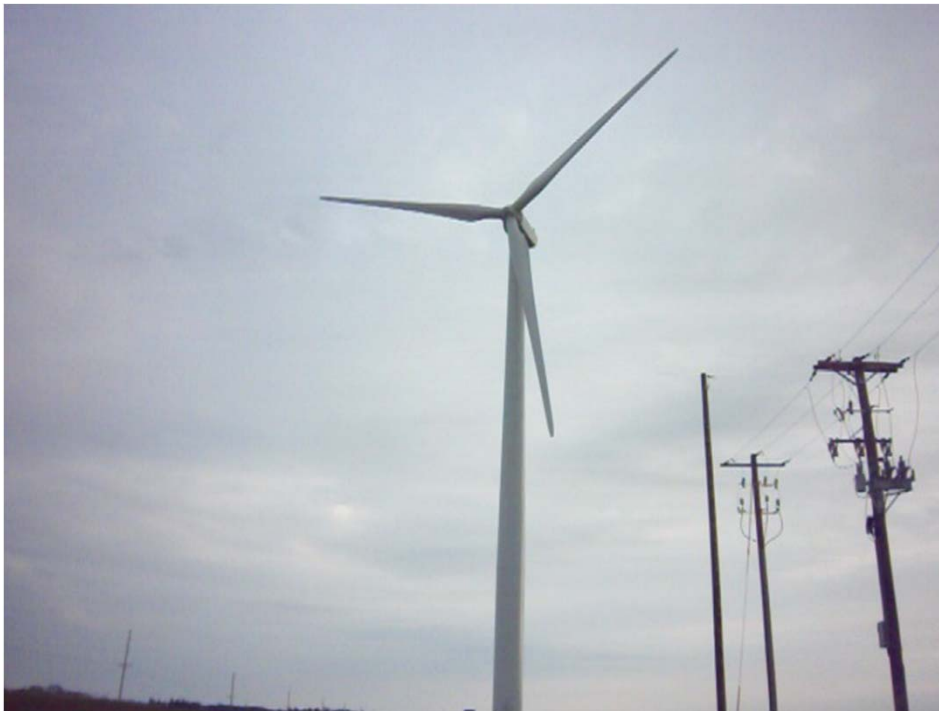
Case 3- Stand Alone Wind Turbine Generator- Northwood IA

“When ever that wind turbine is turning, there is a loud buzz on my phone line”
(Quoted from the customers letter of complaint to the Iowa Utility Board)

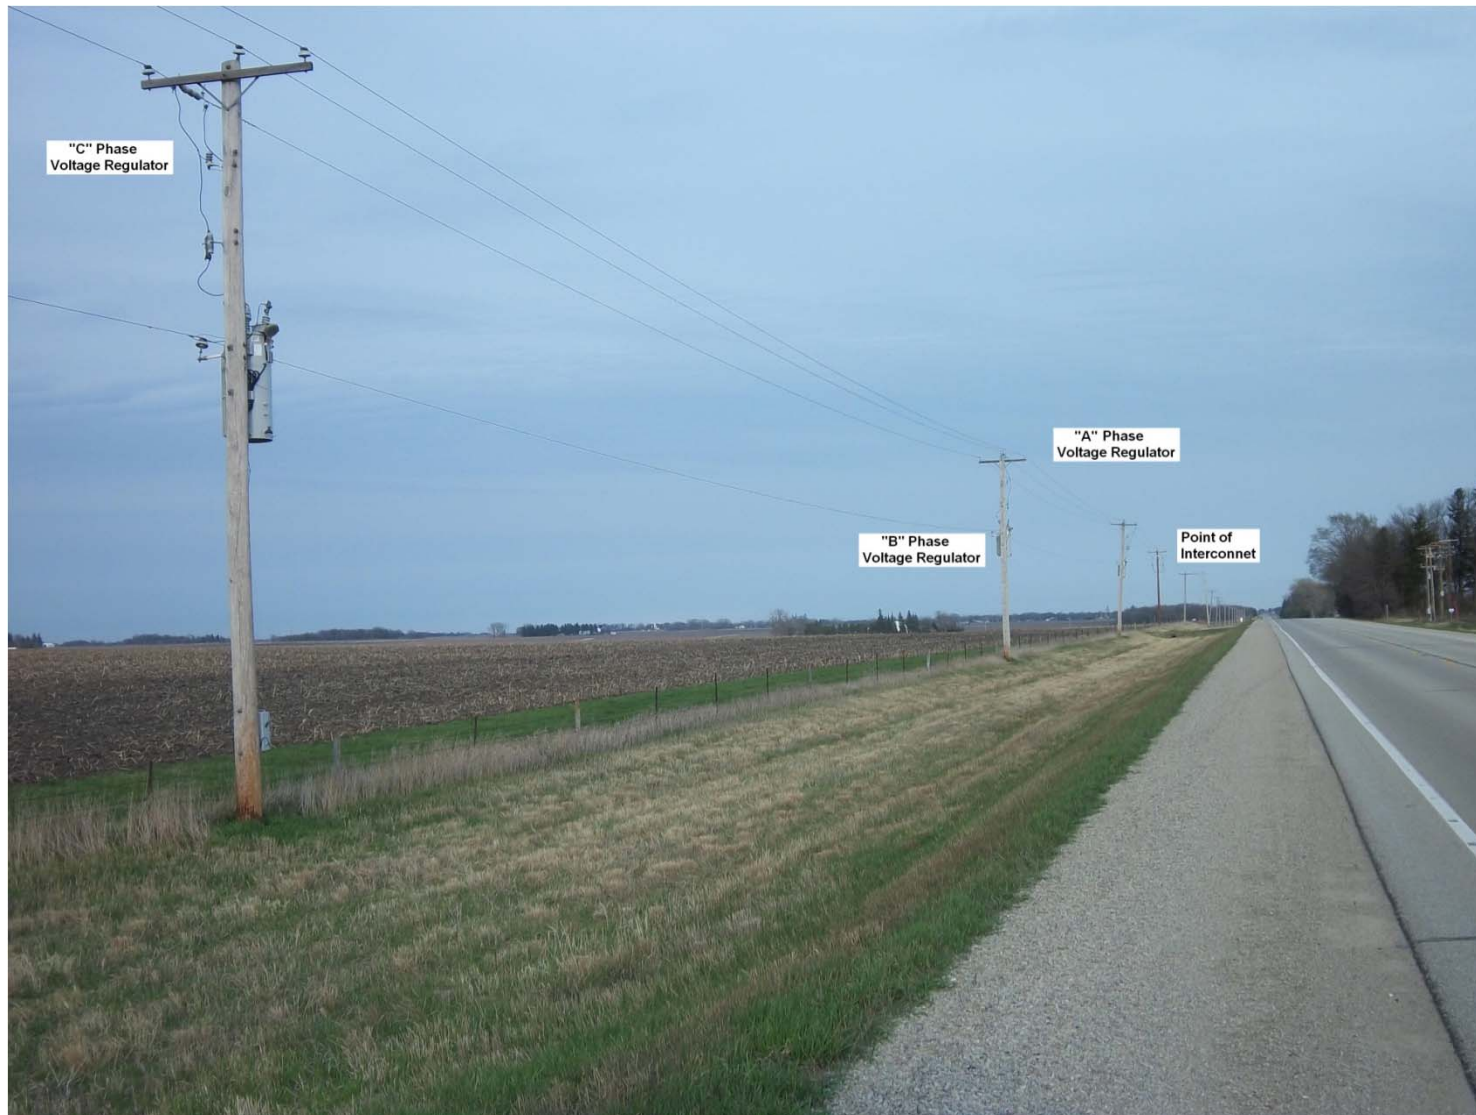
Three voltage regulators at the Point of Interconnect.

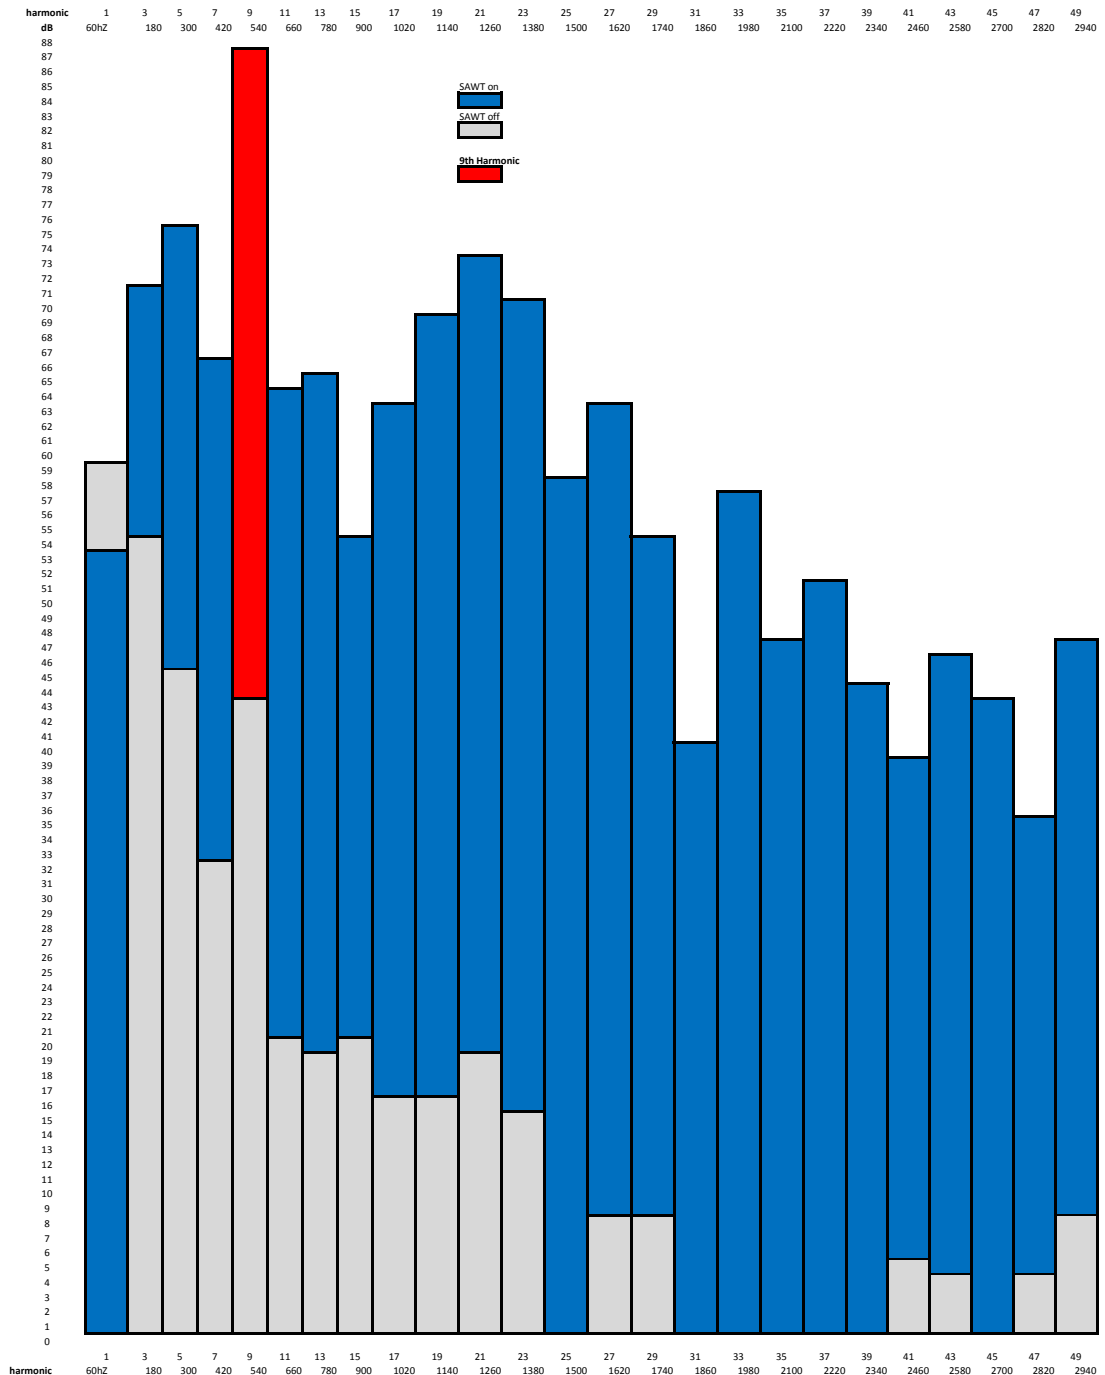
Harmonic graph
with cable pair
data taken with a
spectrum analyzer
and FLAT filtered
from customers
serving terminal.
Stand alone wind
turbine generator
is ON line.

Additional data from “Contel” chart

Top 5 possible sources of harmonics

- 83% Probability- Defective Step Down Transformer
- 80% Probability- Grounded transformer aggravated by grounded capacitors
- 77% Probability- Open Cable Shield
- 72% Probability- AC Side of 12 pulse/ multiphase Rectifier
- 70% Probability- defective or over excited transformers

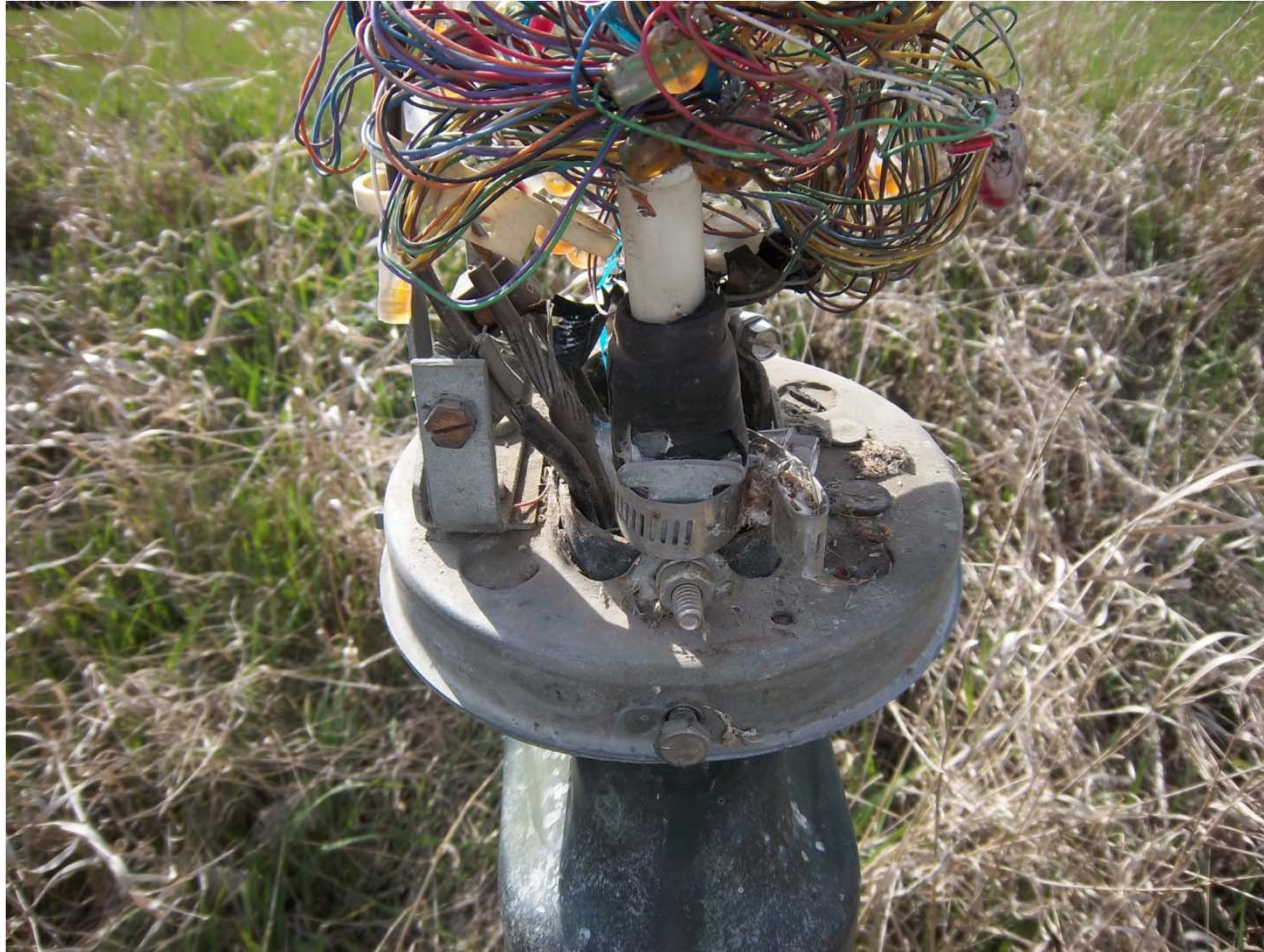
“I’m sure we’ve bonded the cable at every pedestal !!” No shield current here.

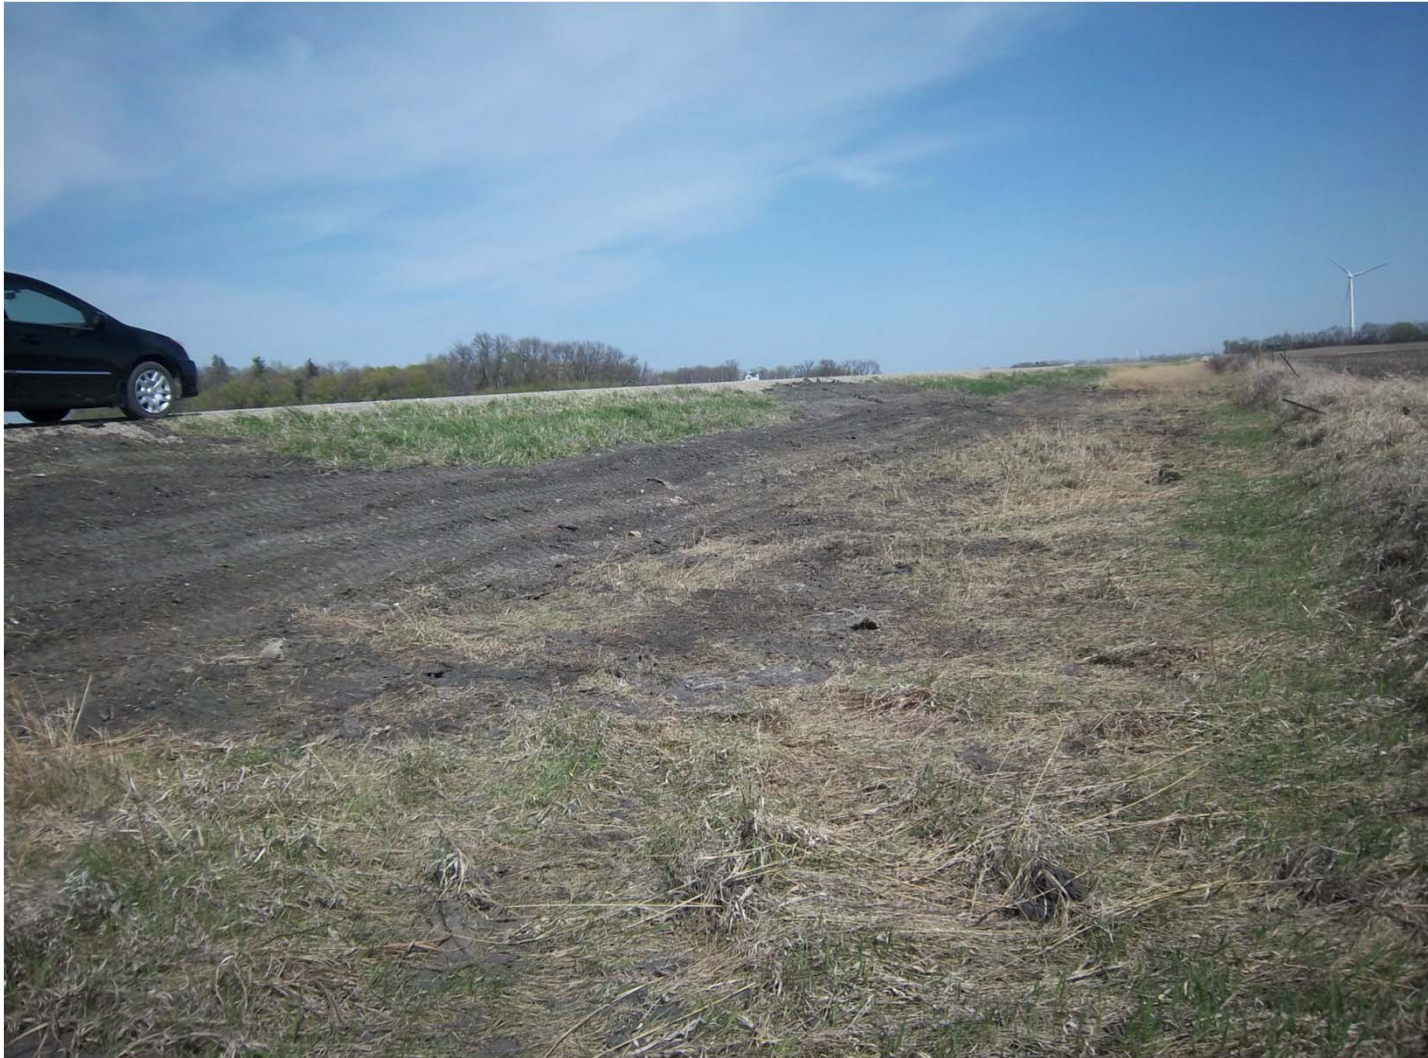
Location on 430th Street where 100 feet of cable was replace due to the damage of the existing cable and two wet cable splices.
