Software Designs for Grounding Remediation of Lightning Transient Problems for Solar Fields

Mark Hendricks, Technical Director, DEHN, Inc.

Session 2: *Grounding for GPR and
Lightning Remediation*
March 17, 2022

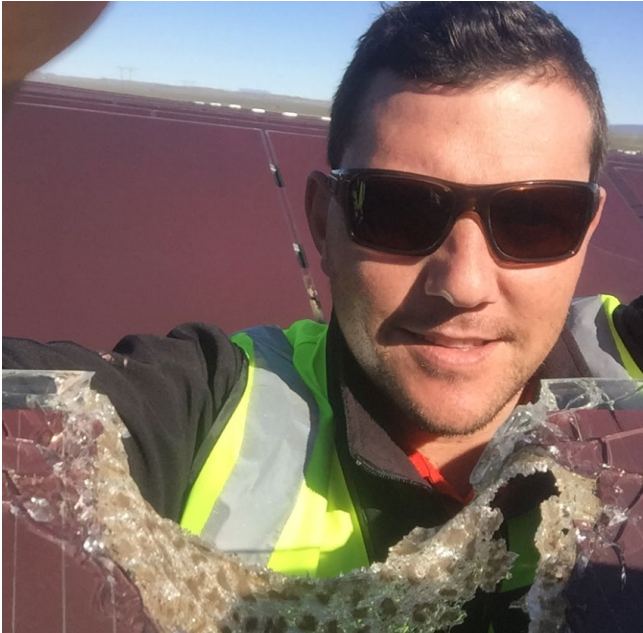
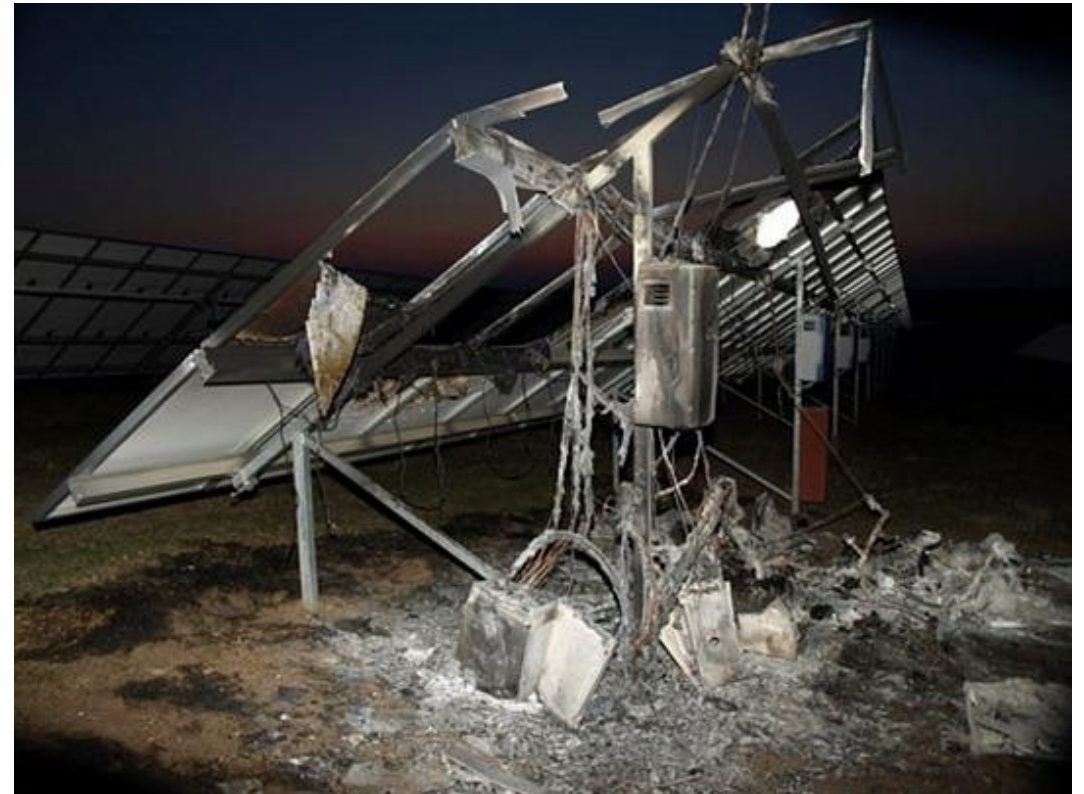
Solar Field Equipment Damage

- It's not just direct strike damage to panels, or transient damage to inverters/combiners.
- Transients can burn out the encoders on the motors that drive the tracking systems.
- Damaged tracking systems greatly reduce the output for those power blocks.

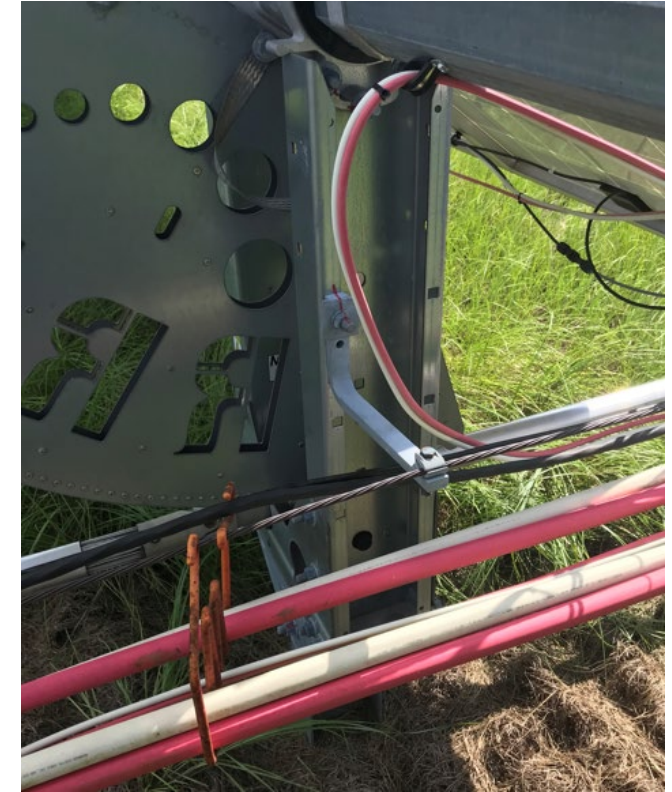
- **Hypothesis:**
- The existing solar field earthing is like a radial spider web with no cross connects.
- Any disturbance can only lead back to the central inverter.
- This seems to be what the customer observes when the GFCI circuits trip.

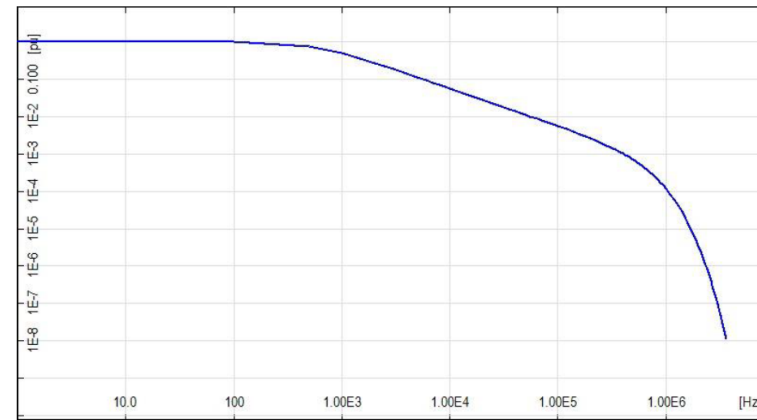
FIGURE 13: NORMALIZED FREQUENCY SPECTRUM

The impulse consists of ~167 different frequencies (shown in Annexure A) which were selected based on the normalized frequency spectrum shown below.

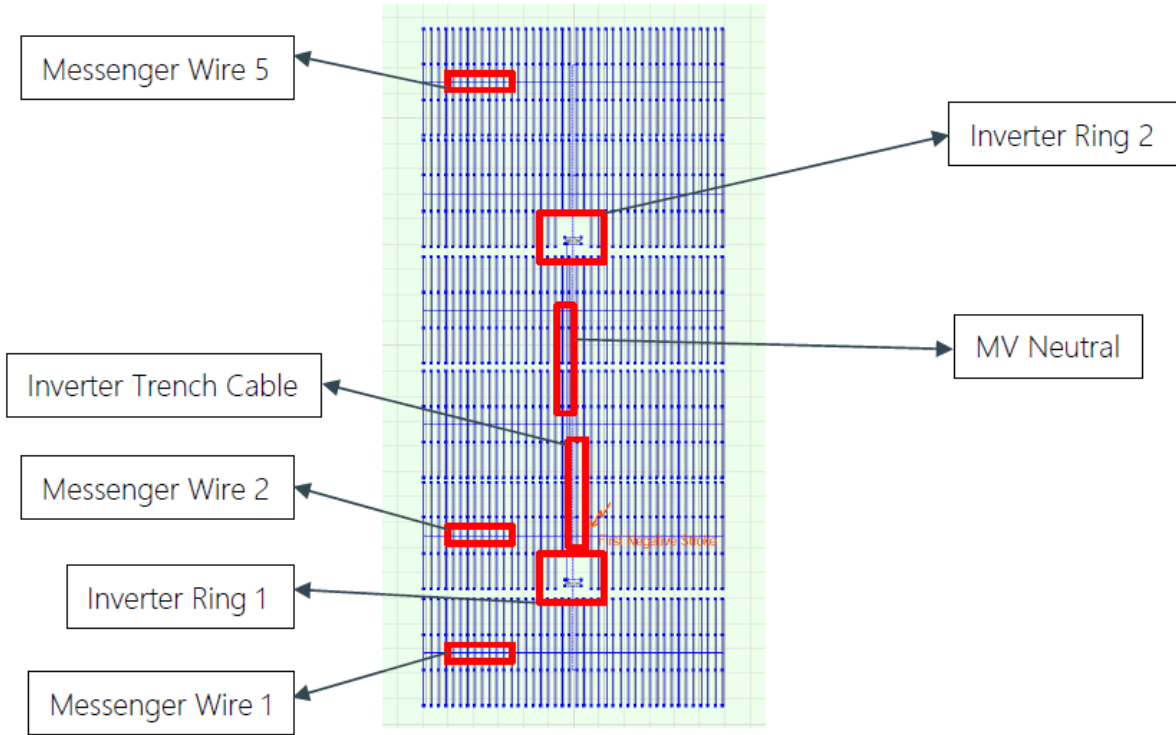
FIGURE 15: IDENTIFYING EQUIPMENT NUMBERS

Simulation of strike near inverter

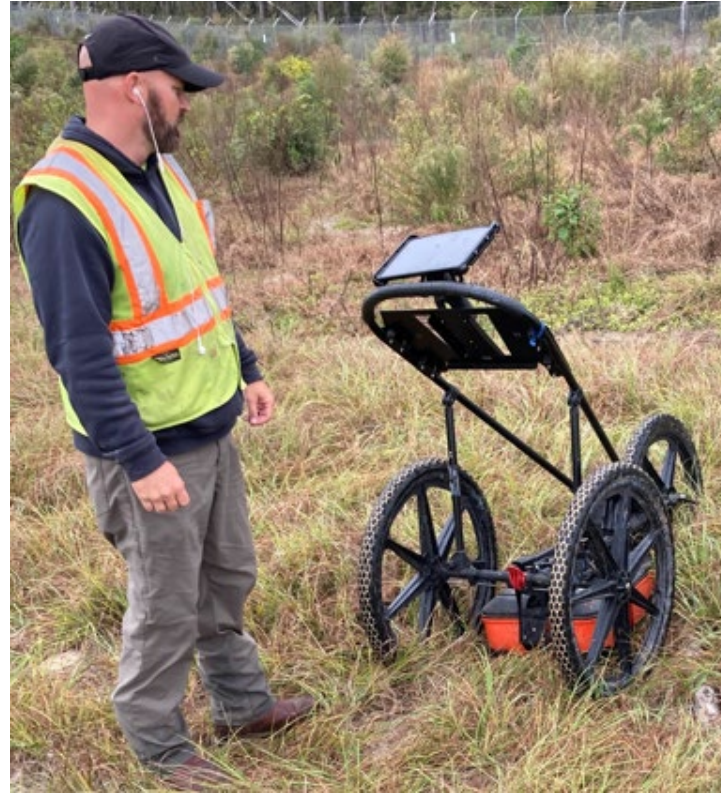
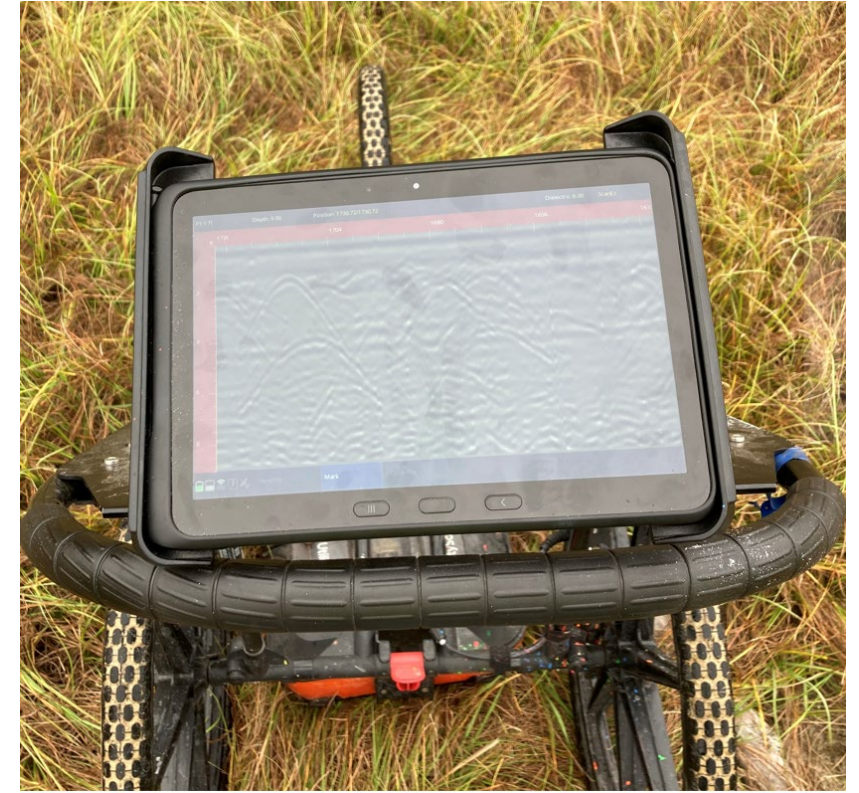
- Every foot of the intended trenching path is surveyed to assure that no electrical wiring system will be cut.

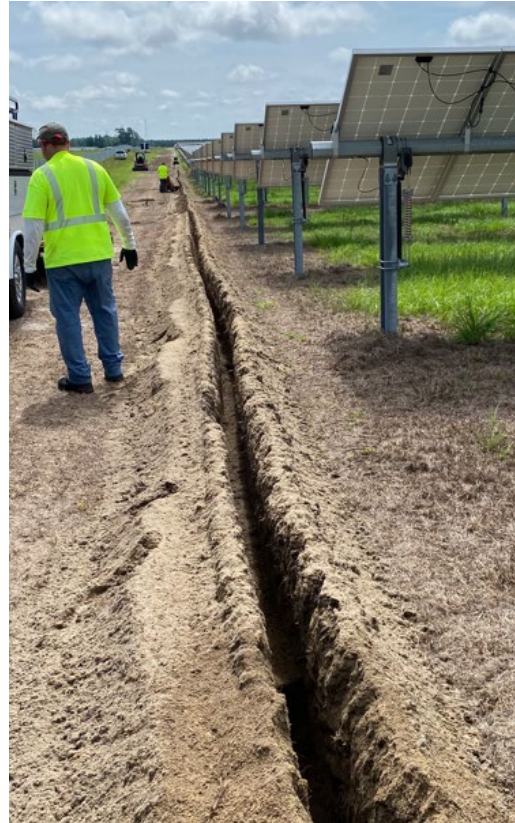
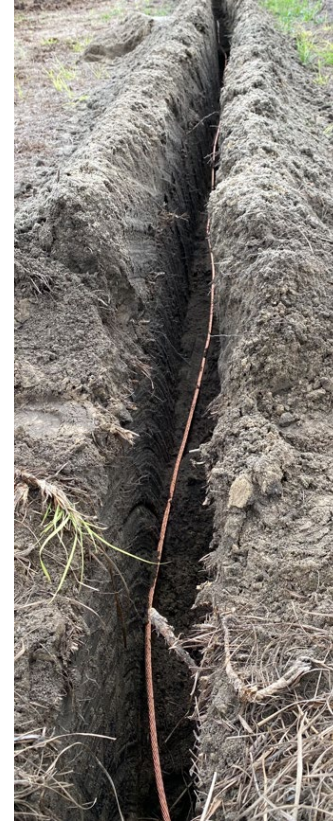
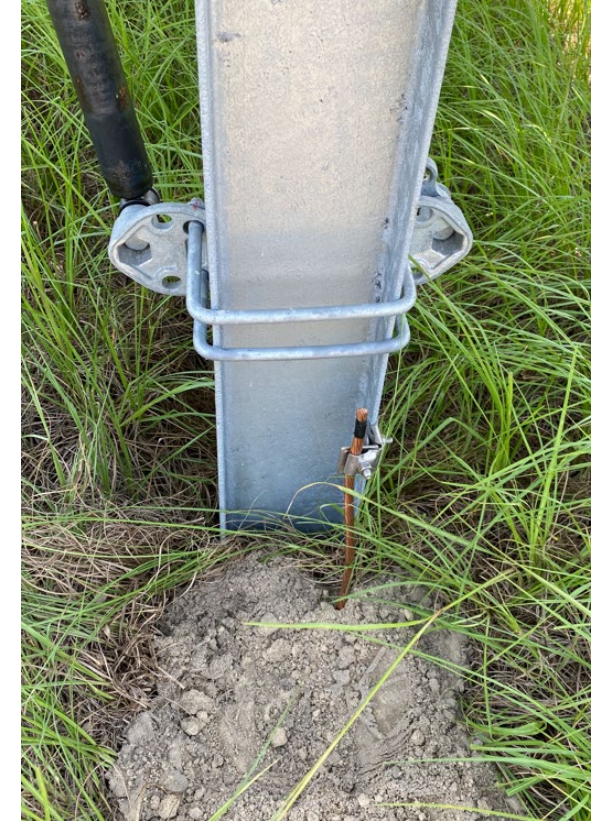
Field Installation

- And then the remediation work can begin!

- The actual repair work involves digging and trenching between and around panels.
- Before any excavation, both GPR and radio frequency inspection is employed to be sure the intended paths are clear of any obstruction.
- The locations of buried power, camera and fiber cables are confirmed, and various unknown debris is revealed.
- You'd be surprised how often the as-built locations are not exactly "as-built"!
