# **Case Studies of Inductive Coordination and Electrical Protection Issues in the Field**

**PEG GENERAL MEETING - 2013**

**DALE STEGMAIER – ICEP ENGINEER, CA  
LARRY PAYNE – COMMON SYSTEMS STAFF**

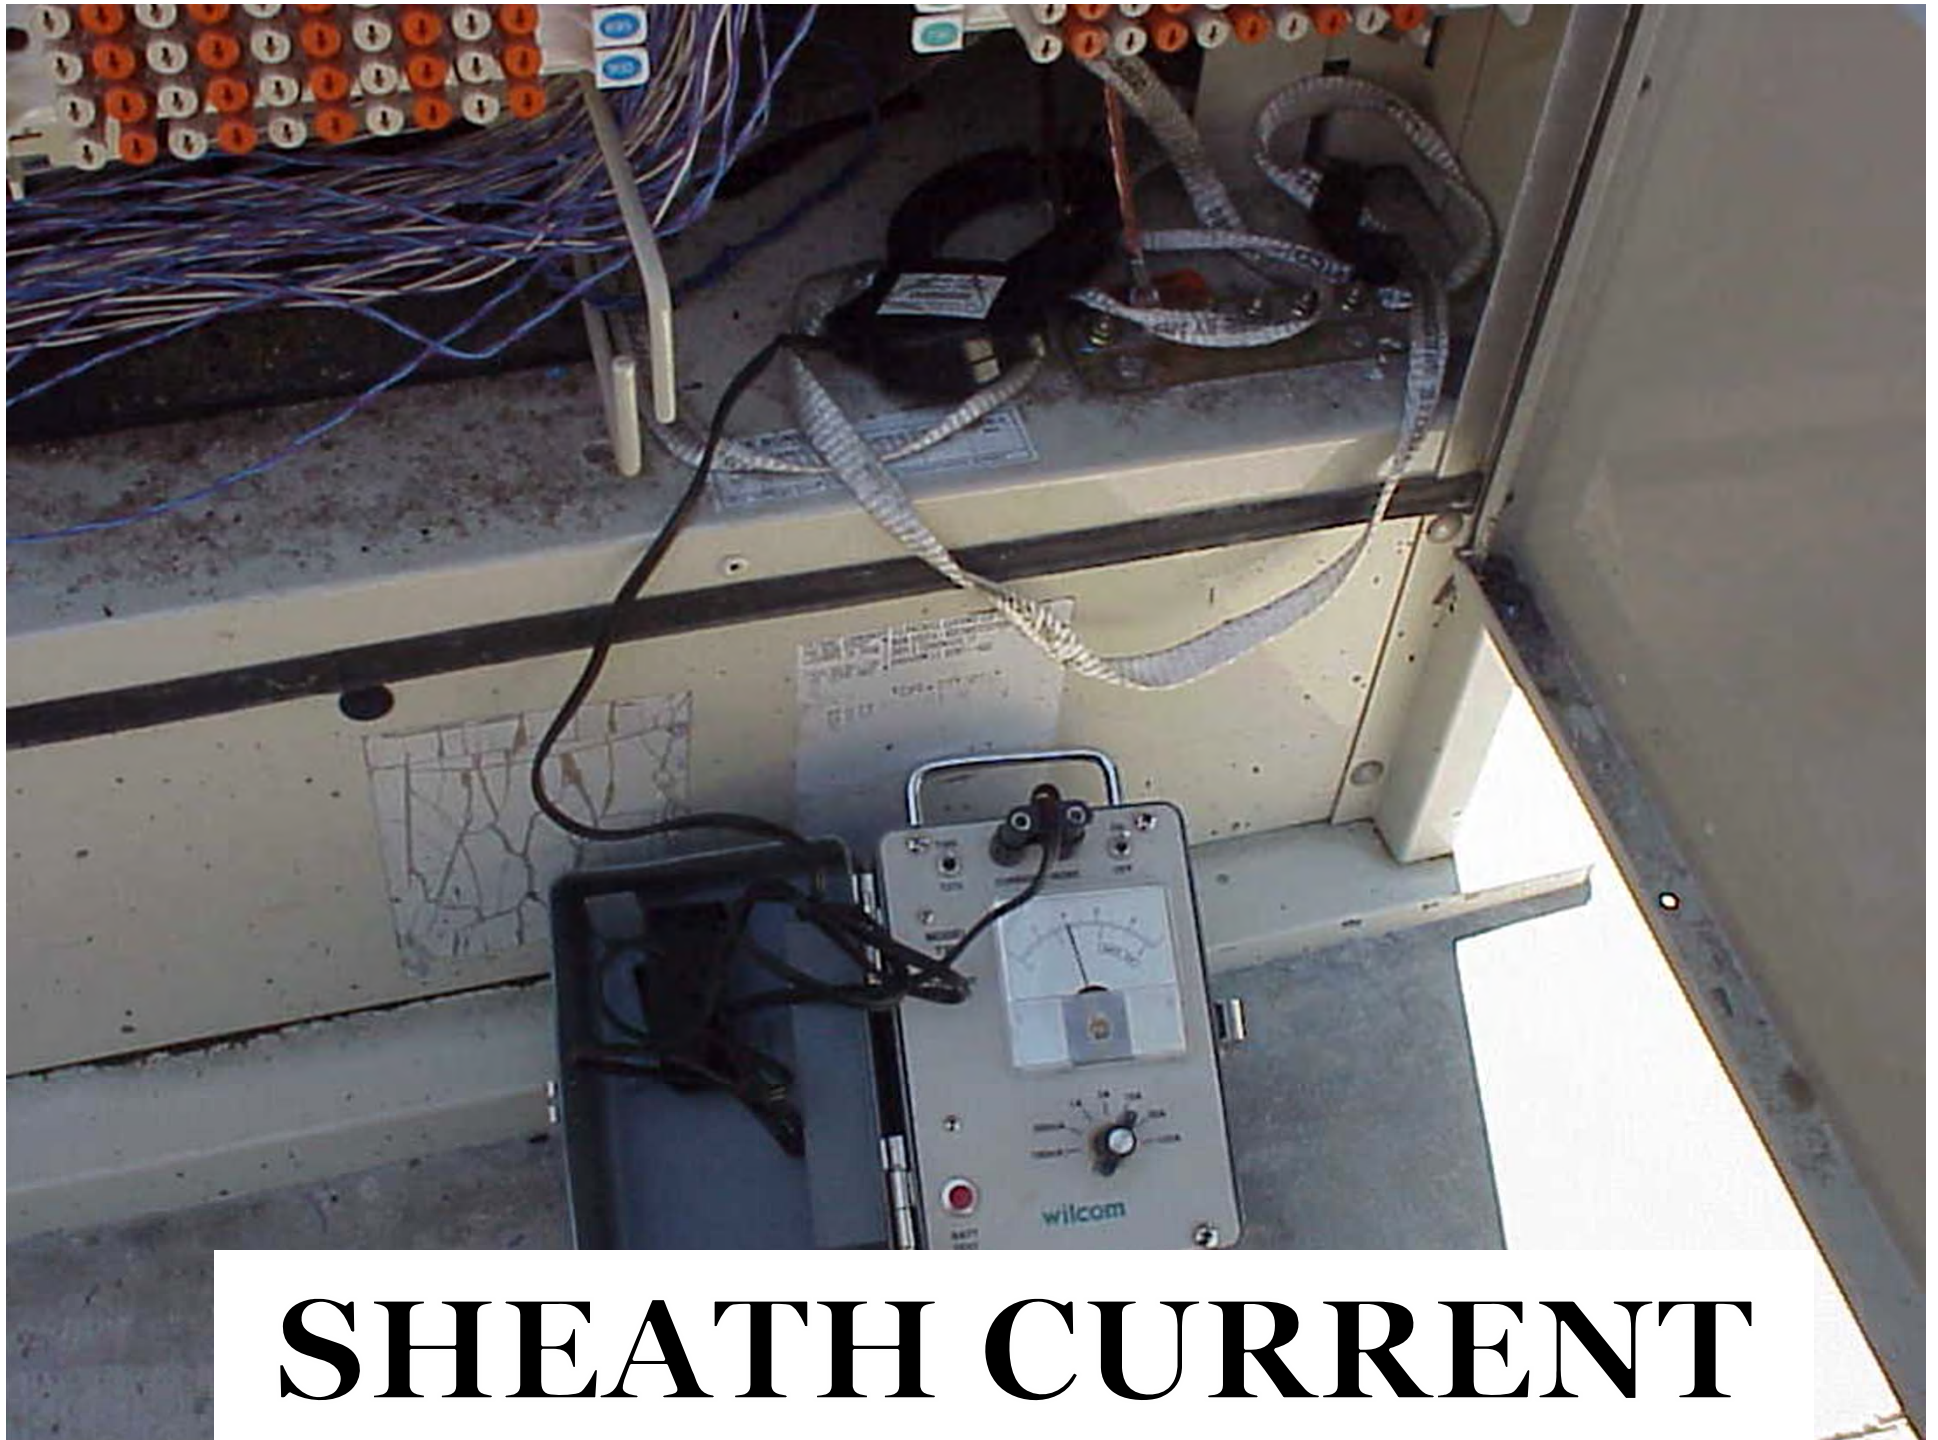
**880 BOX**

13 AMPS  
ON THE  
SHEATH

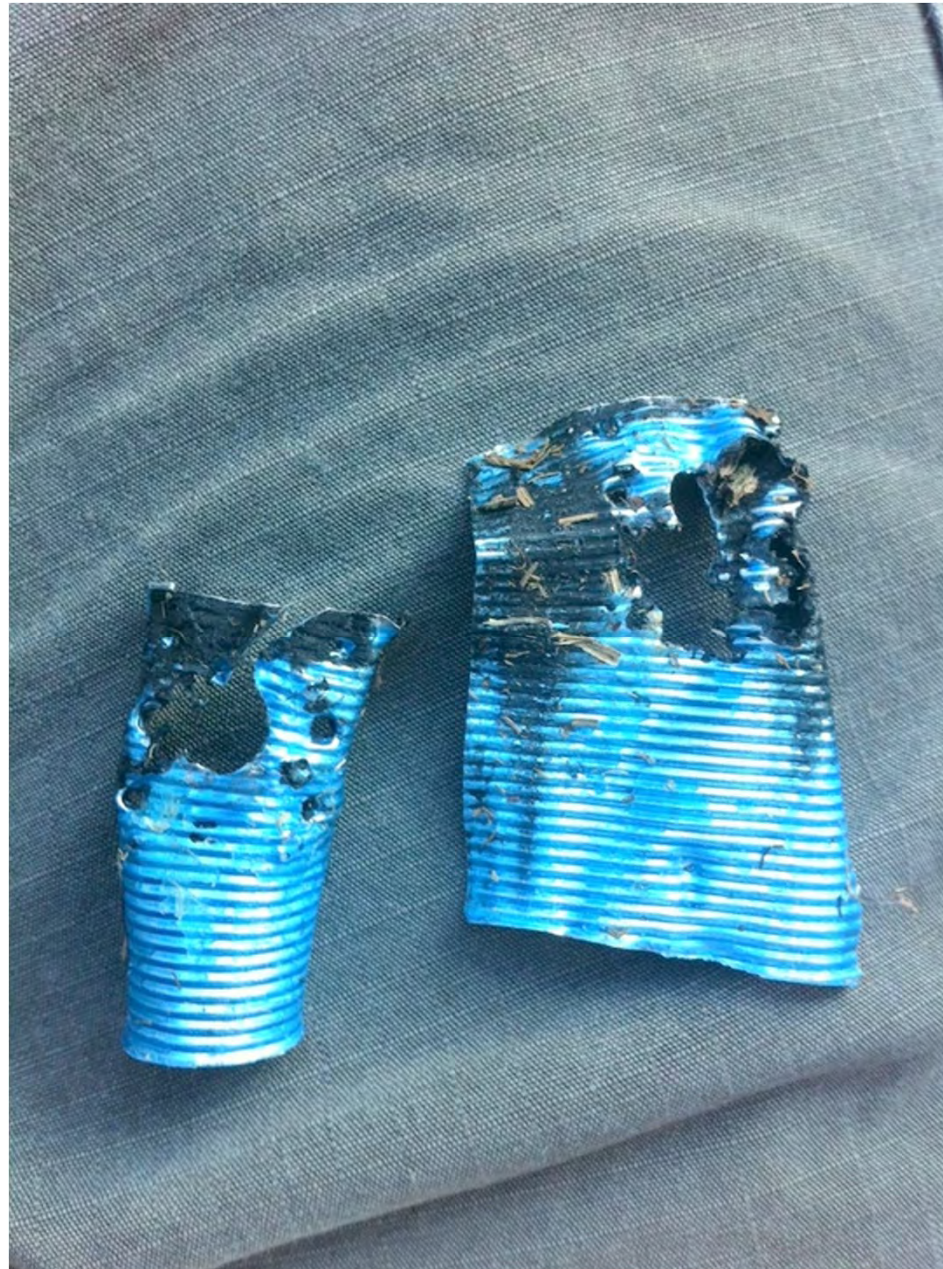
**Pedestal with  
Corrosive Bond**

**Sections of  
Corroded  
Shield at  
Splice  
Location B**

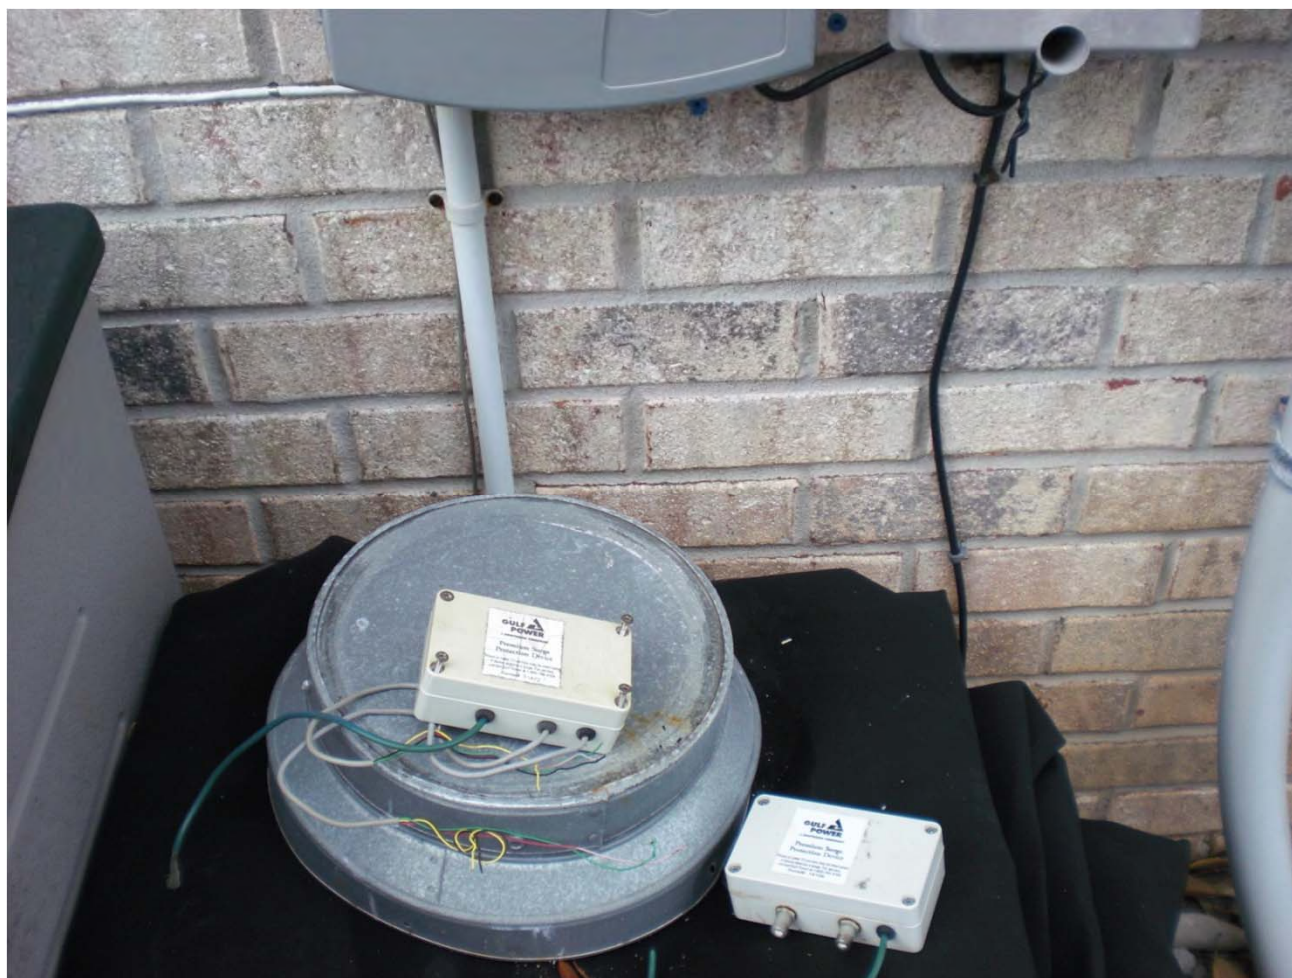
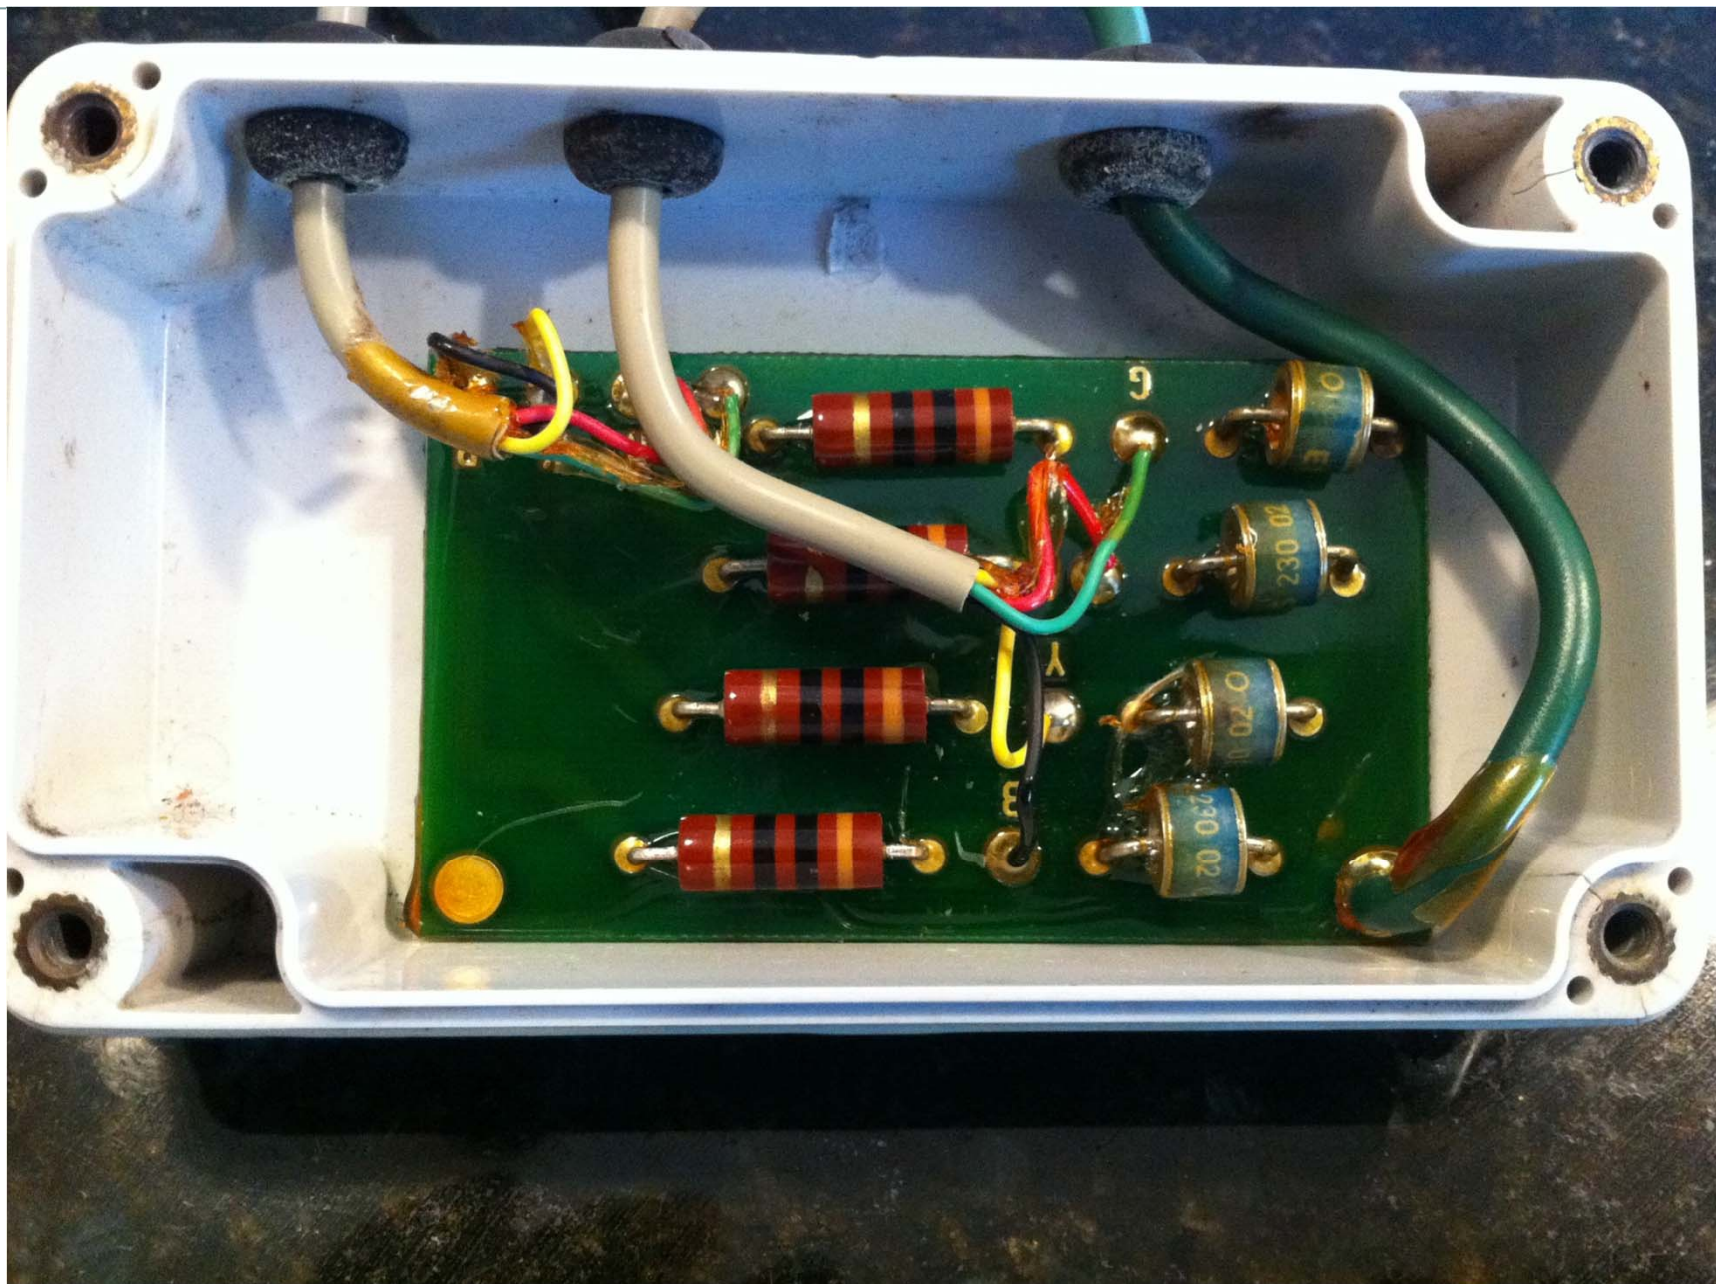
# **“Special Protector”**

- Required by a Power Company for Warranted Protection from Damage
- Placing in series and on customer side of telephone protector
- Would not pass HPNA Signal
- NEC issues
- No listing mark
  - Primary Protector?
  - Secondary Protector?
