Case Studies of Electrical Protection Issues in the Field

DALE STEGMAIER & LARRY PAYNE PEG GENERAL MEETING - 2013

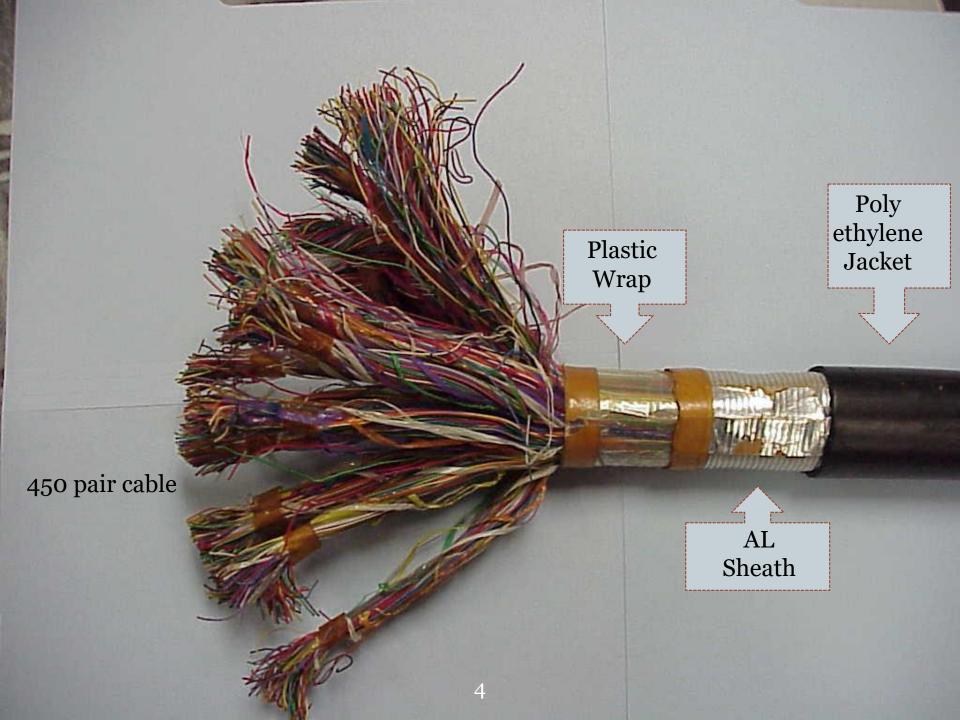
MEASURE SHEATH CURRENT On Cable 17

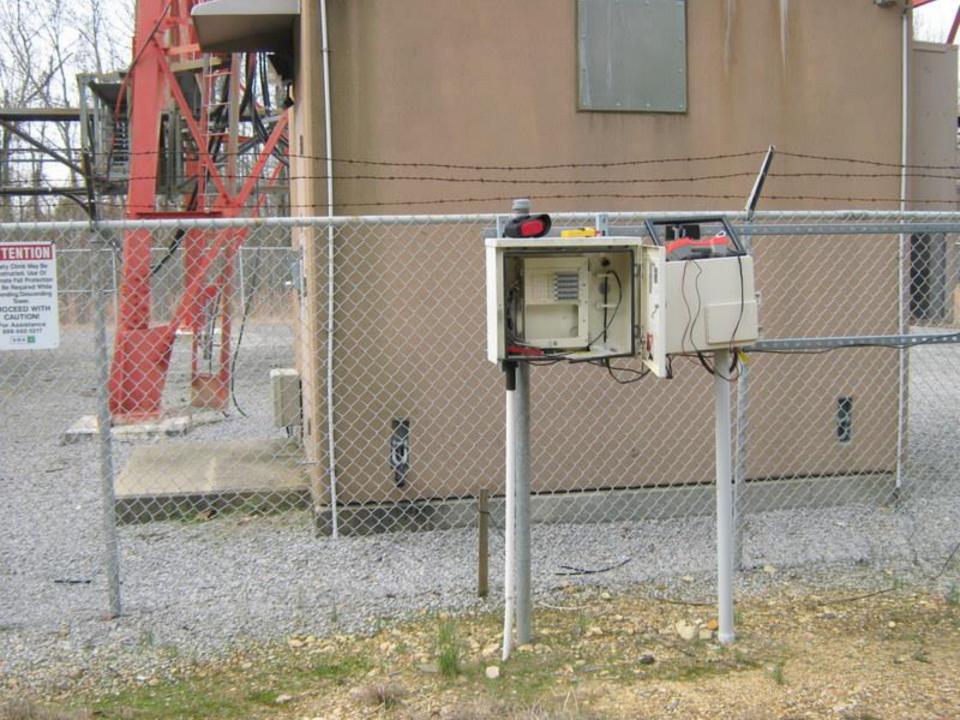
By clamping on the bond strap at location C and seeing no current flow, I was able to immediately determine the shield wasn't working properly from the ground at point A to the ground at point C. Since this is a 300' section of 25-pair cable, the resistance in the shield between point A and C should be less than 1 ohm (1000' of 25-pair cable has a shield resistance of about 1 ohm).

I then removed the bond at point C and measured the induced voltage which was 0.1 volts. This indicted the shield wasn't completely open, so I re-attached the bond and used a more sensitive clamp-on ammeter (AEMC 3731) and measured 0.007 amps. This allowed me to do the simple calculation of (V = I X R) and determine how much resistance I had in this 300' section of shield. My resistance was R = (0.1 / 0.007) = 14 ohms. Therefore, we had a high resistive splice that was adding this additional resistance and was drastically limiting the amount of current that could flow in the shield.

The bonds in the pedestal at location B was where the problem existed. When this bond was replaced, the resistance dropped from 14 ohms to less than 1 ohm and the current increased from 0.007 amps to 1.12 amps.

This section now has 1.12 amps of current flowing on the shield (99% more than before). This increased current is now creating a strong enough magnetic field around the cable to effectively cancel the magnetic fields from the power lines and we can now ground our loopback without the circuit taking errors. When we only had 0.007 amps current flowing in the shield, the magnetic field it was creating around our cable was cancelling less than 1% of the induction from the power lines and thus enough voltage existed on the pairs between the pair and earth that everytime we grounded the loopback, the induced voltage was enough to allow the protectors in the loopback card to intermittently fire to earth and thus caused continued intermittent errors on the circuit.

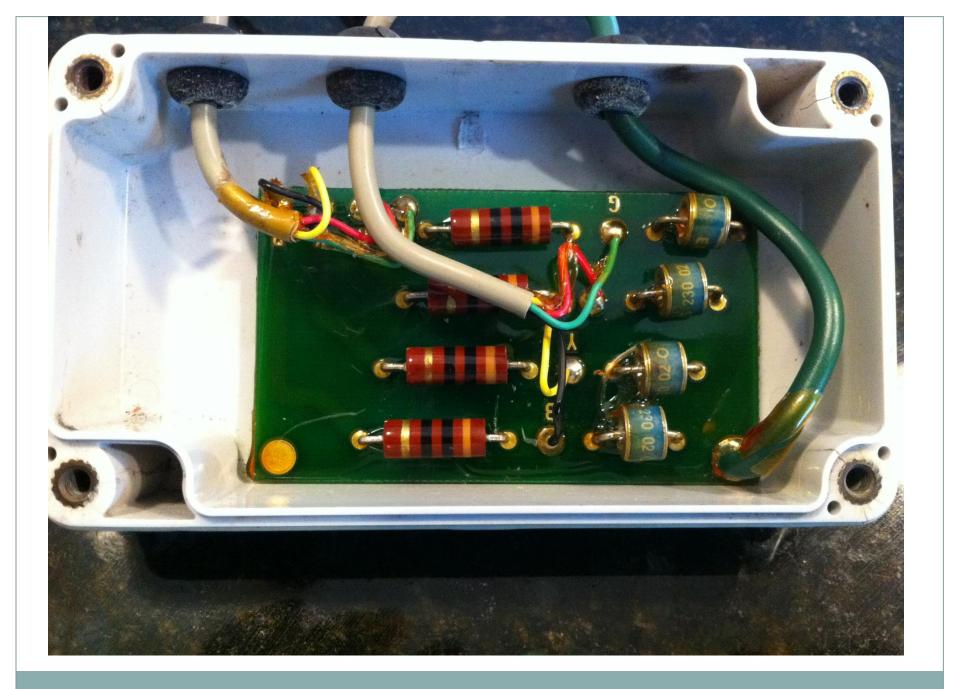
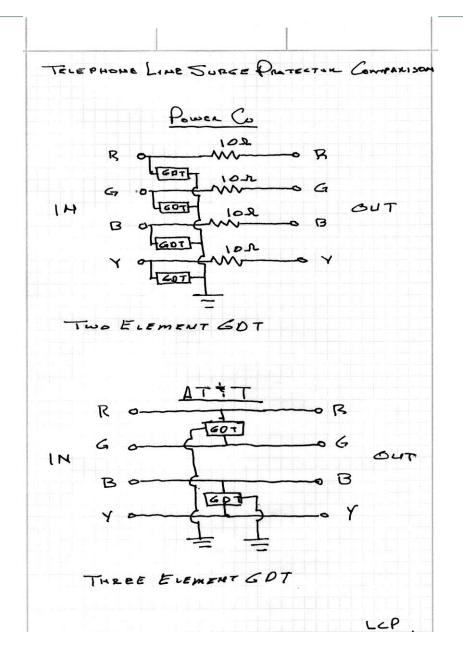
Design Question

- 10 Ohm provides coordination, but not calculated
- Two element gas tubes
 - A device for each conductor
 - Longitudinal to Metallic Conversion during a surge
- Three Element Gas Tube
 - No Longitudinal to Metallic Conversion during a surge

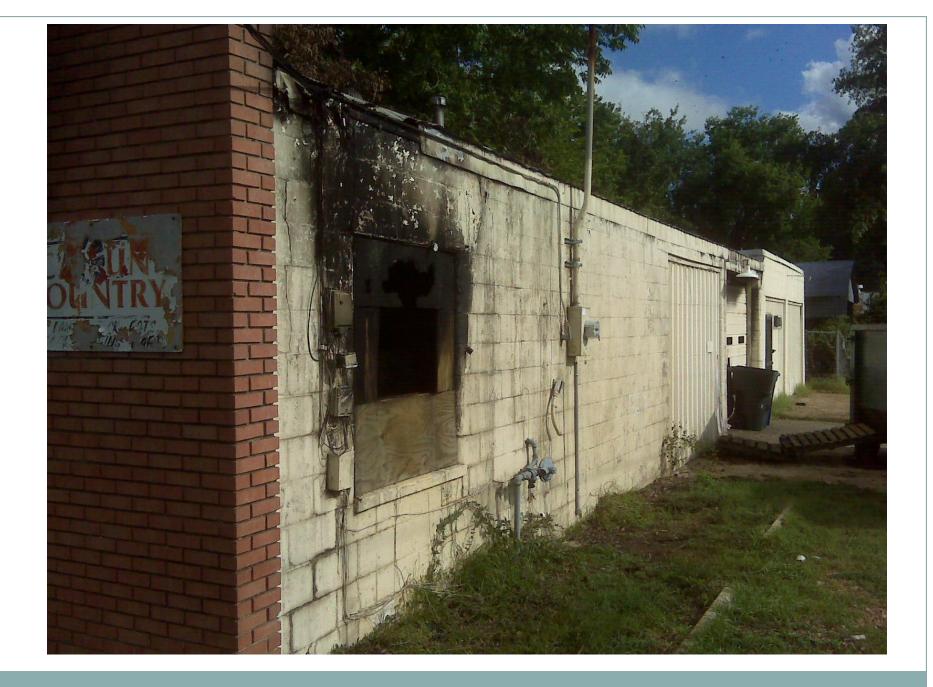
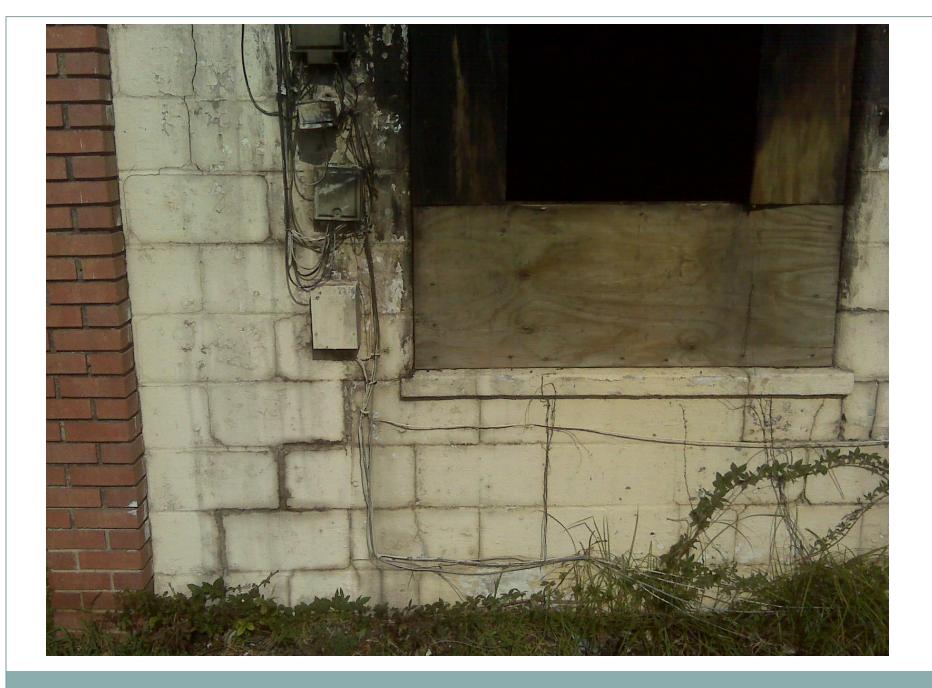
Electric Fence Controller Damage

- Controller for electric fence being damaged frequently by lightning storms.
- Suggested use of special protector
- Originally designed for telecommunications equipment at customer premise.
- GDT and ECL
