Measured Surge Activity at Cellular Sites

Alabama Engineering

Presentation Objective

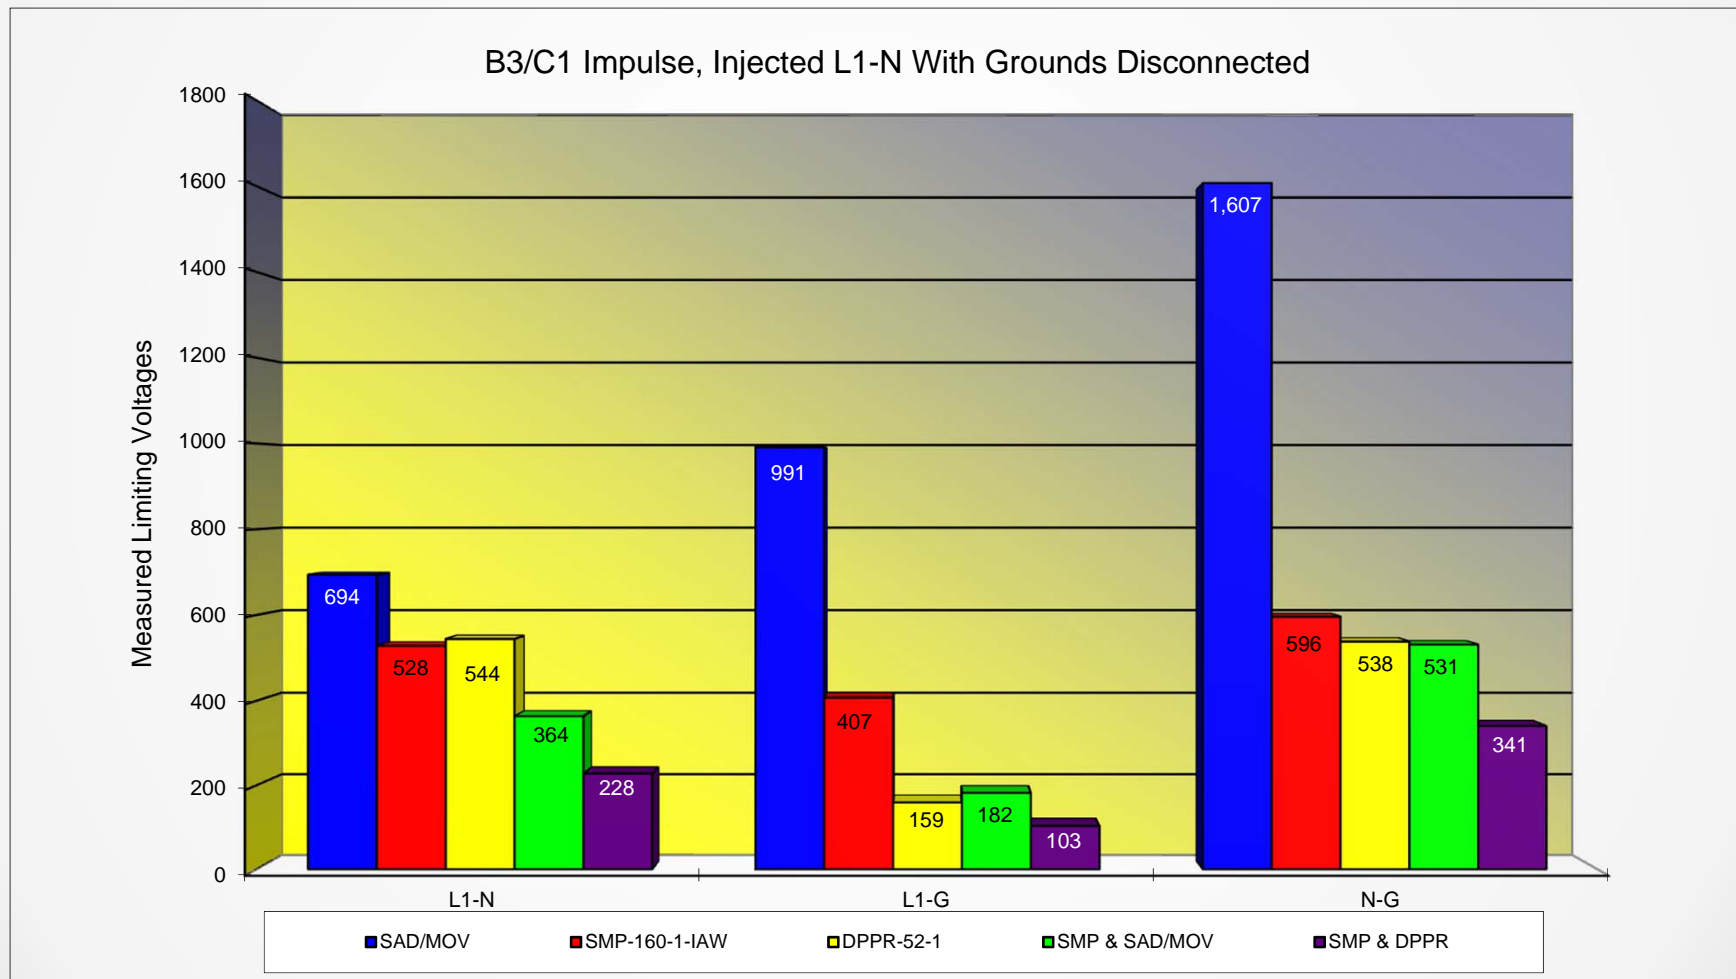
Chart-Testing at Rohn

- Testing performed with shelter sitting on timbers.
 - Shelter was fully manufactured waiting for truck transport and was sitting on large wooden timbers, isolated from earth
- Halo leads not connected to a ring. Shelter ground was “floating” except AC power to Velonex
- BMI and ROHN personnel present during testing.
- Surges were injected at shelter/Service disconnect on shelter exterior.
- MLV recorded on buss of DP-1
- Every time a surge was generated, the conduits buzzed and fluorescent fixtures illuminated momentarily.

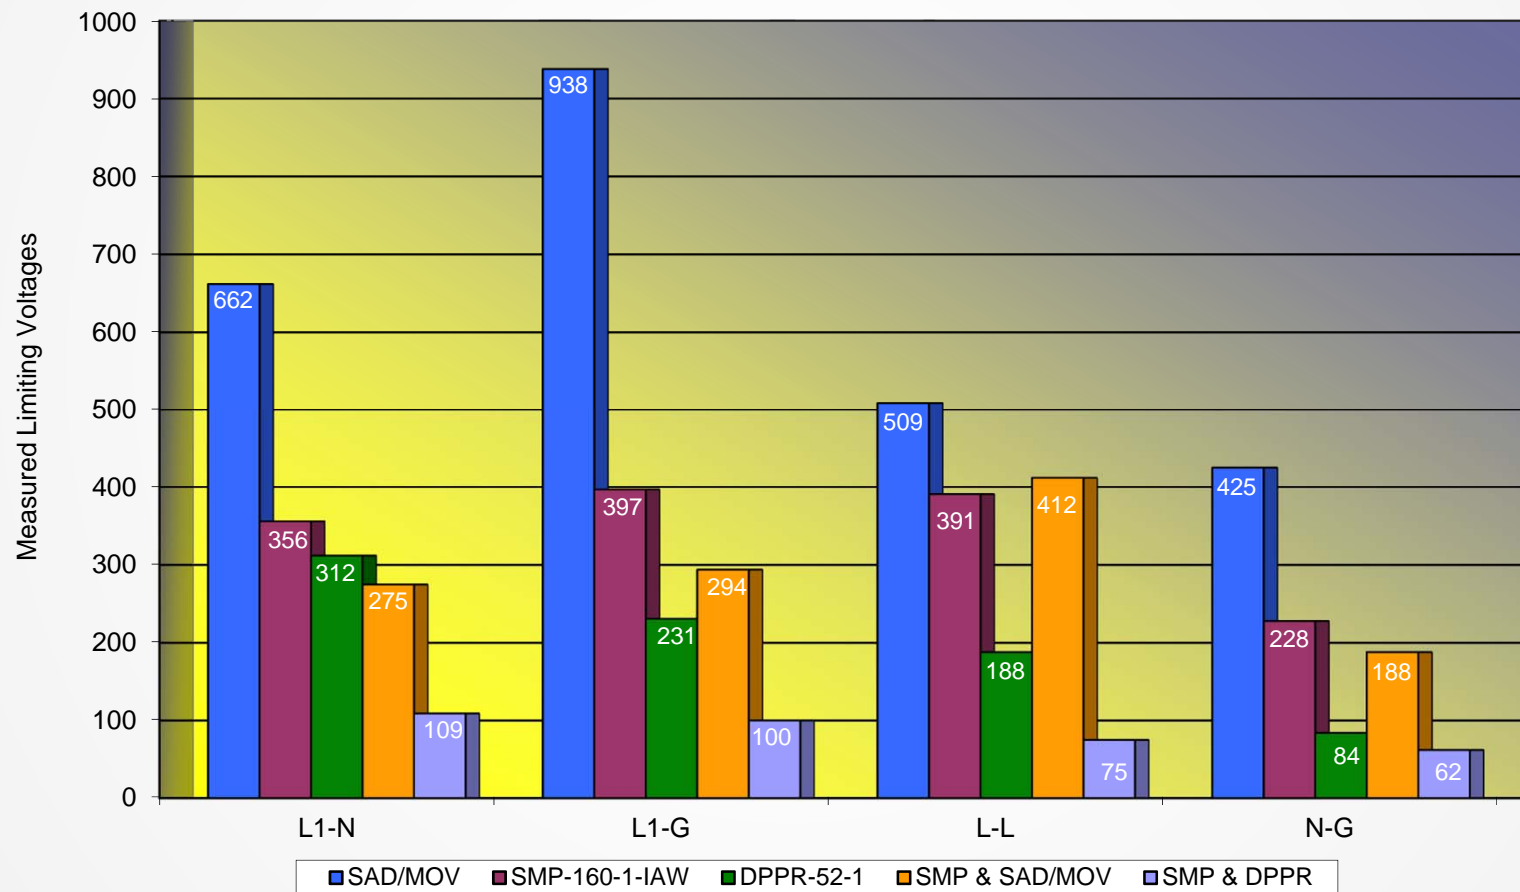
Chart-Testing at Rohn

IEEE, A3 100kHz RW, No Shelter Gnd, No Halo, With TVSS

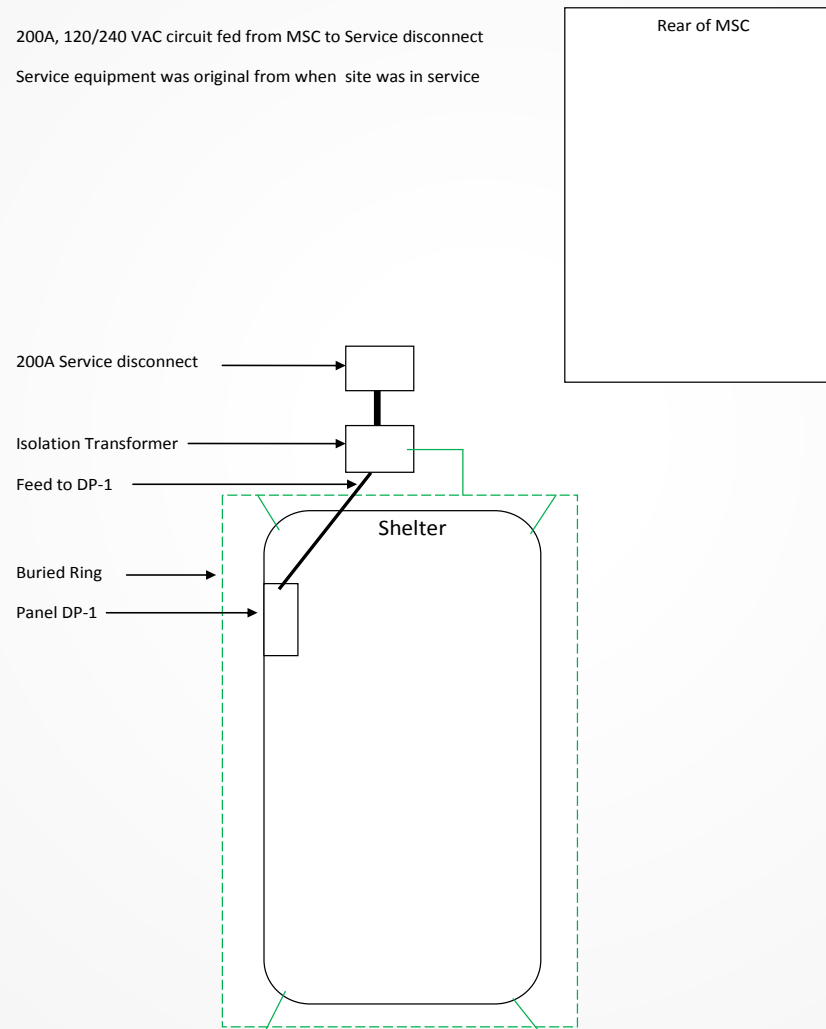
Pine Mountain Test Layout-NTS

200A, 120/240 VAC circuit fed from MSC to Service disconnect

Service equipment was original from when site was in service

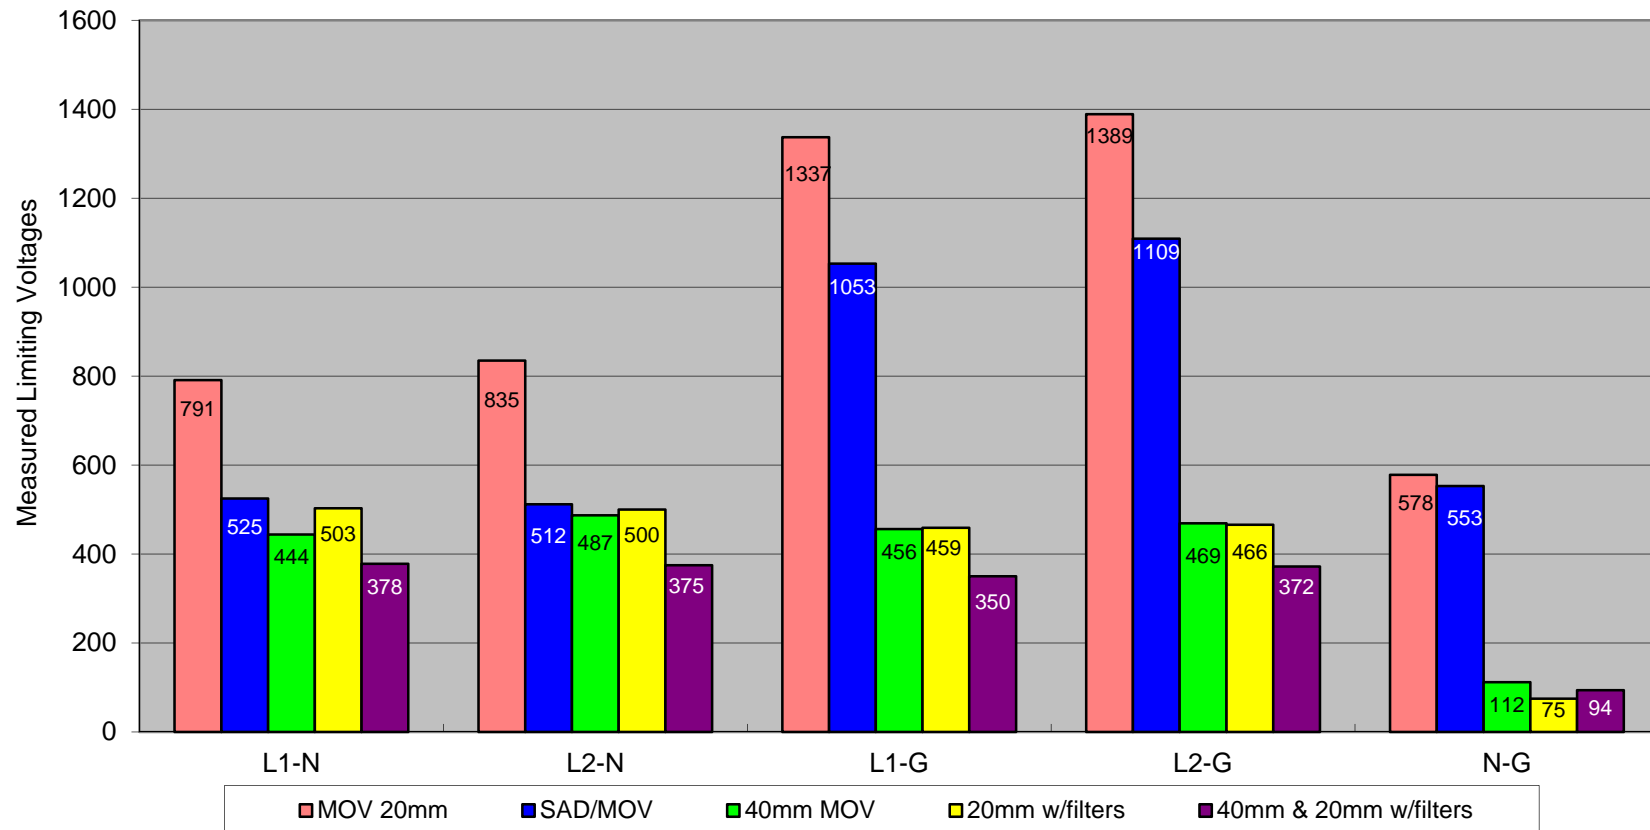
Schillenger Road

B3/C1 Combination Wave, Injected L-N at Service Disconnect, Measured at Distribution Panel

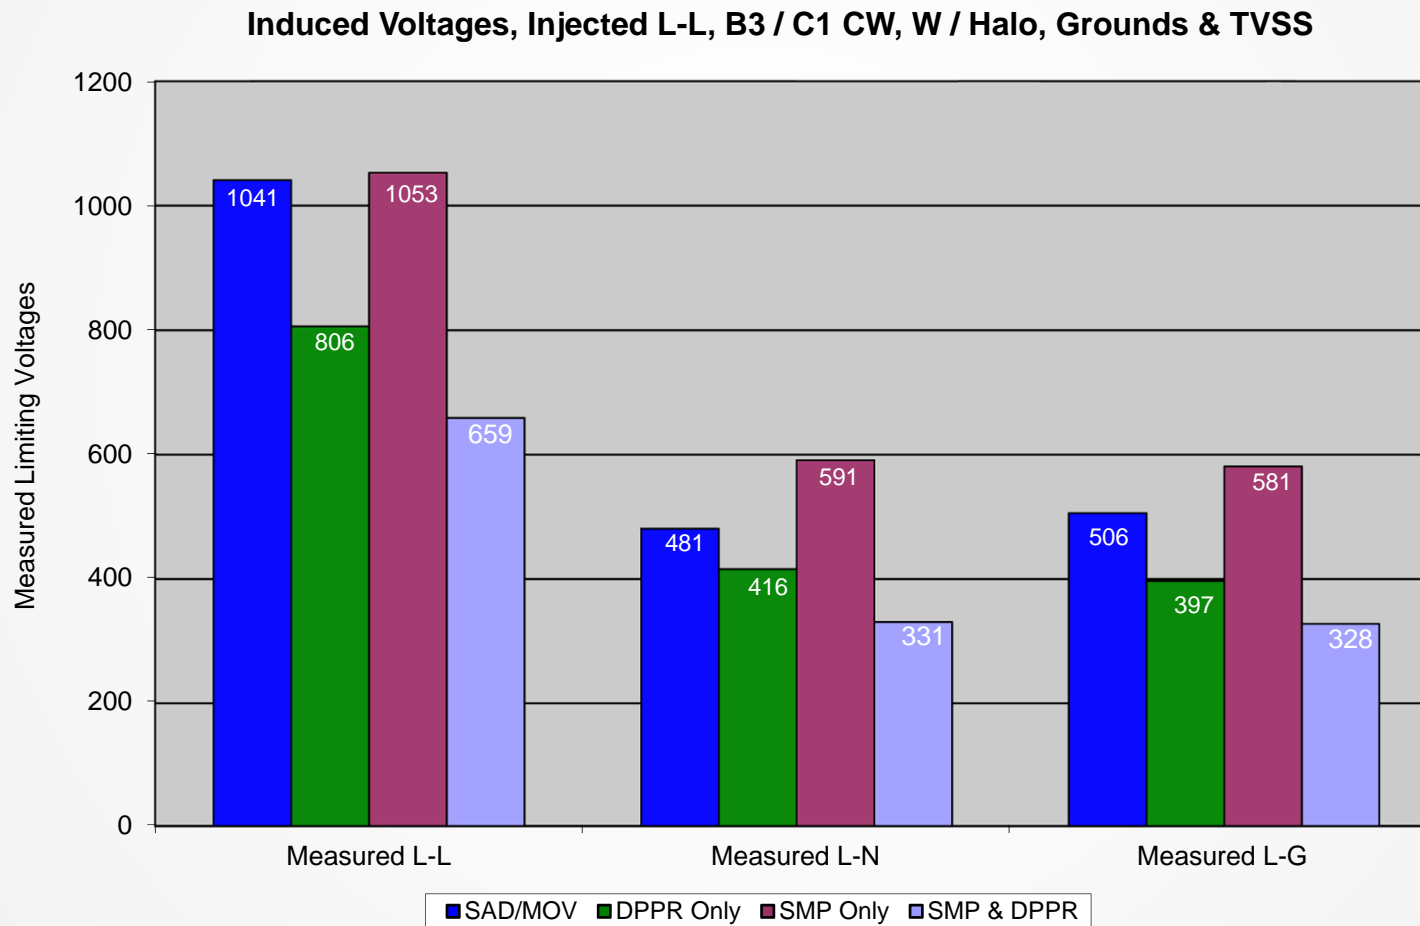
Induced Voltages

6kv Transient injected L-N created 4.9kv transient on L-L
6kv transient L-L induced 2.9kv on L-N/L-G

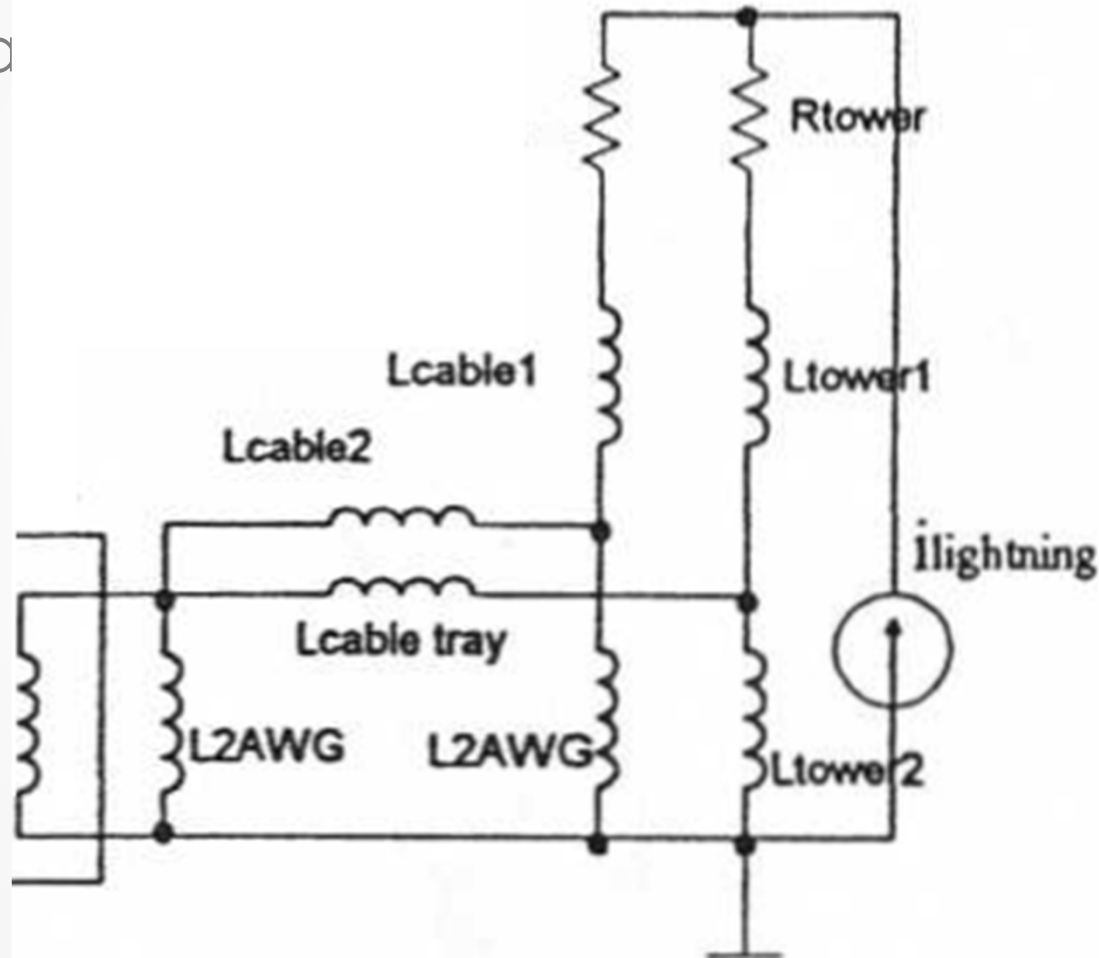
- Induced Lightning Voltage on the RS422 Alarm Bus - Autoplex Series II Cell Site
- The output of the transmit chip in the UN166 board is connected to the inputs of the receiver ICs in the LAF and the OIF frames through RS422 cable.
- In addition, all transmit ICs in the LAF and the OIF frames are connected to the receiver circuitry of the UN166 board. The ground for each of the driver and receiver circuit in each board is connected to the frame which is then connected to the cell site interior ground ring.
- Therefore, any frame voltage differential will appear at the input (output) of the receiver (transmit) ICs since the driver and receiver pairs on the separate frames are linked via the RS422 bus.
