# **Optical Network Terminals (ONTs):**

## ***Lightning Damage and Standards - What's the Latest Information?***

**Jim Wiese**  
**ADTRAN, Inc.**  
**901 Explorer Blvd.**  
**Huntsville, AL 35806**  
**[Jim.wiese@adtran.com](mailto:Jim.wiese@adtran.com)**

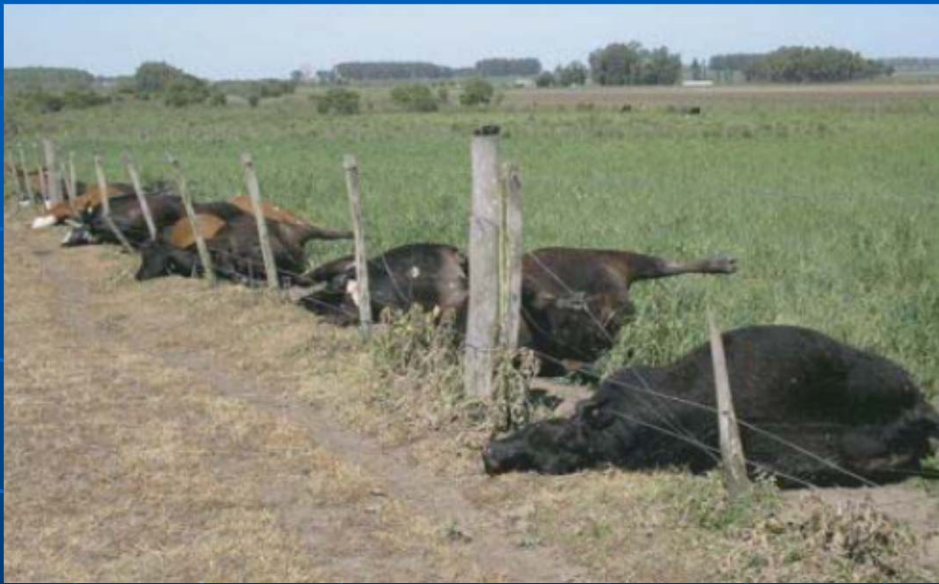
**You cannot protect cows or golf greens either!**

When the current starts to spread when a cow is eating grass, the current flows from the cow's mouth (A), goes through its leg (B), and goes back to the ground. The current will flow until the voltage becomes zero.

Because cow's hind leg (D) has lower potential energy than its front leg (C), the current can flow through the cow. The cow becomes a part of electric circuit.

Then the cow gets a big electric shock and it usually dies.
