## Power GPR-Related Telecom Equipment Damages-Case Studies

John E. Fuller Larry Payne AT&T Global Engineering Support Common Systems Standards (see last page for contact info)

Presented To: Protection Engineers Group March 20, 2013

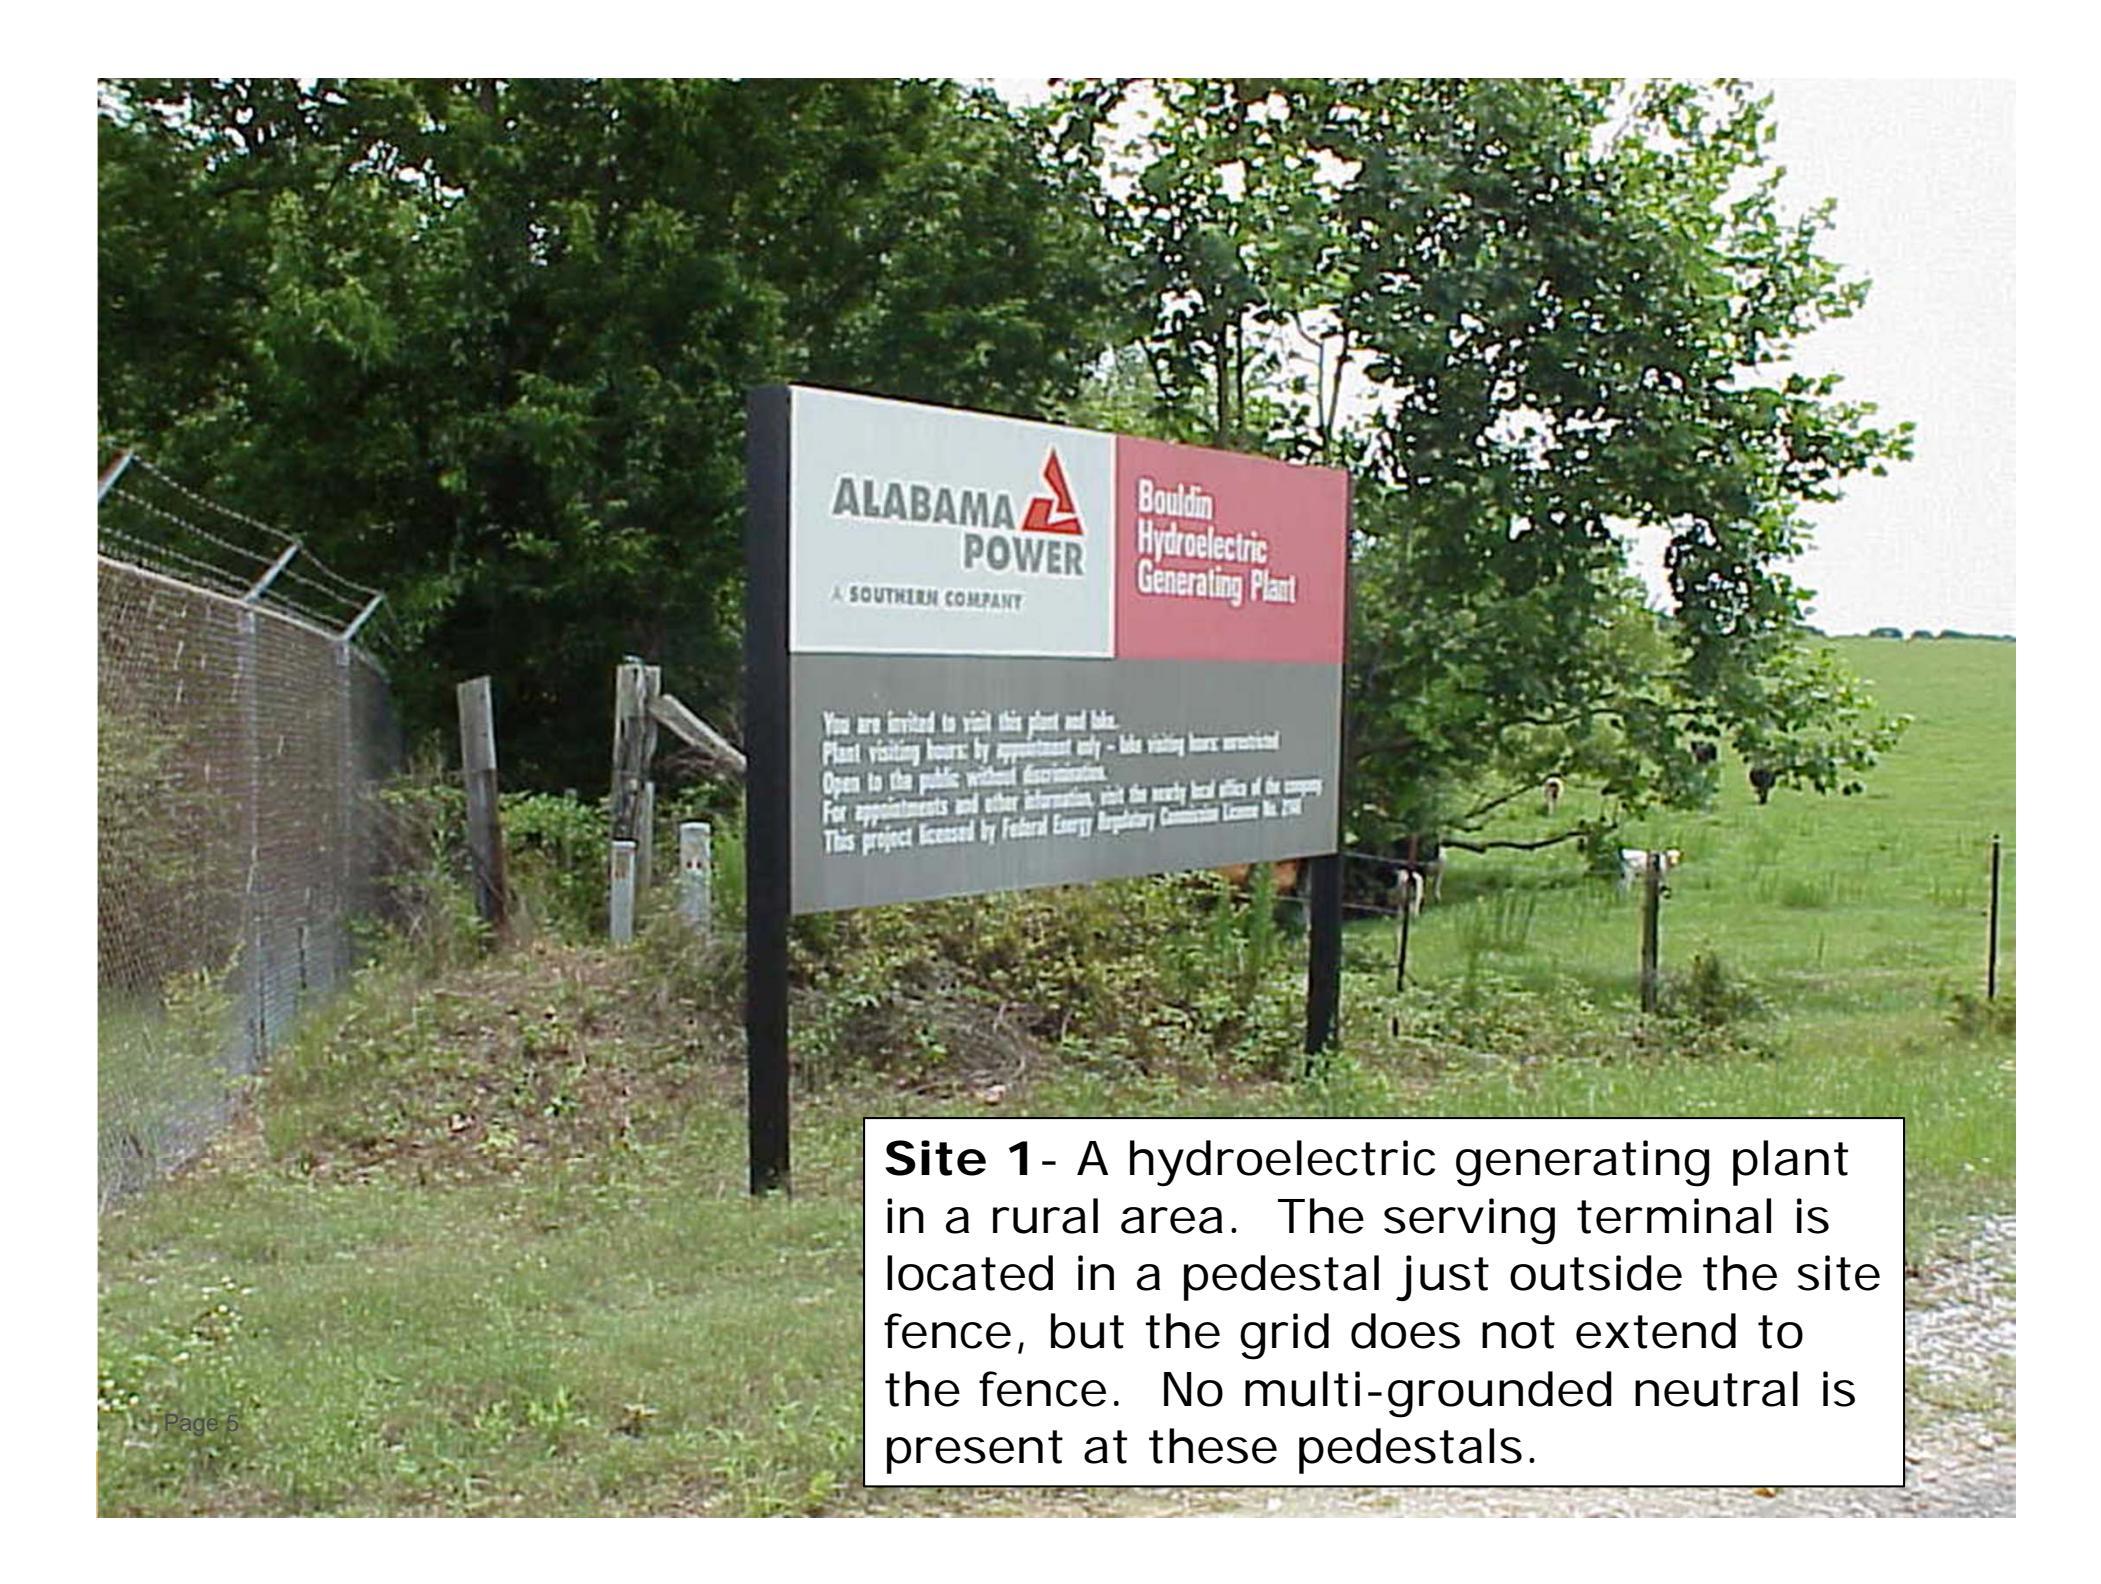
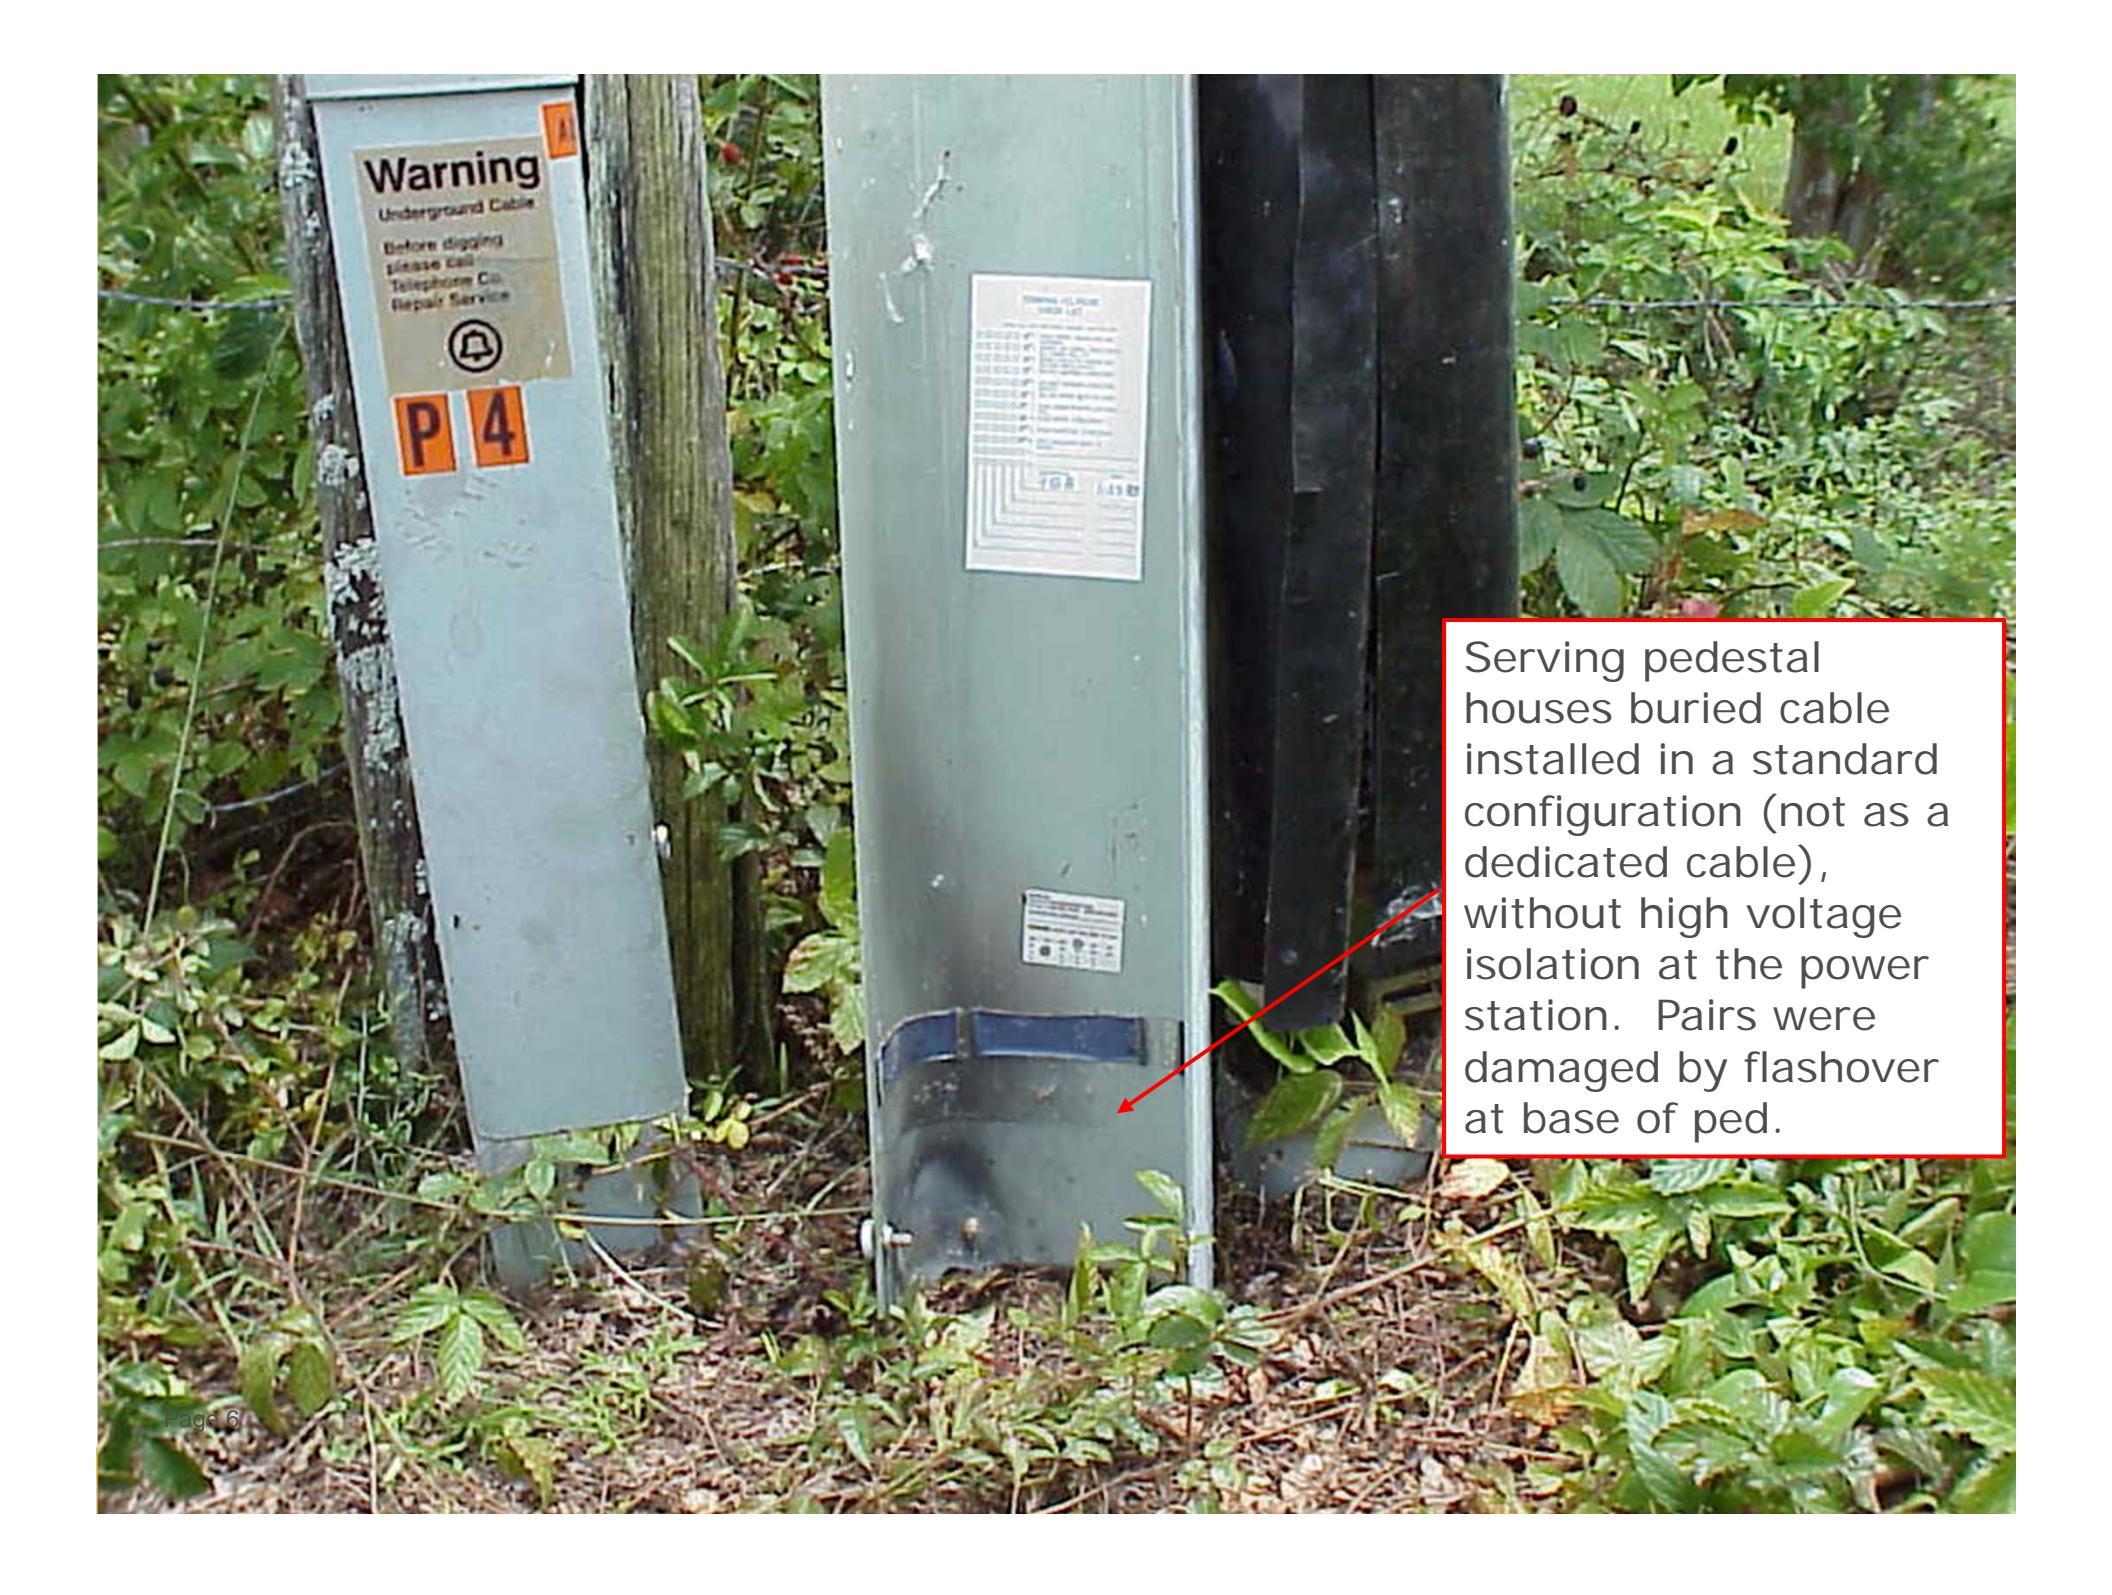
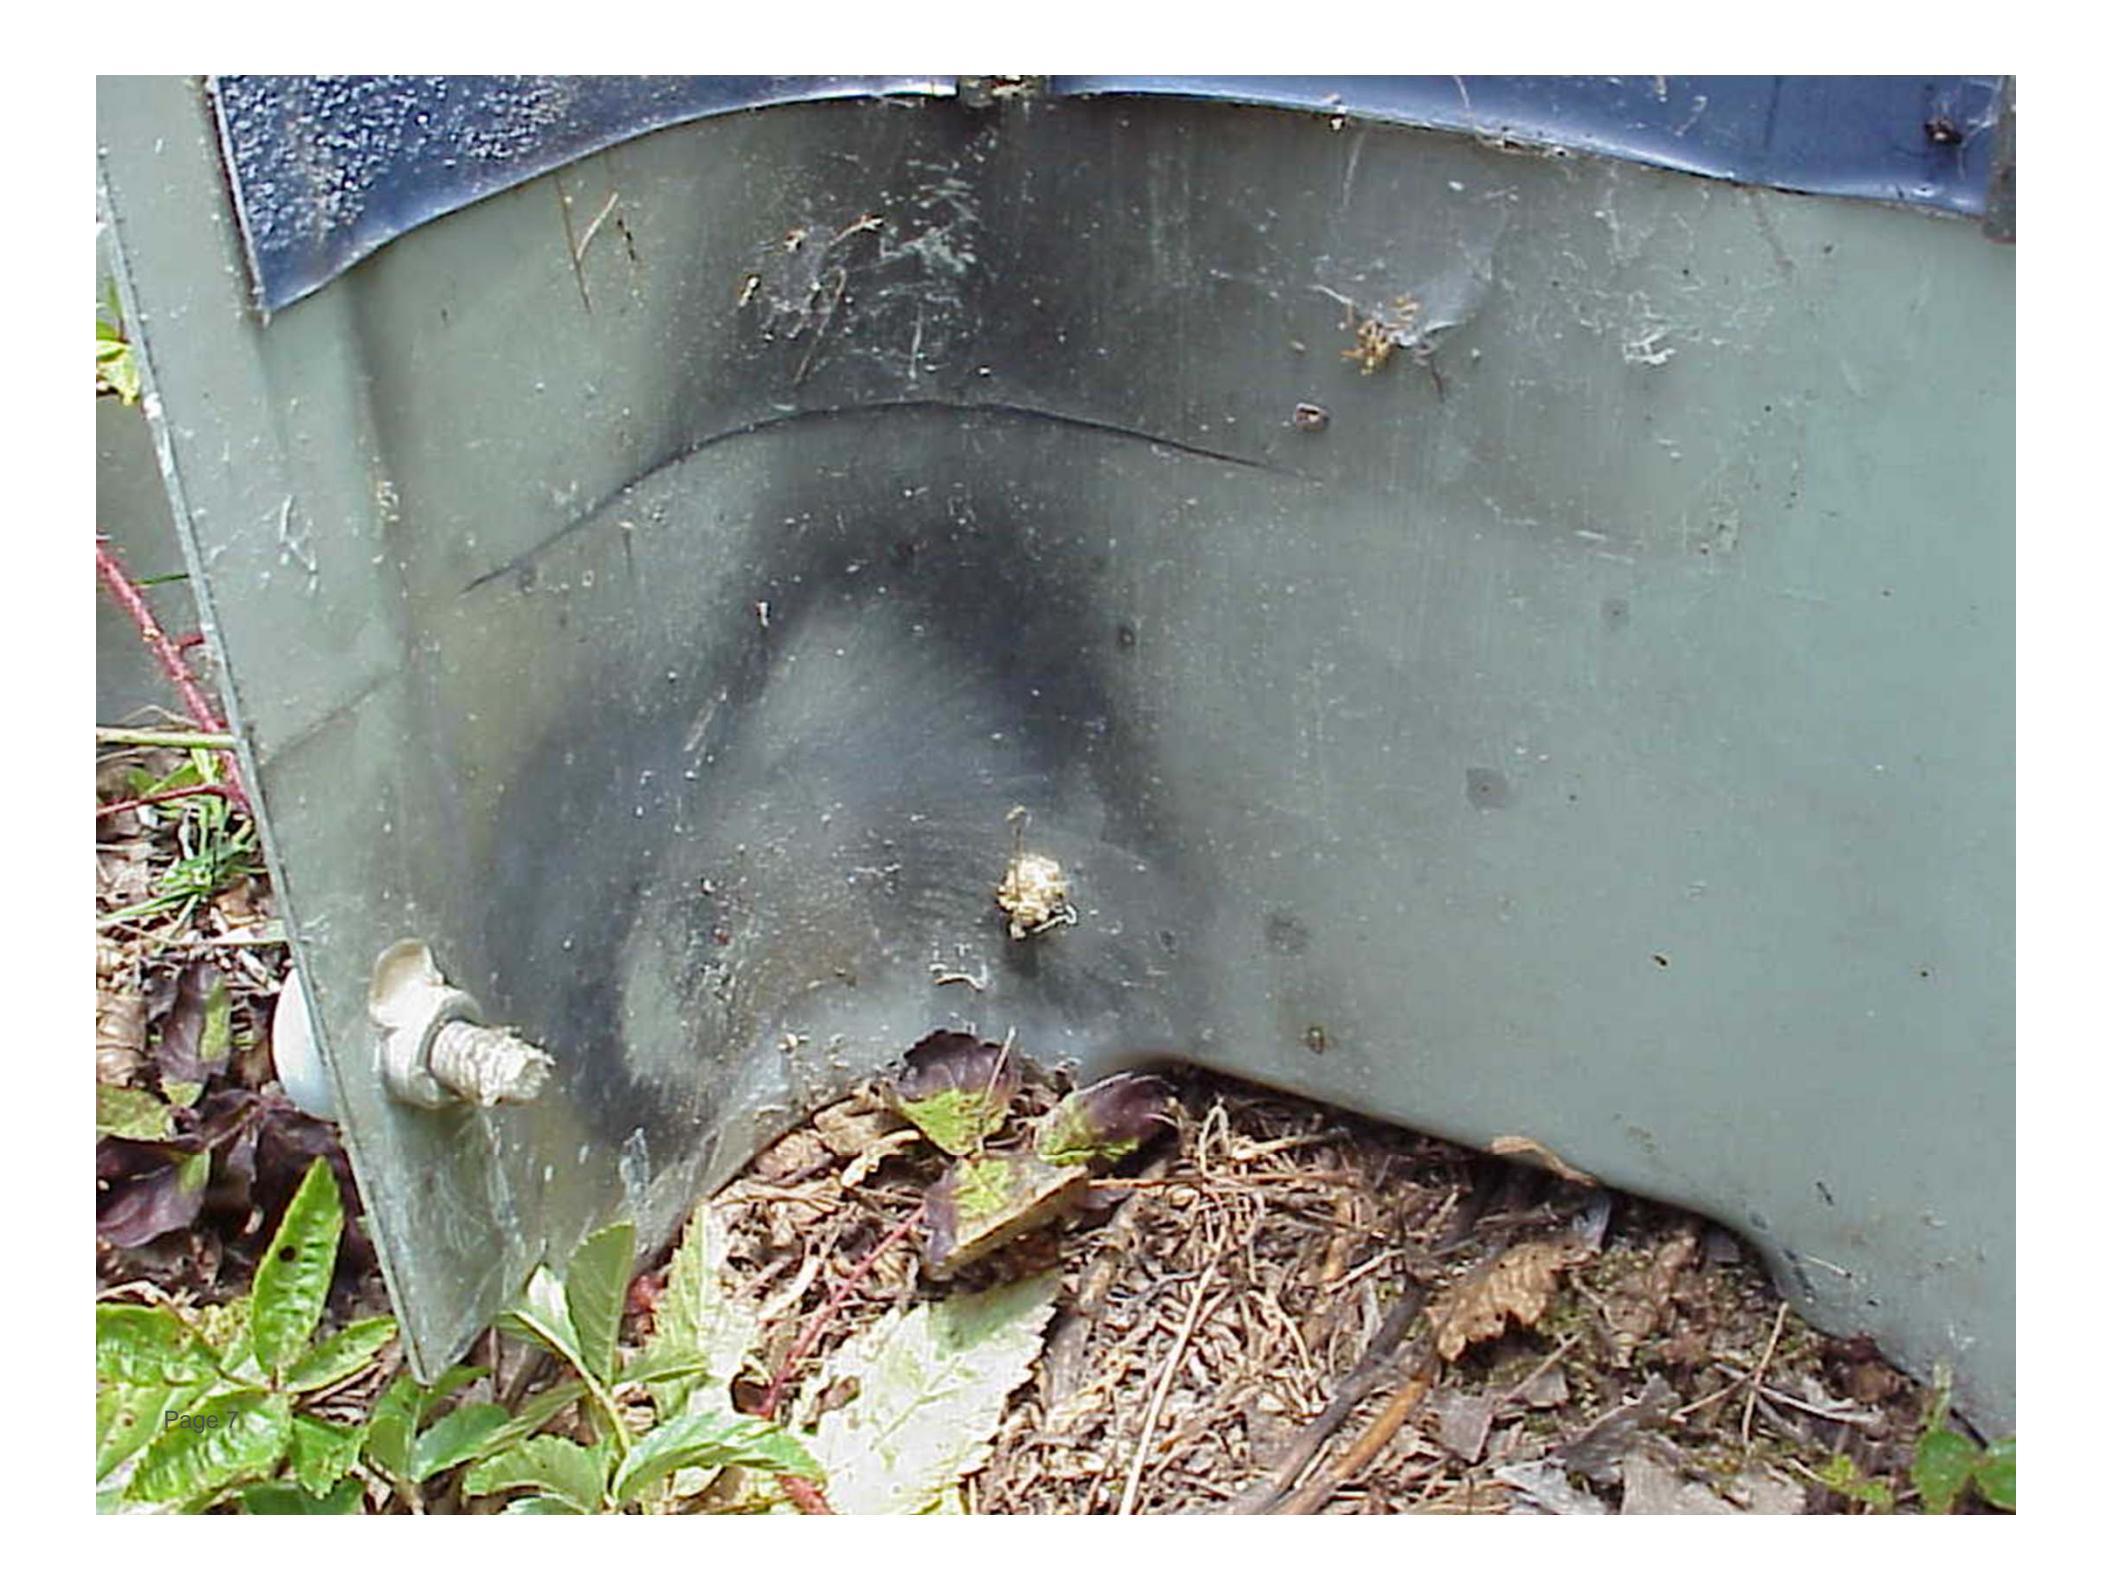
Site 1- Power generating plant without high voltage GPR protection

At the next pedestal toward the CO, rat's nests, spiders, and another local ground were confirmed...
