# To Fuse or Not to Fuse? That is the Question:

Codes, Science, and Case Studies to Support the Unfused Battery Bus in 48 Volt Dc Power Plants

Dan McMenamin

March 19 - 21, 2013  
San Ramon, CA

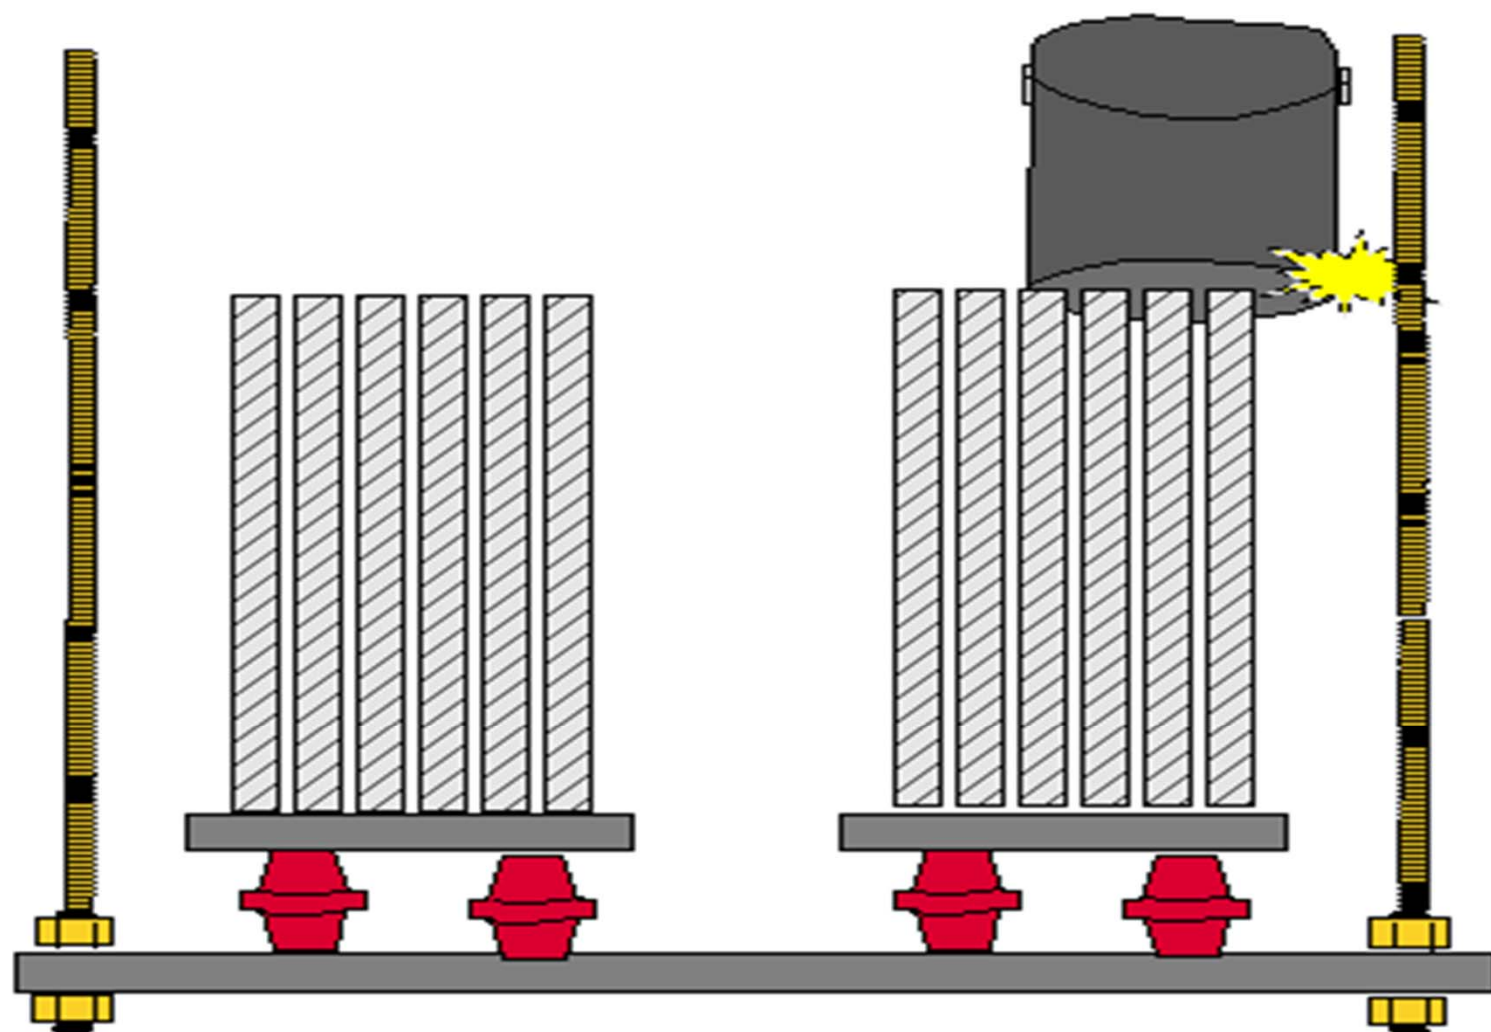
A painter mistook aluminum busbars in a 6,000 Ampere power plant for structural steel. He placed a 1 gallon paint can on the bus shorting the Battery side of the bus to grounded support items.

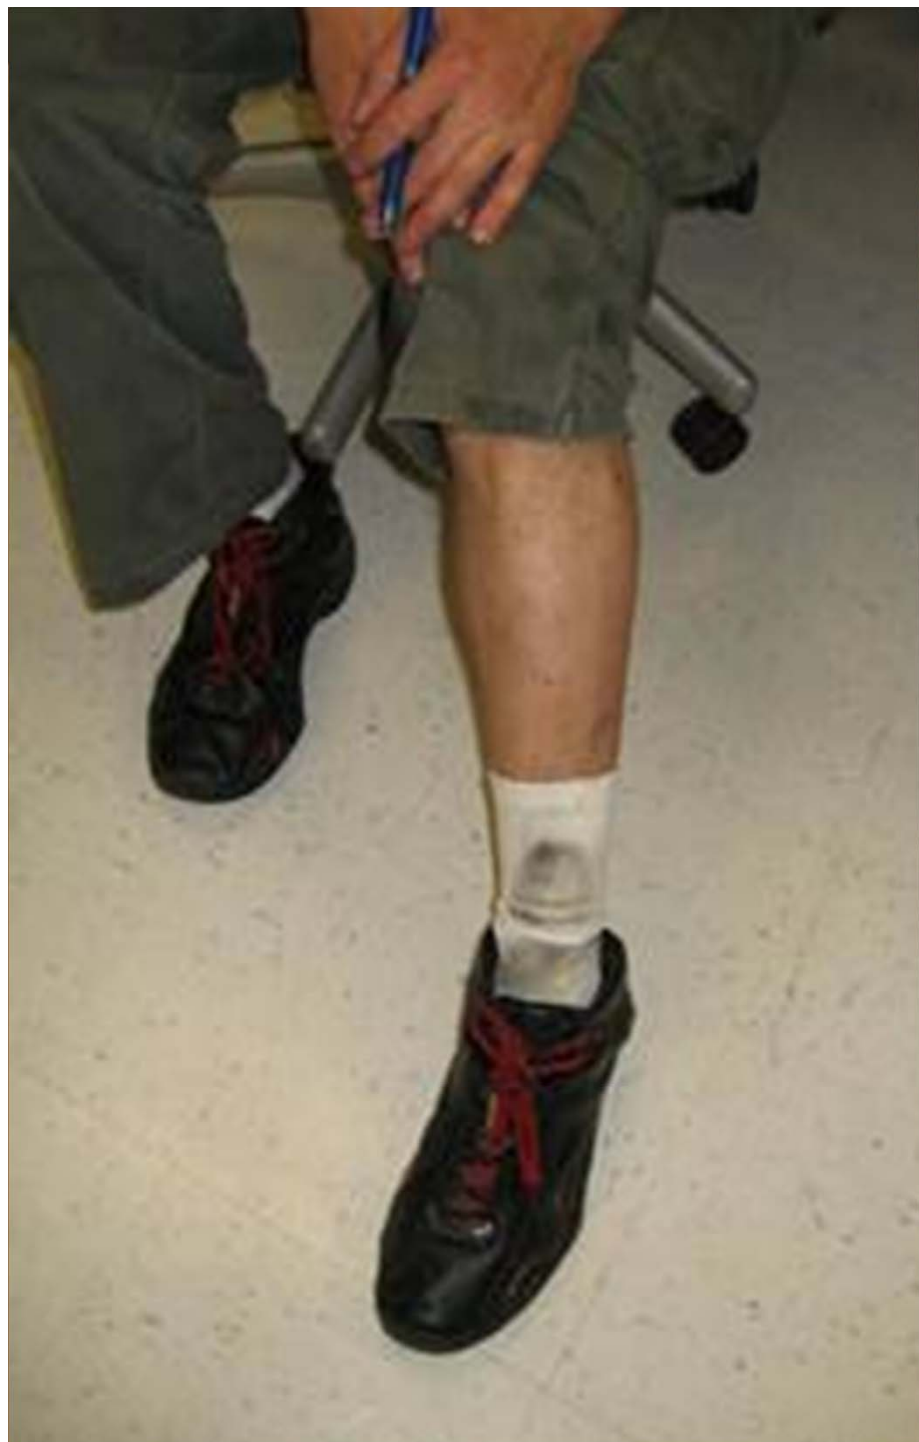
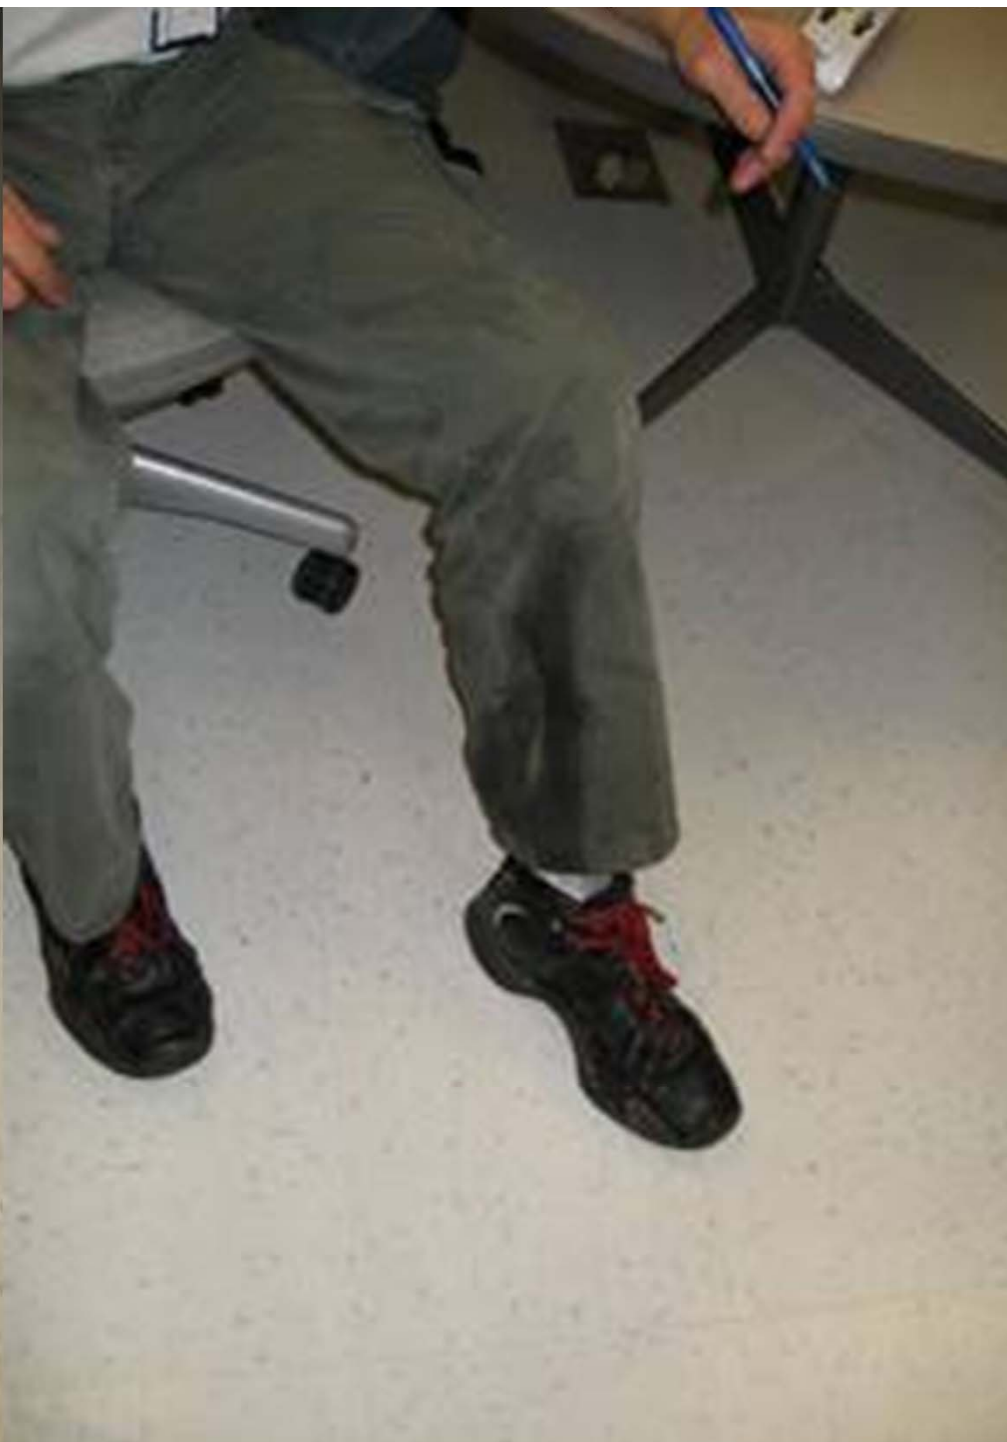
Installer drilling a concrete ceiling placed one foot onto the sheet steel cover of an enclosed dc busduct shorting the grounded cover into the battery bus of a 10,000 Ampere power system.
