Evaluating Wood Pole Structural Integrity using Ultrasound Non-Destructive Inspection Technology

Wayne Hall – President Utility Asset Management Inc

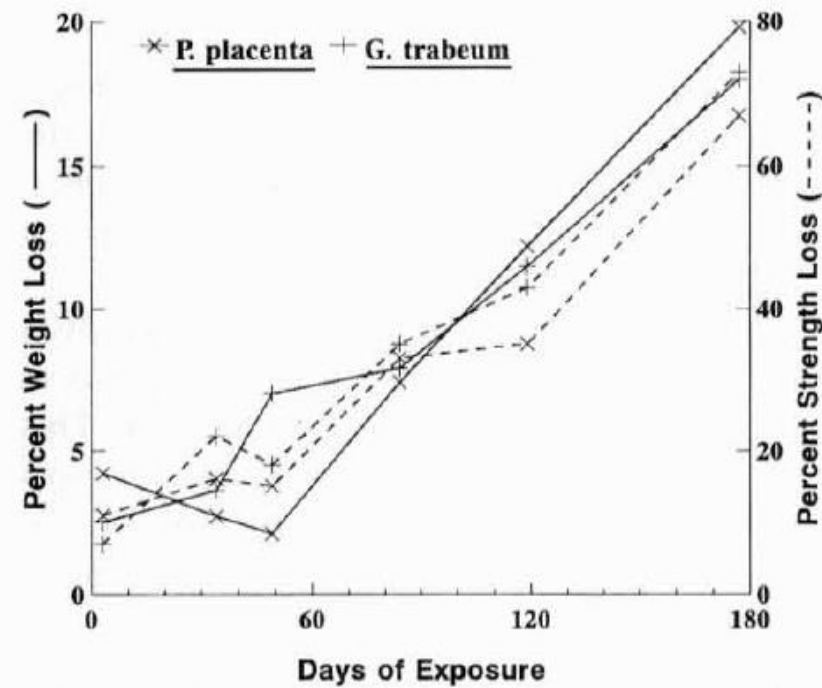
Weight Loss in Incipient Decay Stage => Strength Loss

FIG. 3. Effects of two brown-rot fungi on wood weight loss and modulus of rupture of Douglas-fir heartwood microbeams.

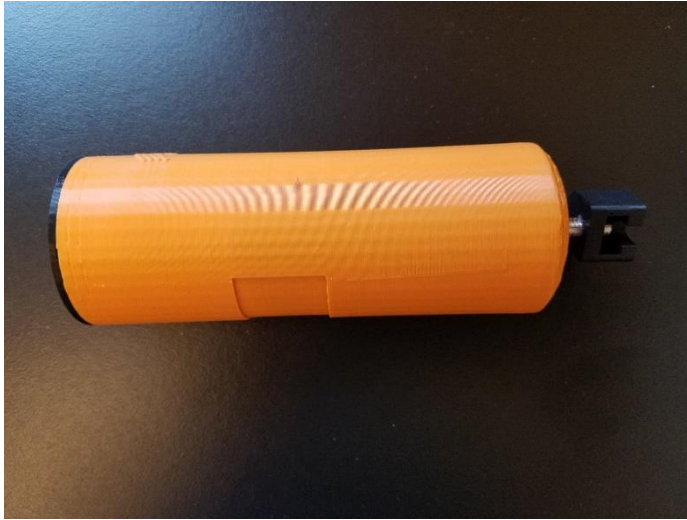
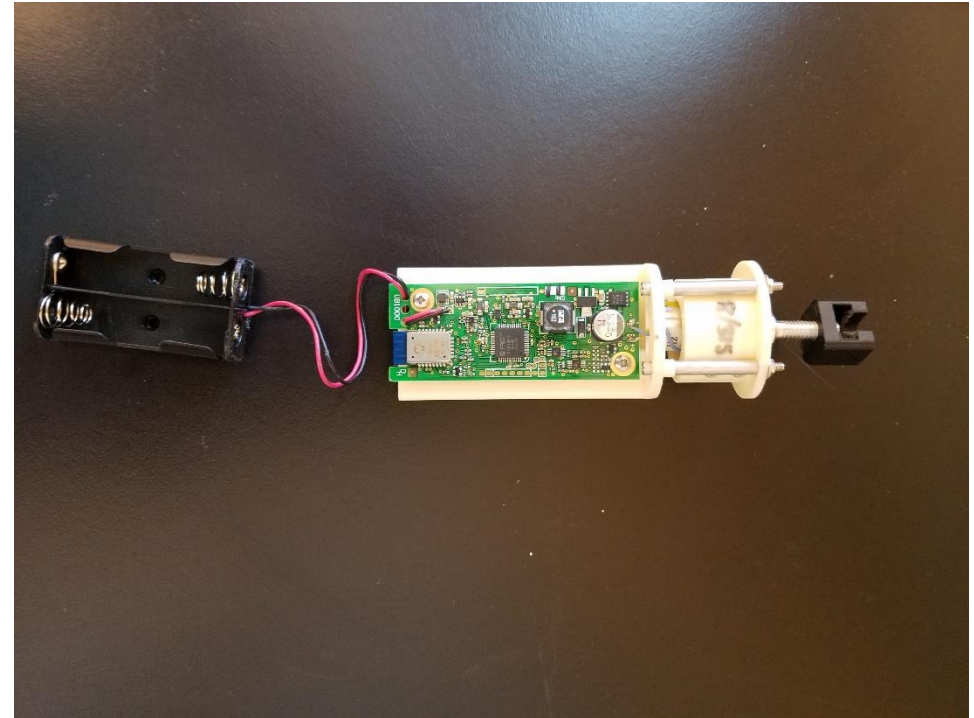
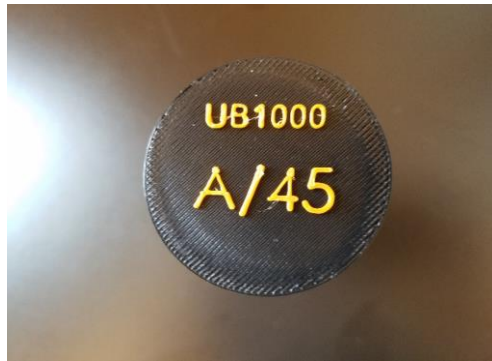
UB1000 Device

- UB1000 - Ultrasound Device
 - Serves as both transmitter and receiver
 - Generate pressure wave at 50 KHz
 - Transmits raw signal to tablet via Bluetooth for further analysis
 - Over 8000 samples downloaded per double download
- Time Domain Energy Algorithm (TDEA) / Pole Analysis App
 - TOF Calculation Immediately
 - ADC (Analog Digital Conversion) downloaded and displayed
 - DSP (Digital Signal Processing) algorithm to avoid false detection.
 - Arrivals 1A, 1B and 2 Calculated
 - Report Generated Pole Analysis App (PAA)

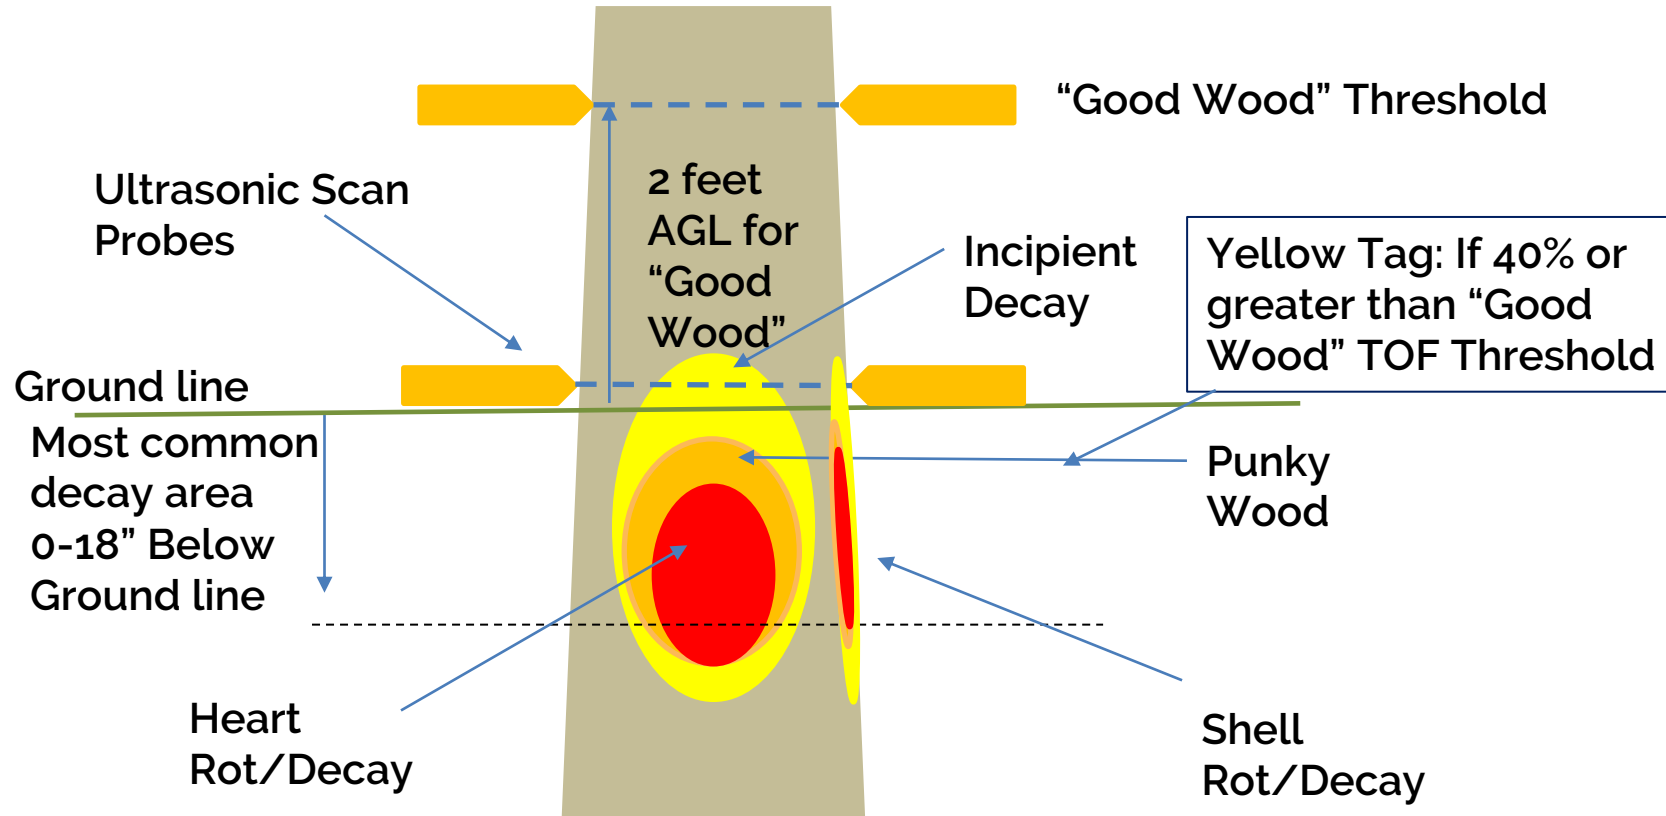
Decay Stages – Ultrasound Advantage

(Identifies all Decay Stages)

Ultrasonics Provides the same efficacy as the "Partial Excavate, Sound and Bore" process

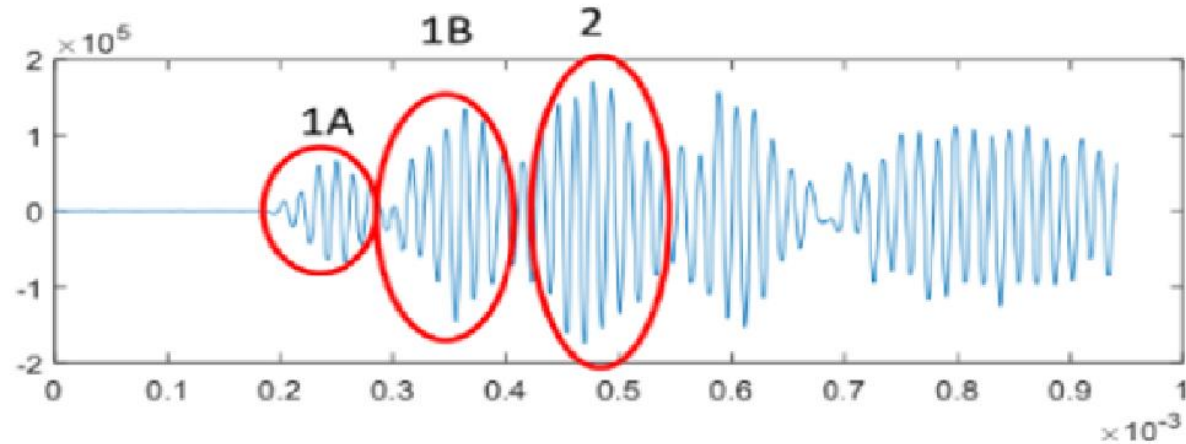
ADC

Example Signals – Good Pole

- 1A – First Arrival – Fastest / lightest signal through heart*
- 1B – First Arrival – Stronger signal through Internal/heart*
- 2 – Second Arrival – Strongest Signal around shell*

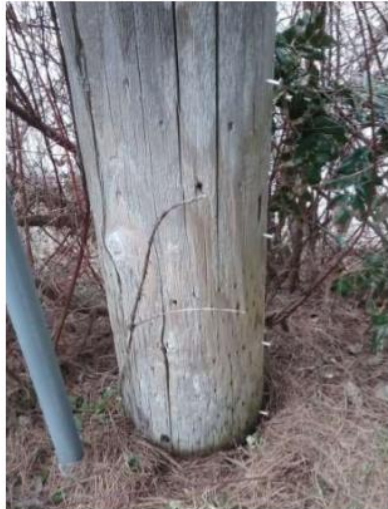
Test Result Pole ID 725186303

Example – Shell Rot – ADC Signal

Red tagged for shell rot with GLC = 40 inches

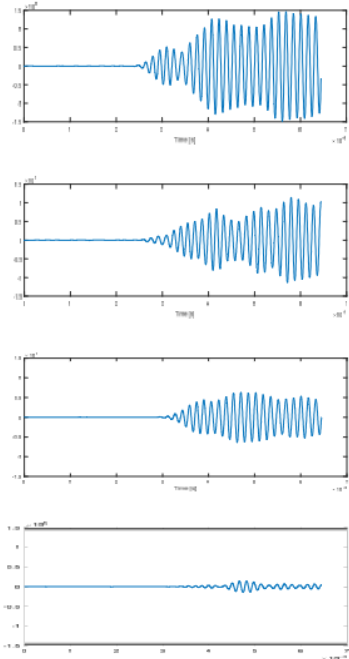
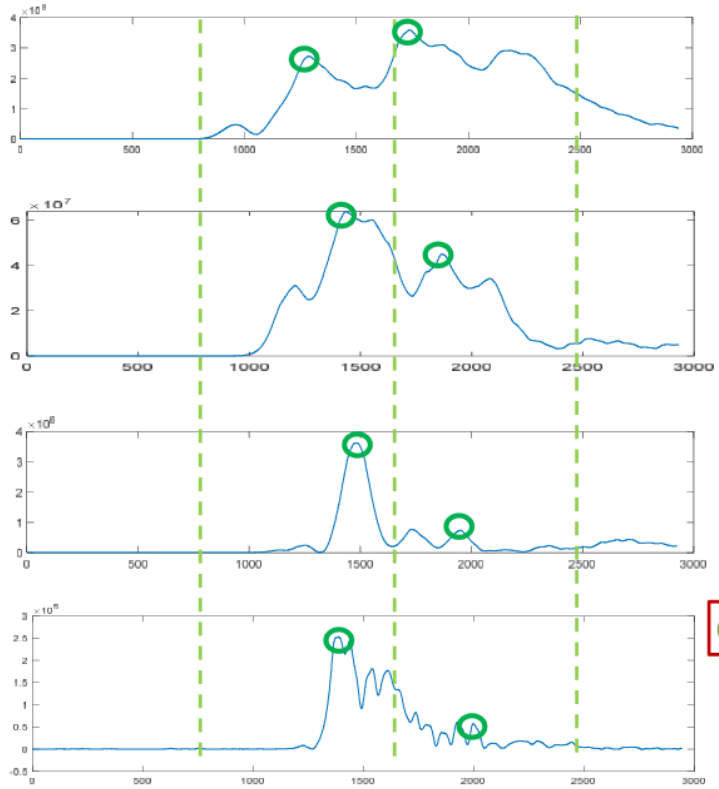
Test Result Pole ID 725186303

Example – Shell Rot – DSP Signal

Internal/Heart Circ/Shell
1st Arrival Region 2nd Arrival Region

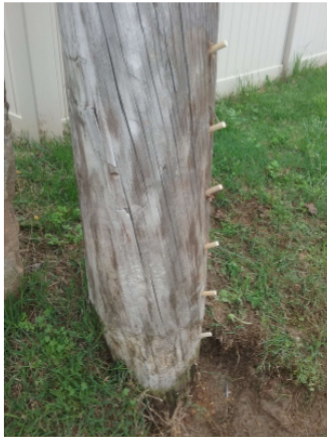
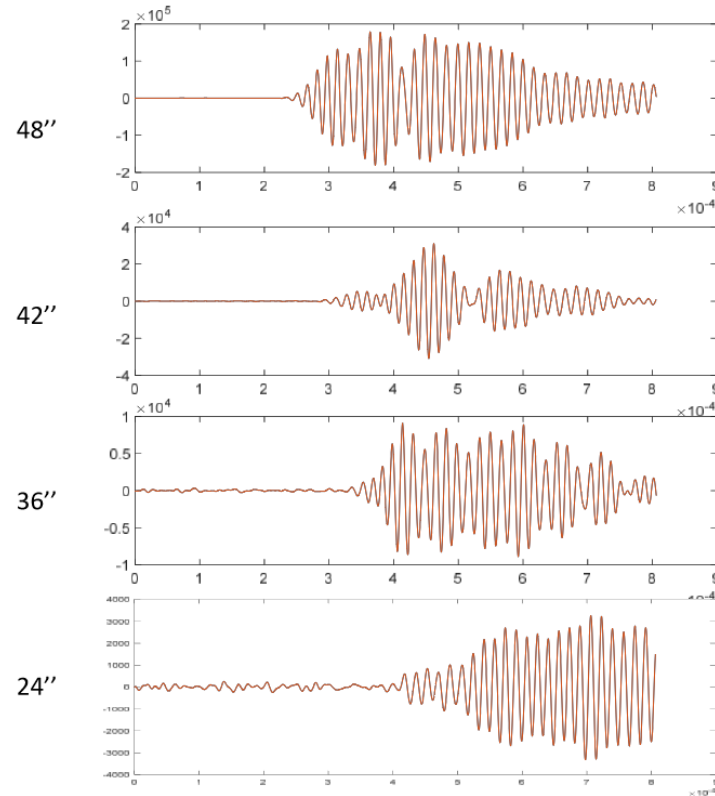
Test Result Pole ID C140

Example – Internal Decay– ADC Signal

Red tagged for heart rot with GLC
= 40 inches

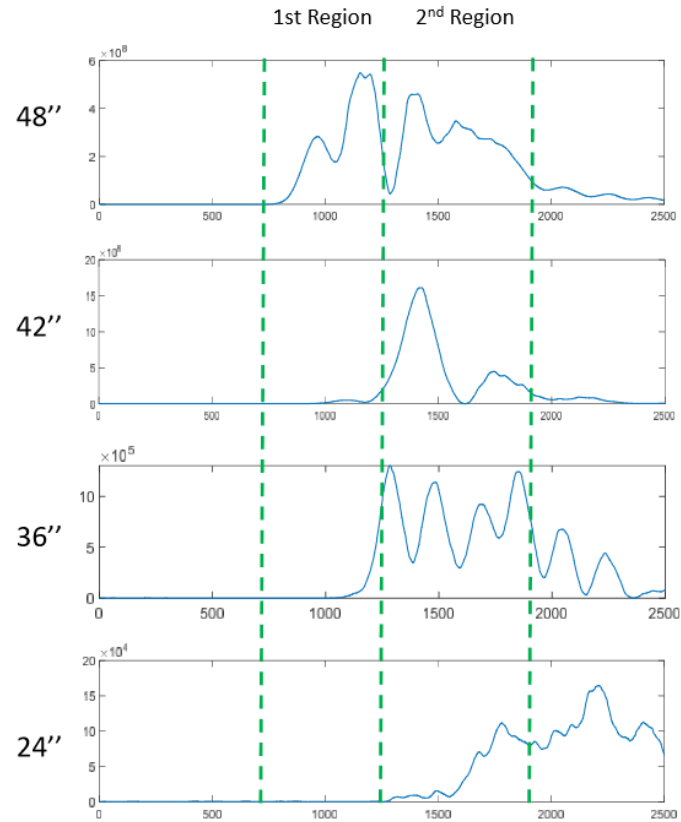
Example – Internal Decay – DSP Signal

Internal/Heart Circ/Shell

1st Arrival Region

AGL	TOF1B	Peak Energy
48	377	5.3
42	353	0.0048
30	374	0.0027
12	ND	ND

Huge attenuation in the 1st arrival region suggests heart rot decay.

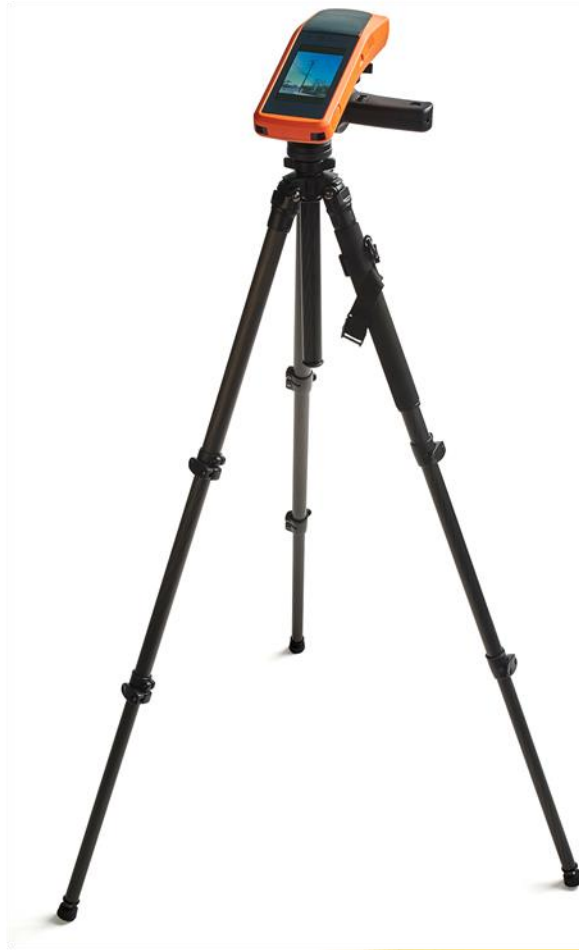
IKE 4 Device

The IKE 4 device incorporates the latest mobile technologies to produce a best-in-class high-performance, lower-power field data collection solution. Key device features include:
